CITY OF ANN ARBOR MRF INSPECTIONS

Findings From June 11, 2016

The following findings were identified during a safety inspection at the MRF on June 11, 2016.

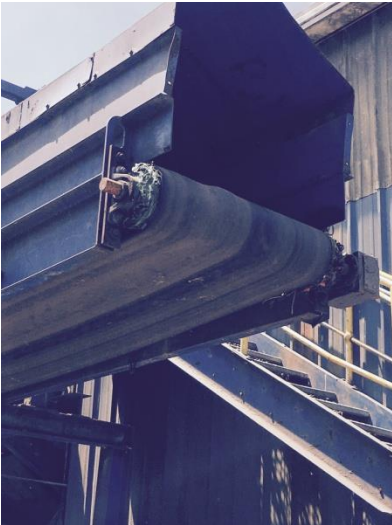
Material located / jammed in conveyer roller

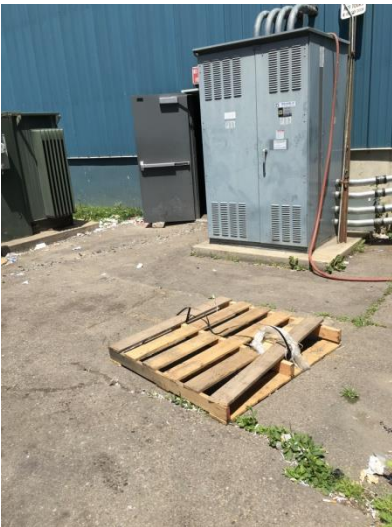
Excessive trash located outside

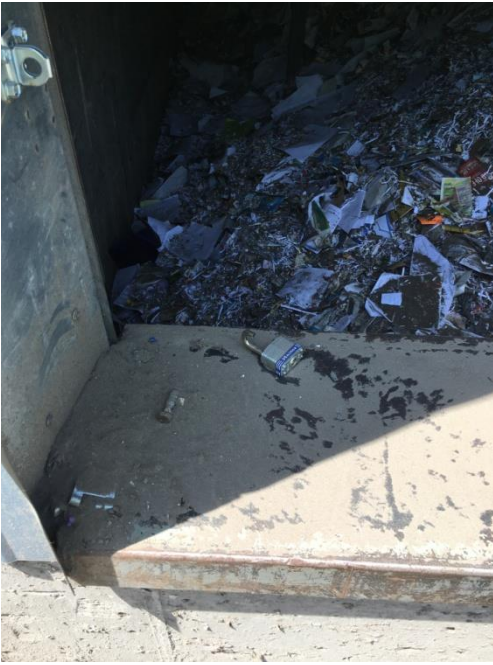
Improperly secured confined space with lock cut-off

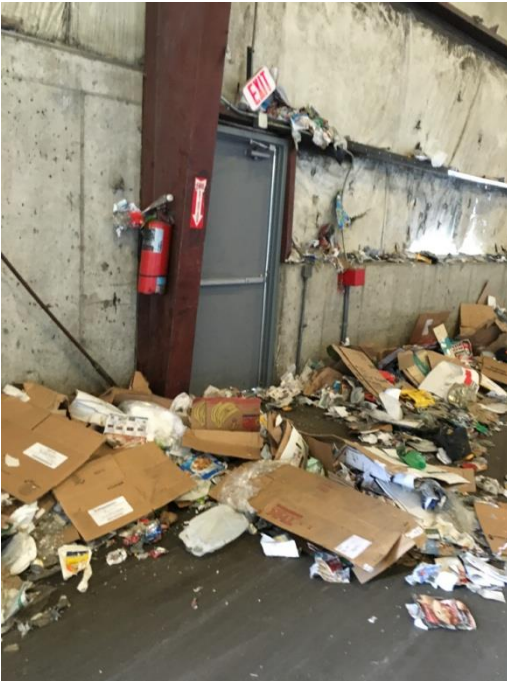
Fire extinguisher and fire exit blocked with material. Exit sign damaged

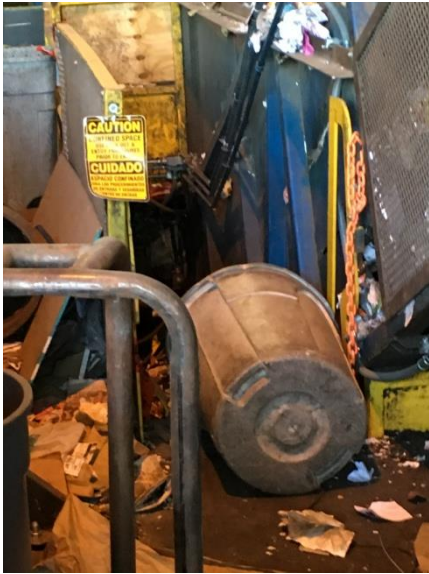
Confined space unsecure and blocked

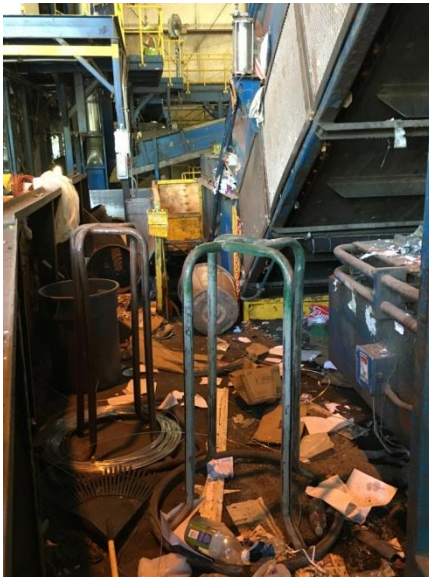
Blocked E-stop at baler.

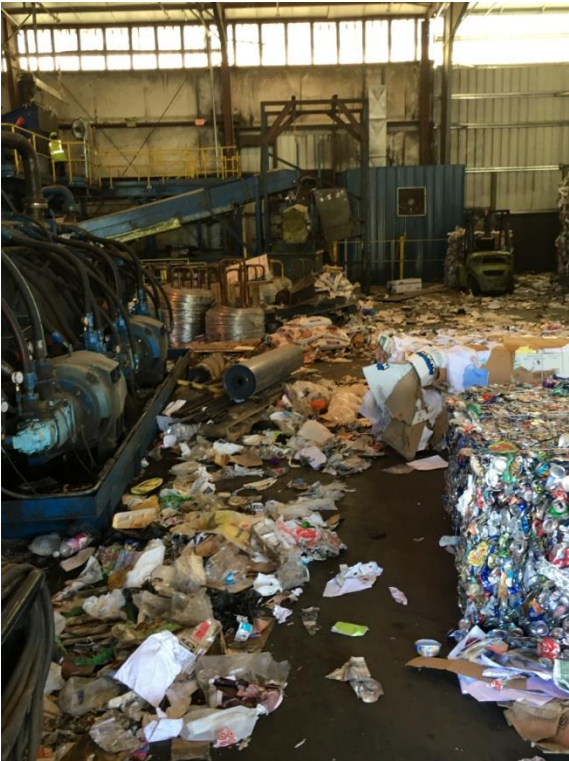
Excessive trash, improperly stored material, and egress concerns

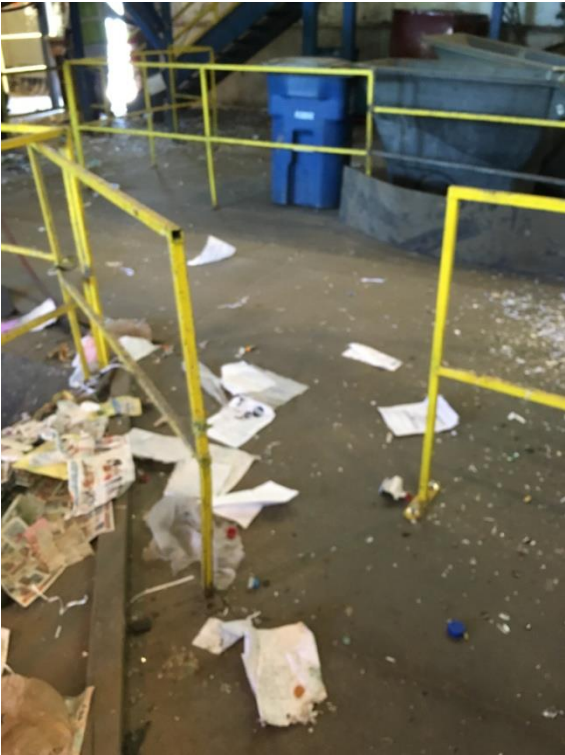
Unsecured blockade / railing

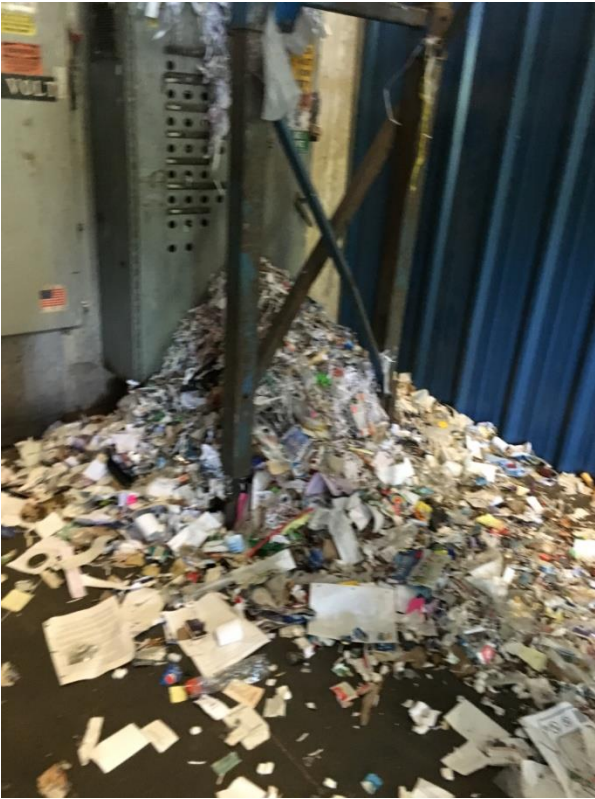
Excessive material and trash.

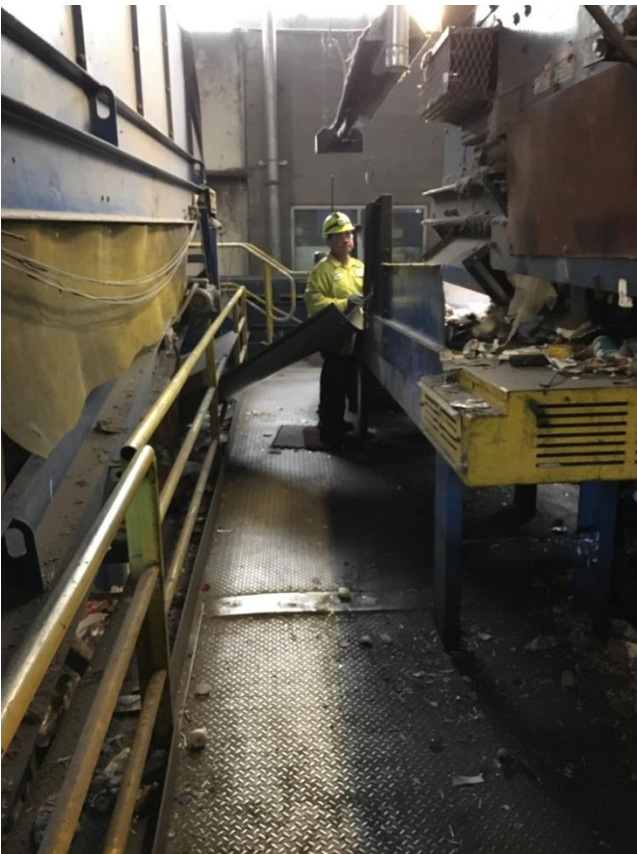
Blocked egress or no sign indicating not an egress area.

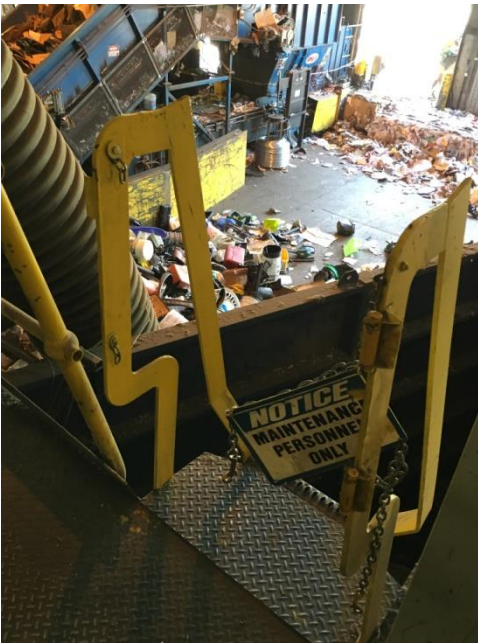
Unsecured authorized area.

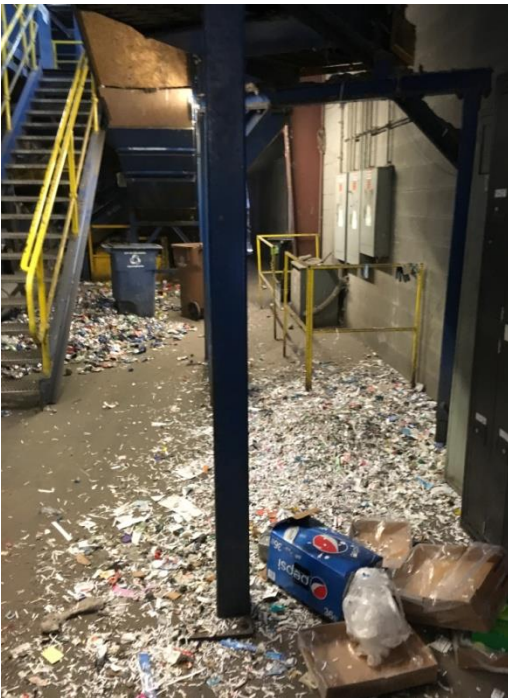
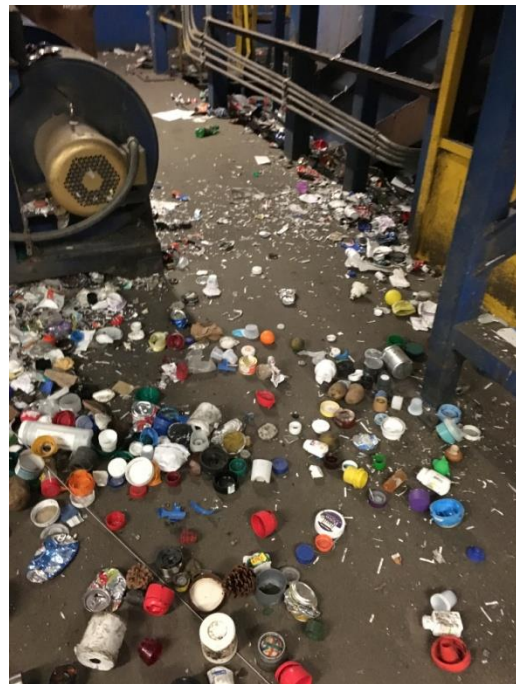
Excessive trash / material located on floor creating slip, trip and fall hazards.

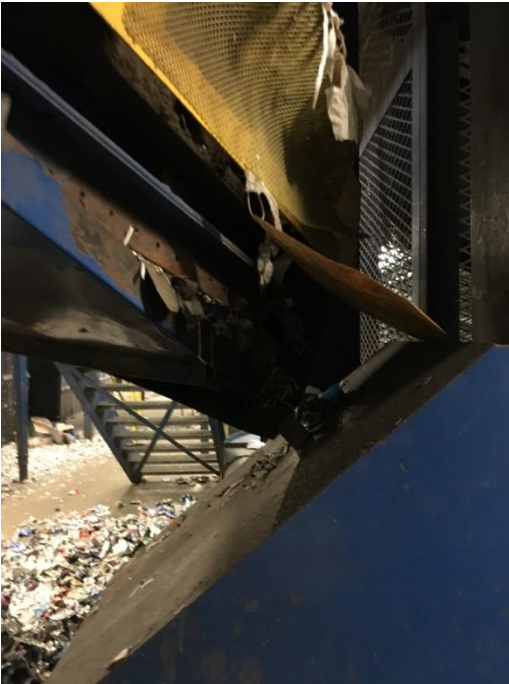
Damaged equipment causing material spillage resulting in slip, trip, and fall hazards.

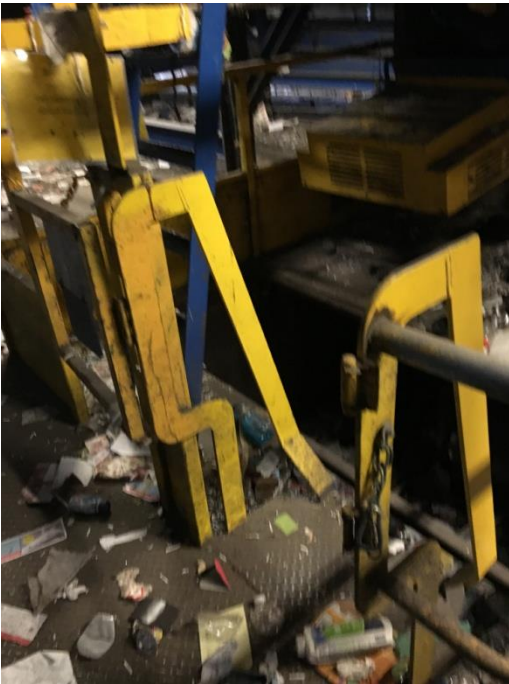
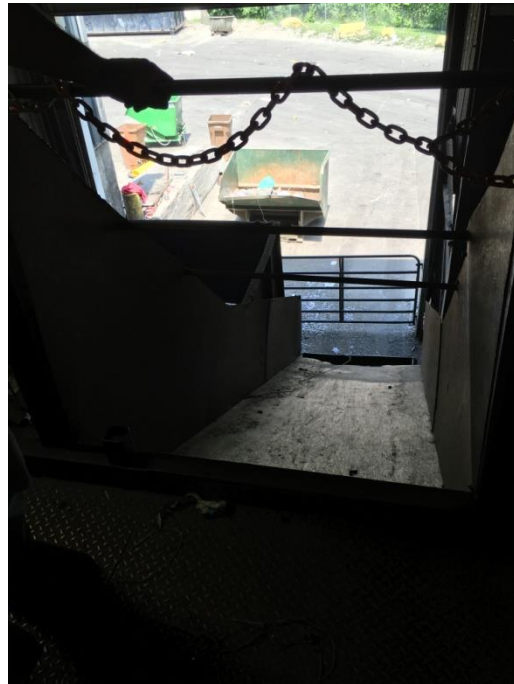
Fall Hazards / missing railing or chains.

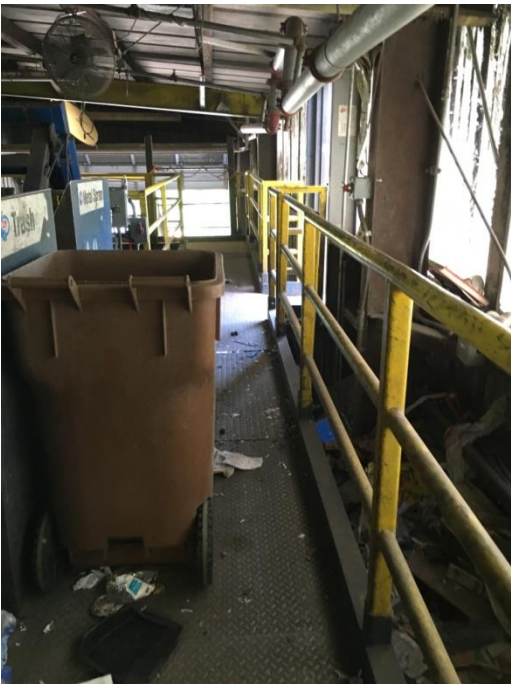
Blocked fire egress.
