Materials Recovery Facility  
Safety Observation Form

Date: Tuesday, June 21, 2016

Name of Observer: Shawn Qualls

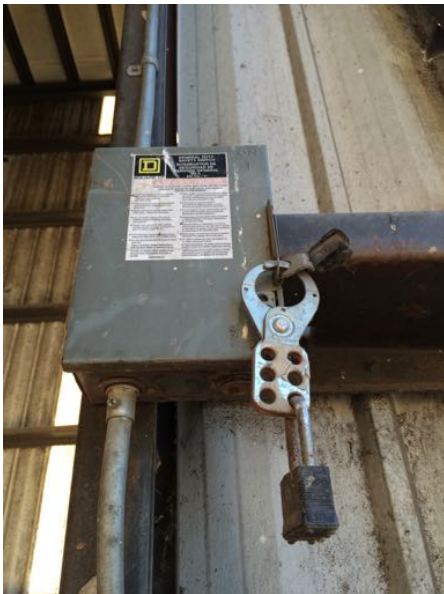
Top left:

- Switch: blade bent
- Improper labeling
- Cover not secured against unauthorized entry
- Out of service? If so, no tag.

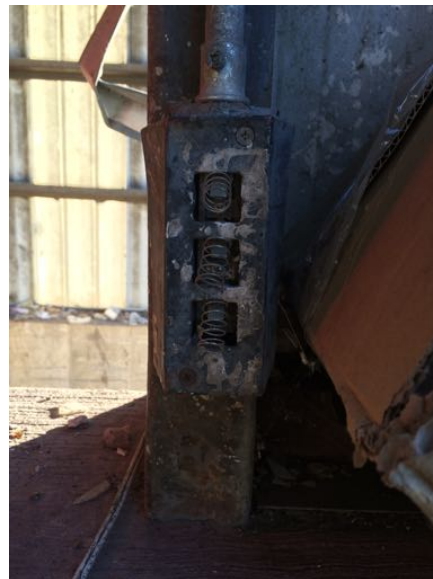
Top right: missing button covers

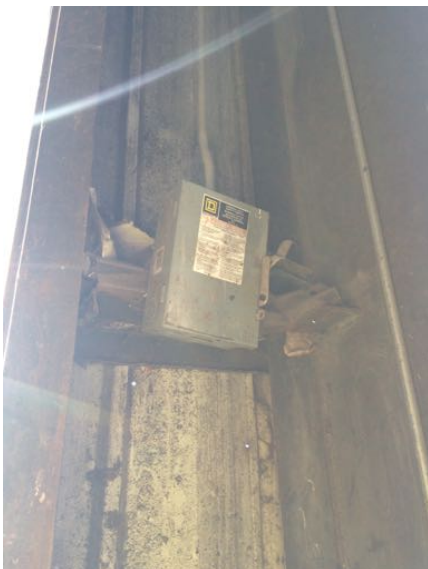
Bottom:

- Heavily damaged
- Switch: blade bent
- Cover not secured against unauthorized entry
- Not secured – steel cross-beam damaged

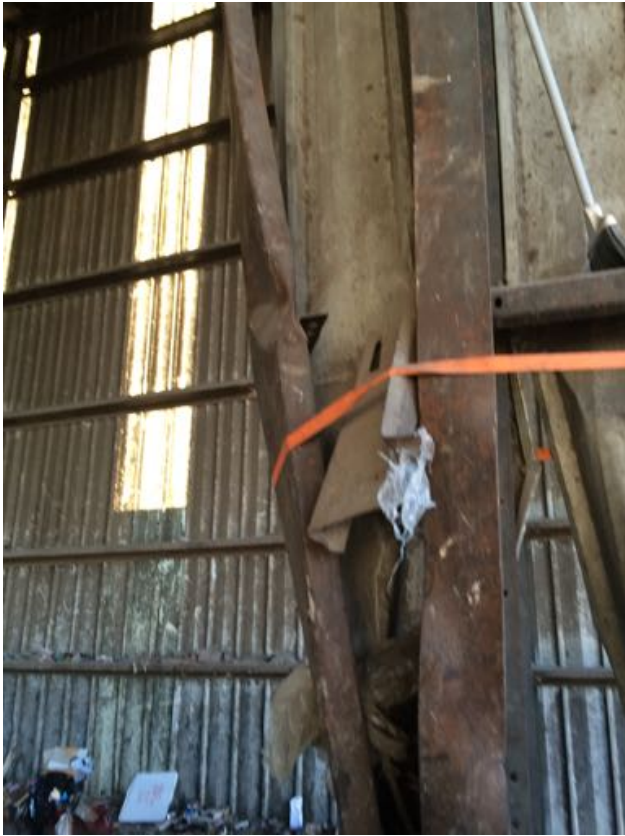
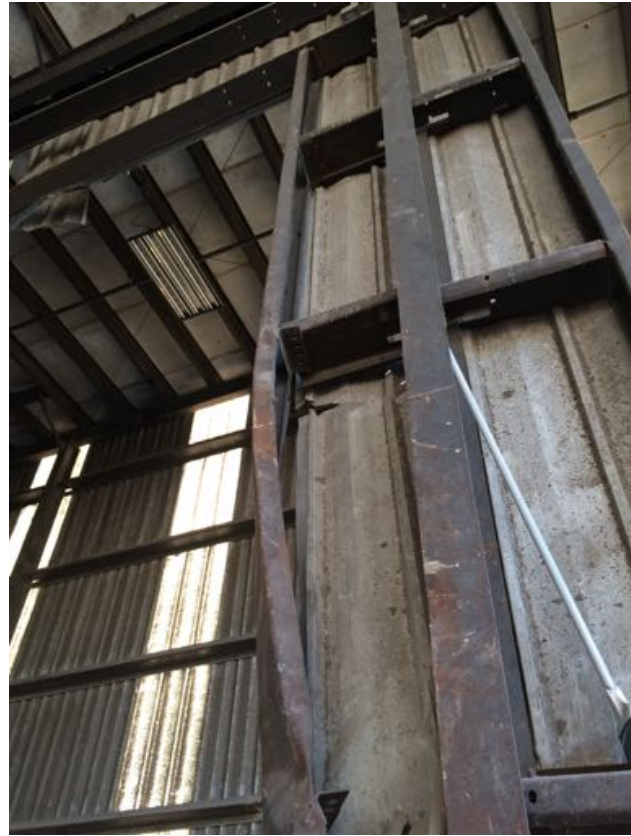
Top: Structural damage – struck by equipment

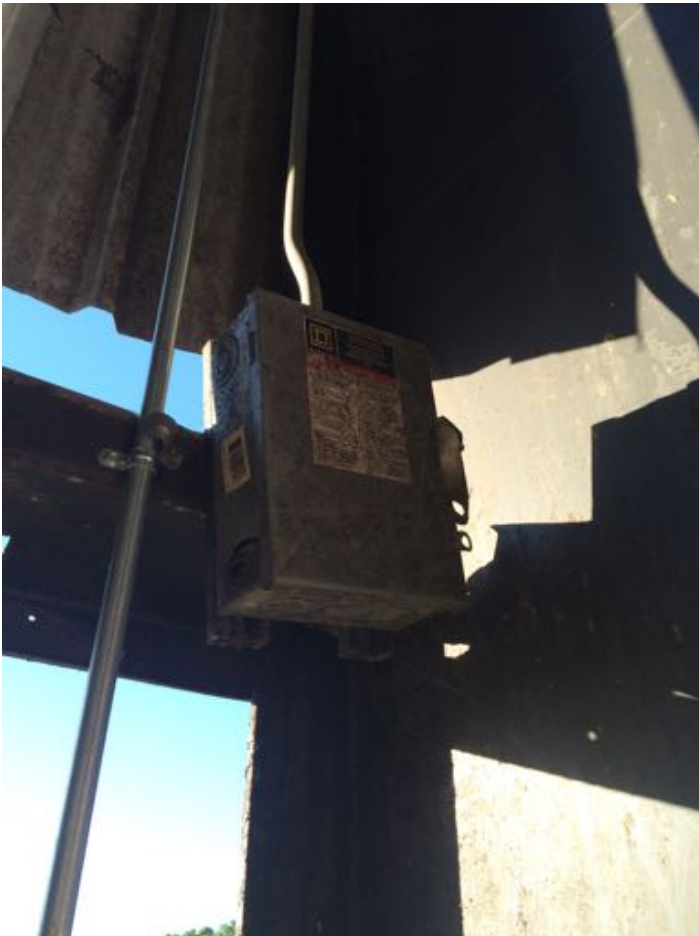
Bottom:

- Switch: blade switch missing
- Improper labeling
- Holes in exterior of enclosure
- Cover not secured against unauthorized entry
- Exterior sheet metal missing from building – switch exposed to elements

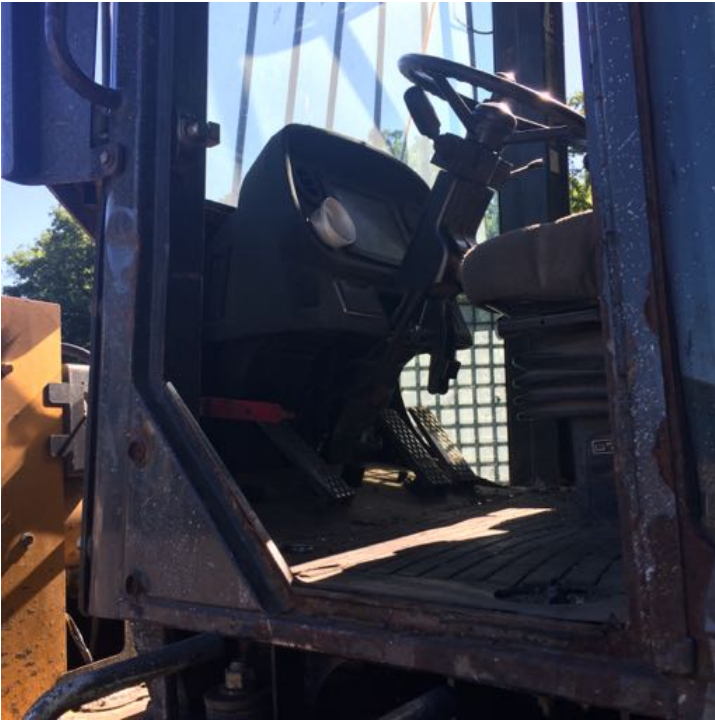
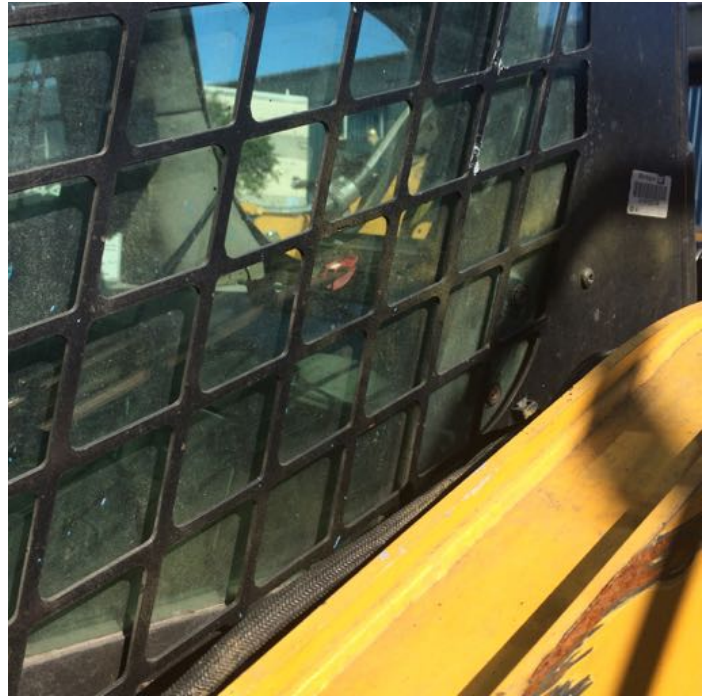
Top: two pieces of equipment with missing fire extinguishers

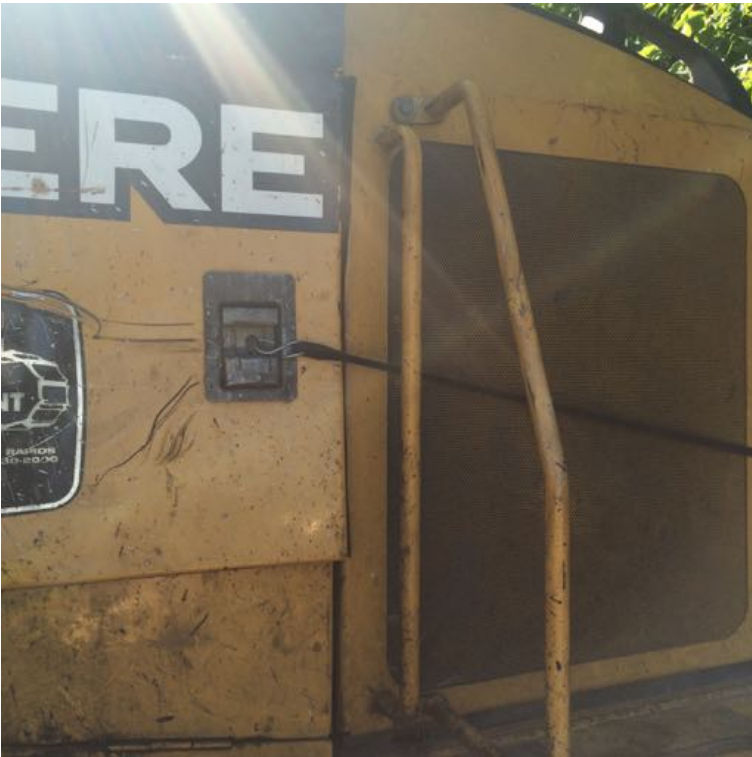
Bottom: exterior door panel secured with bungee cord

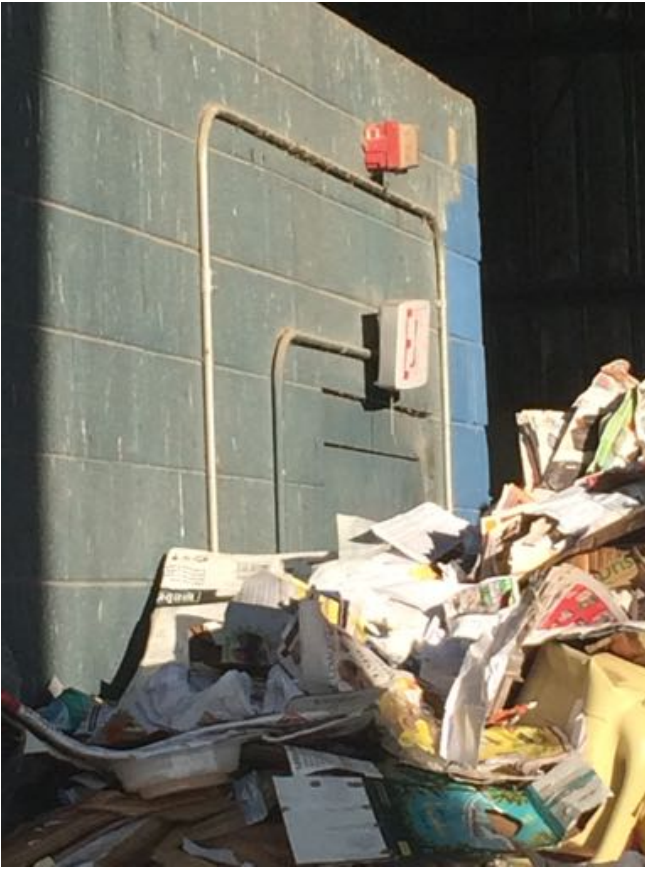
Top left:

- Door blocked
- Exit sign not secured

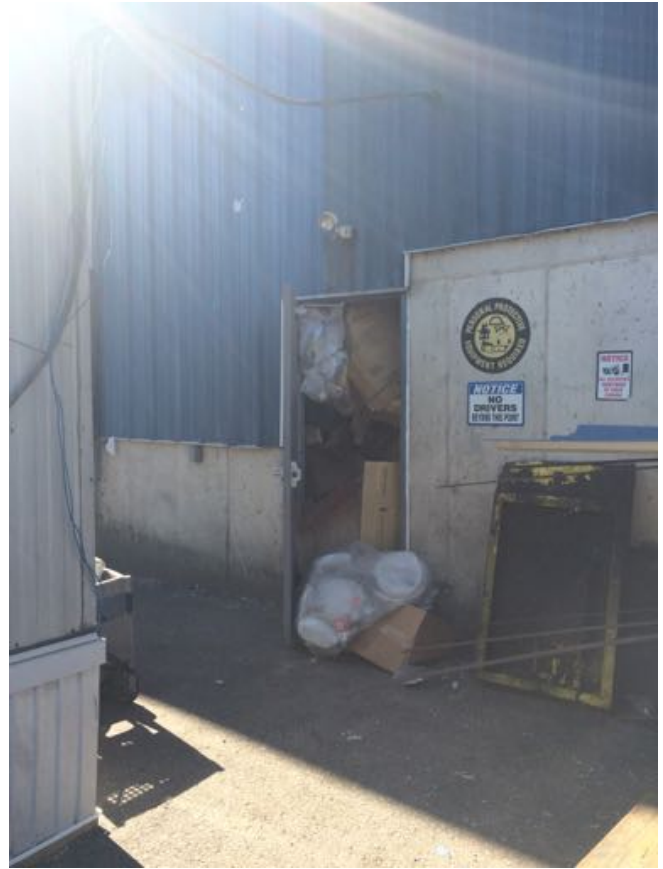
Top right:

- Door blocked
- Materials (metal) improperly stored; sticking out creating cut/puncture hazard

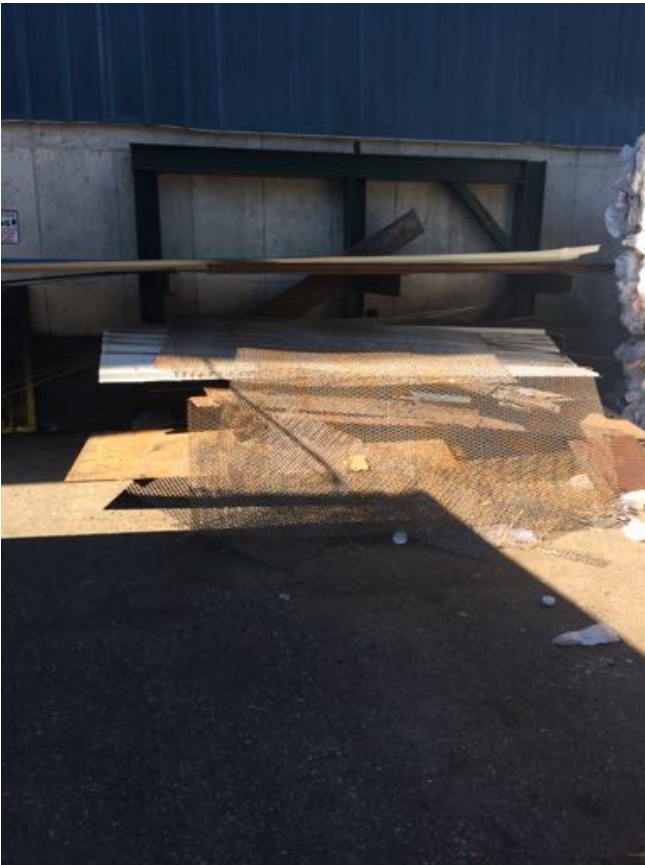
Bottom: Improper materials storage.

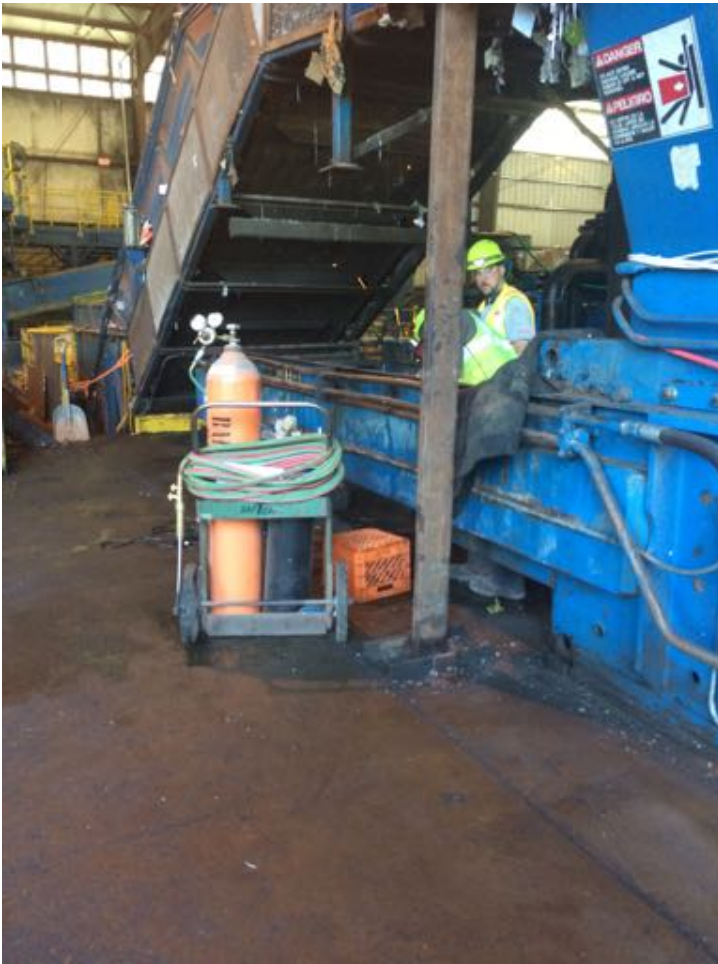
Top left: CG cylinders too close to ongoing cutting operations; within range of flying sparks.

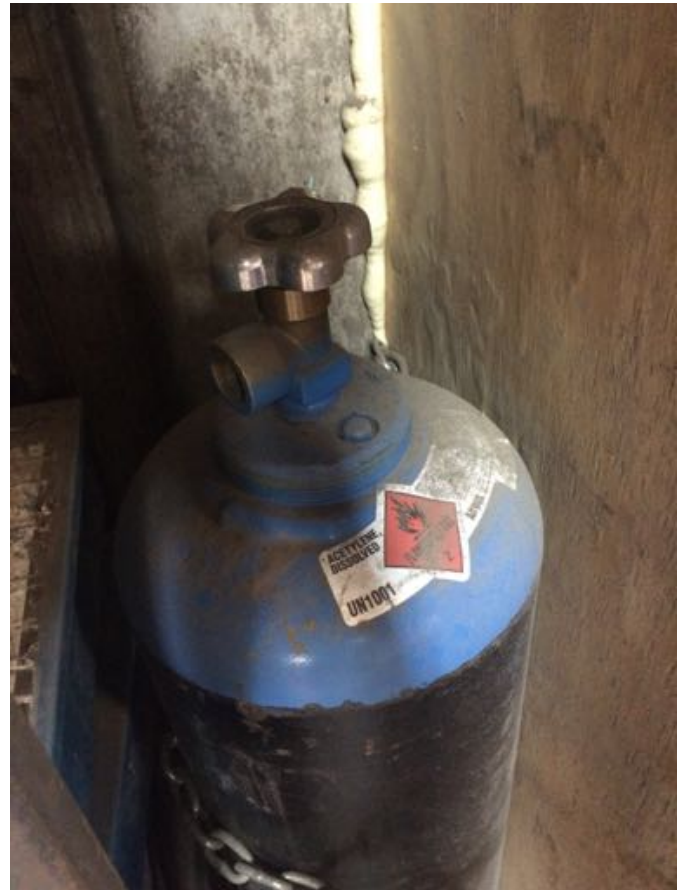
Top right: CG Cylinder stored without cap

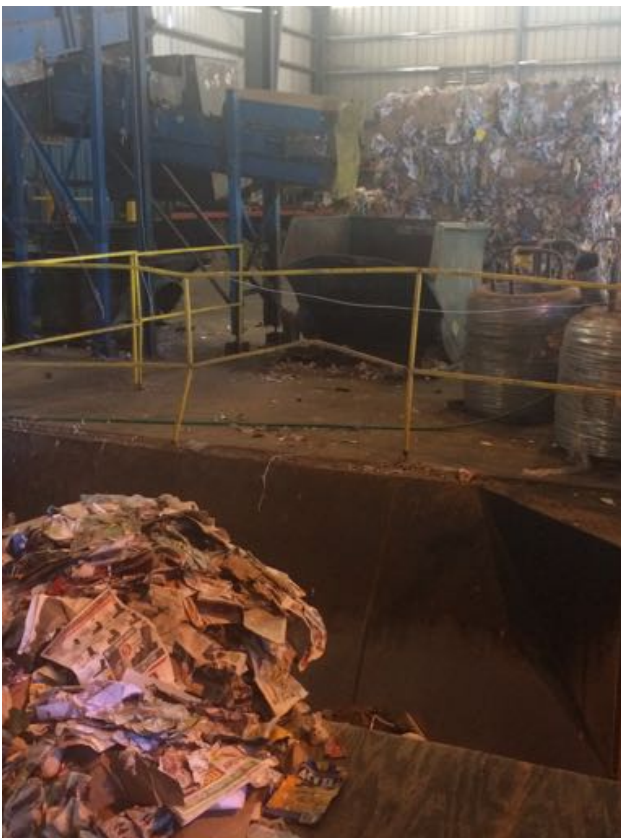
Bottom: damaged guardrail

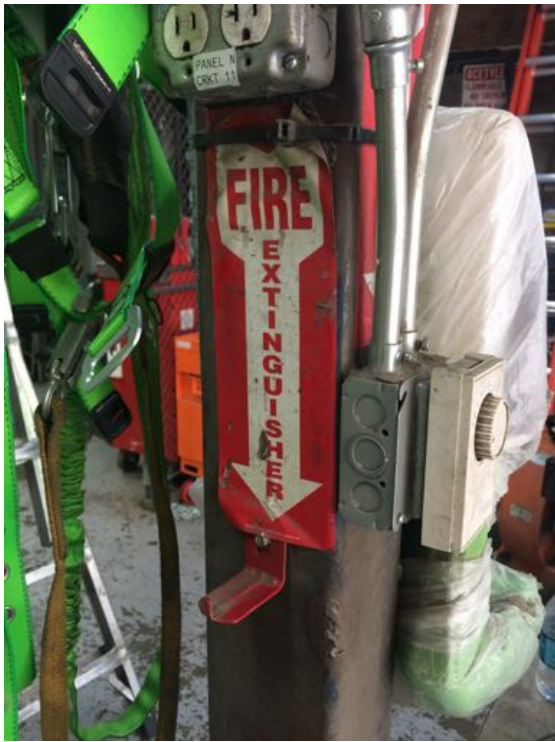
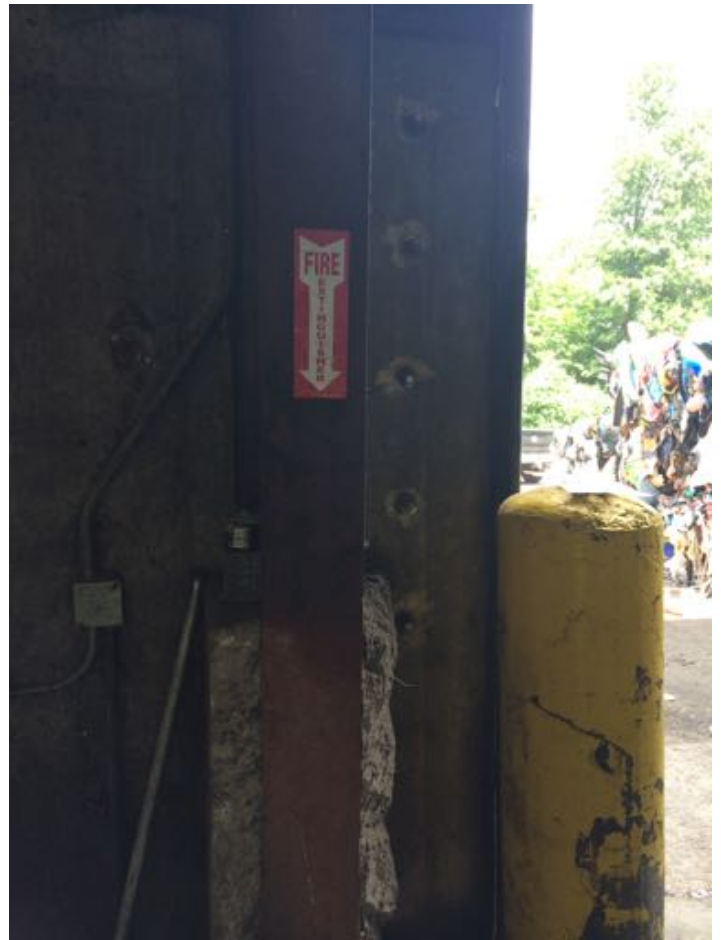
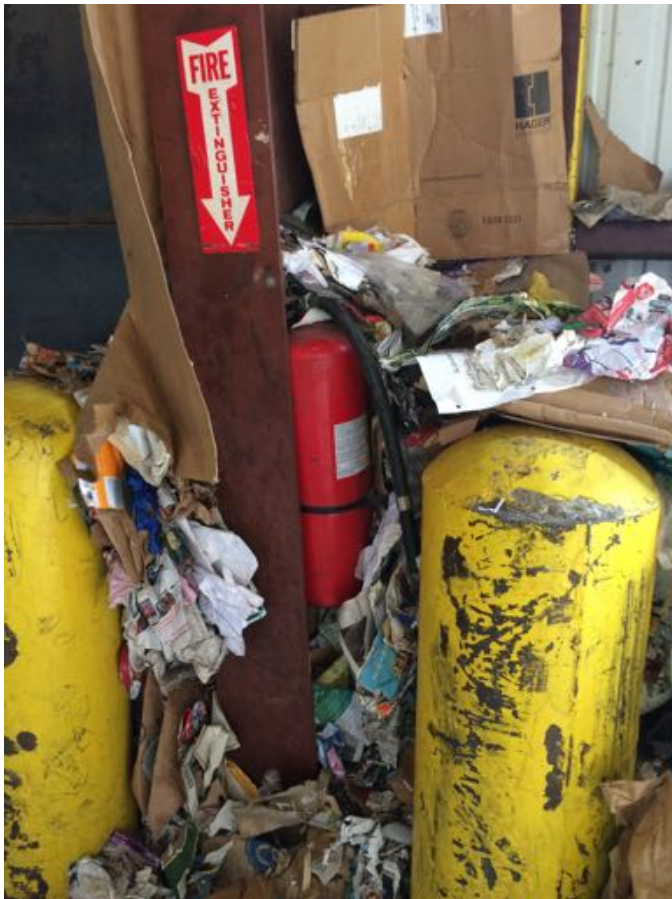
All: Fire extinguishers missing or inaccessible

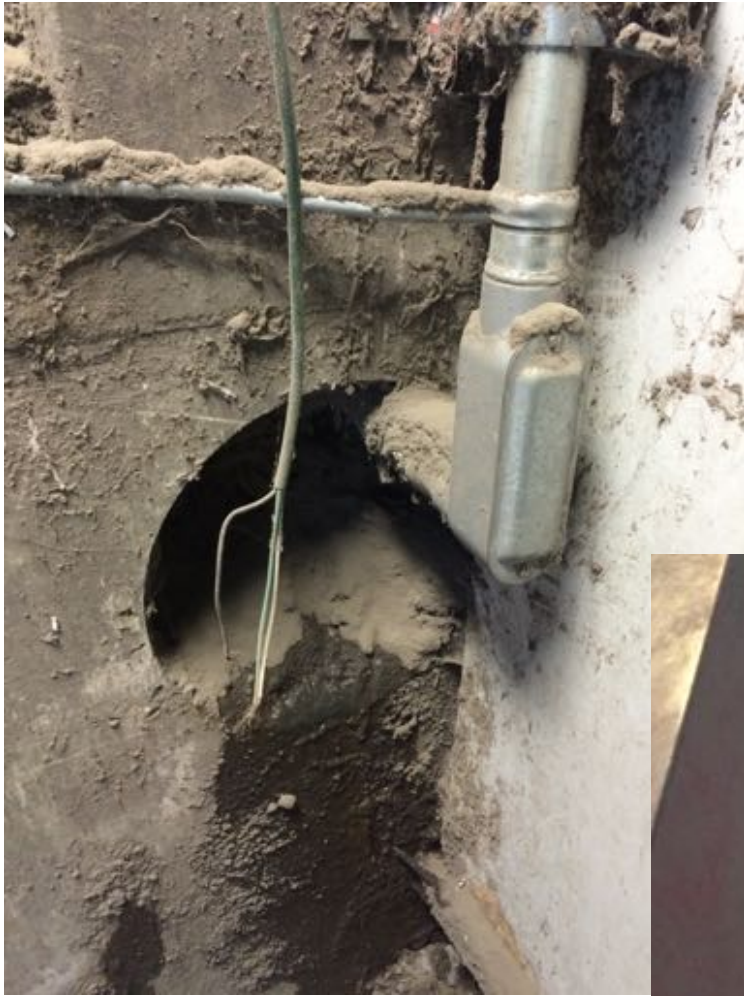
Left:

- Exposed wiring
- Dust build-up near exposed wiring;  
fire hazard

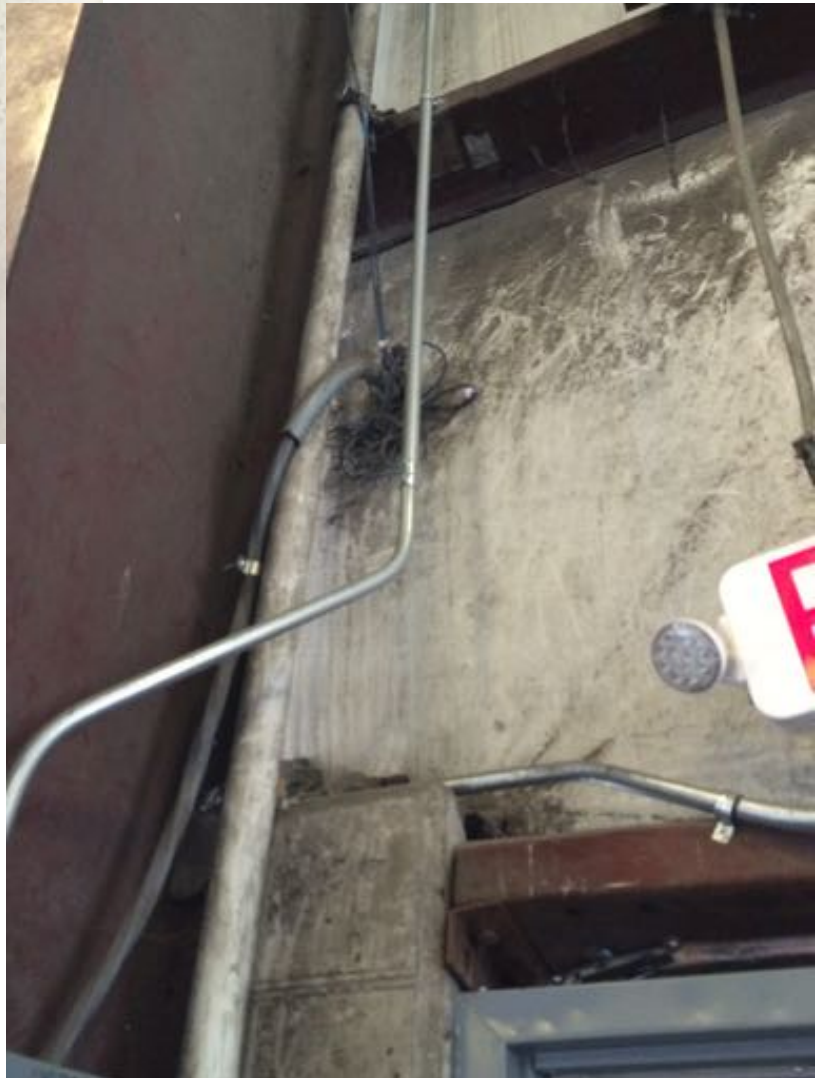
Right: Exposed wiring

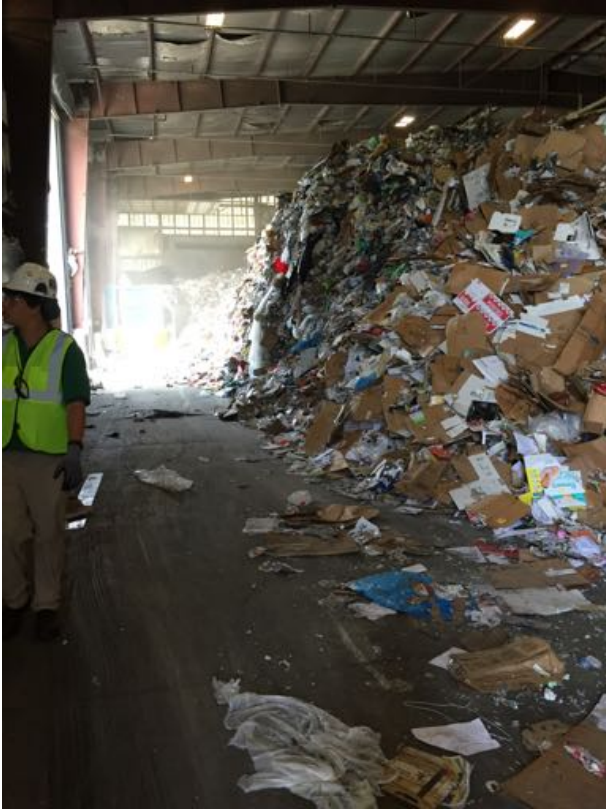
Top left: pile is too high and potentially unstable. "walkway" not suitable for people to walk through (crush hazard). Area should be barricaded.

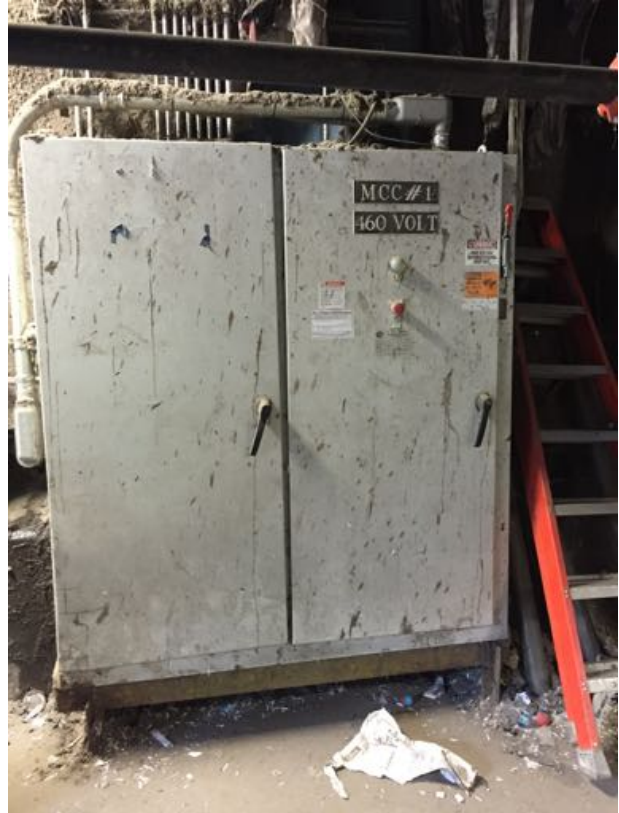
Top right:

- Electrical cabinet inside (former?) confined space.
- Dust/debris atop/underneath cabinet.
- Make sure working clearance can be maintained.
- Access control – make sure cabinets are locked or inaccessible to unqualified persons.

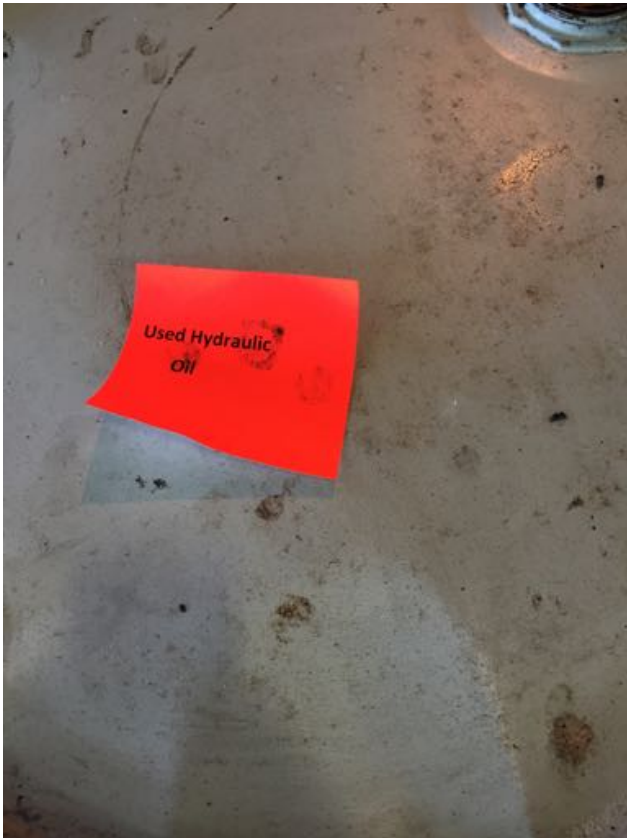
Bottom: Labeling

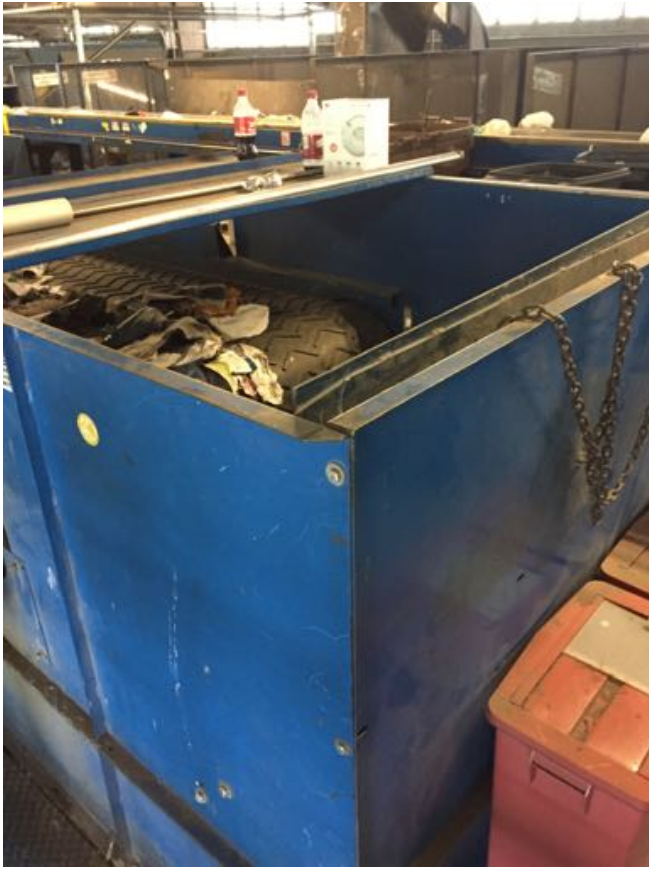
Top left: No guard

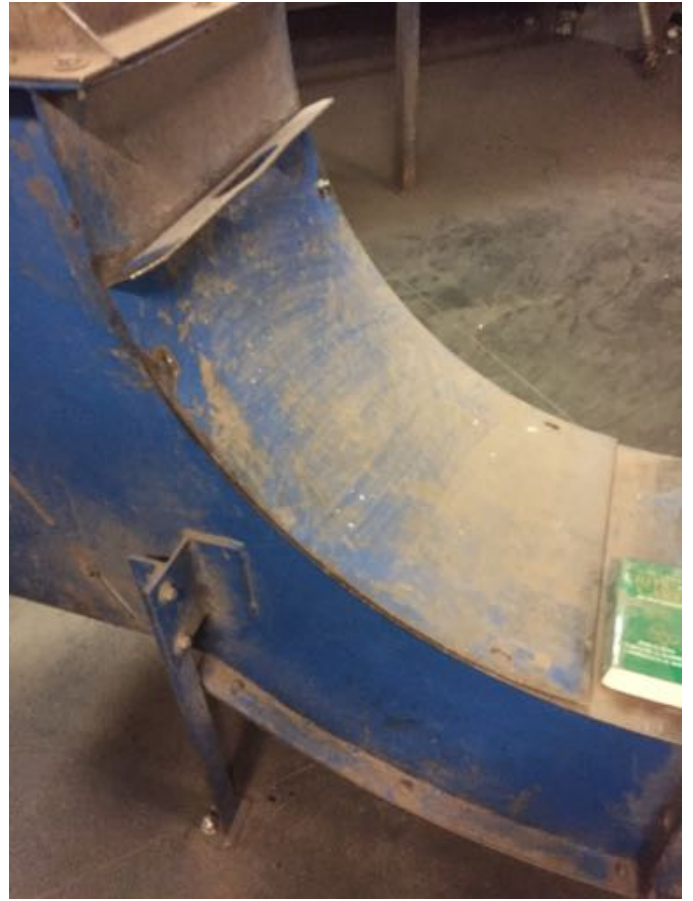
Top right: Cover not secured, screws missing

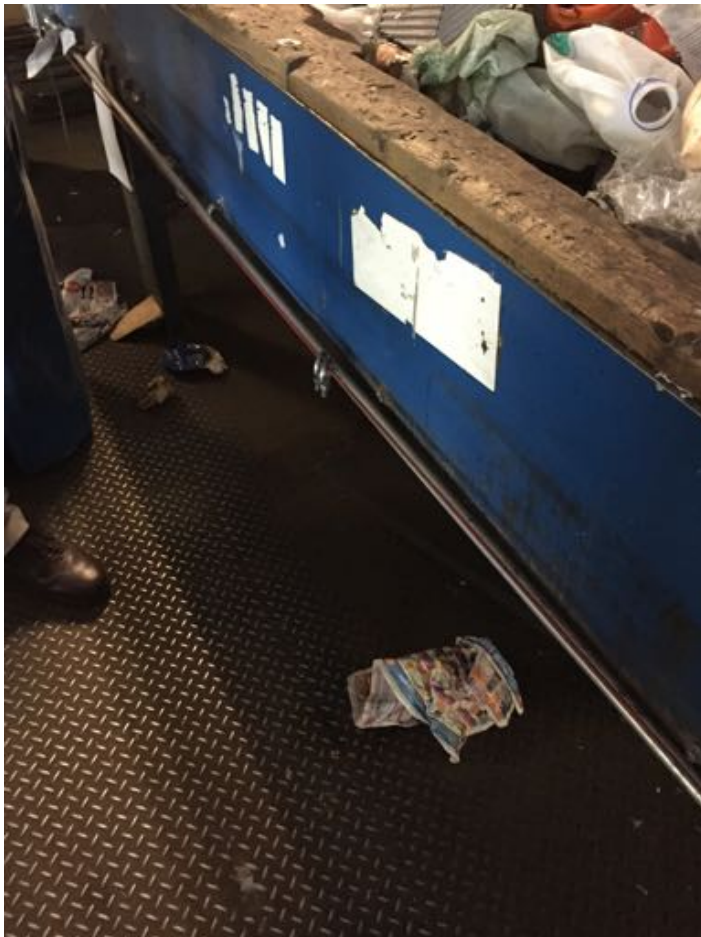
Bottom: Eye bolts that hold emergency stop-line to the conveyor at multiple points came out.
