Materials Recovery Facility  
Safety Observation Form

Date: Wednesday, June 22, 2016

Name of Observer: Shawn Qualls

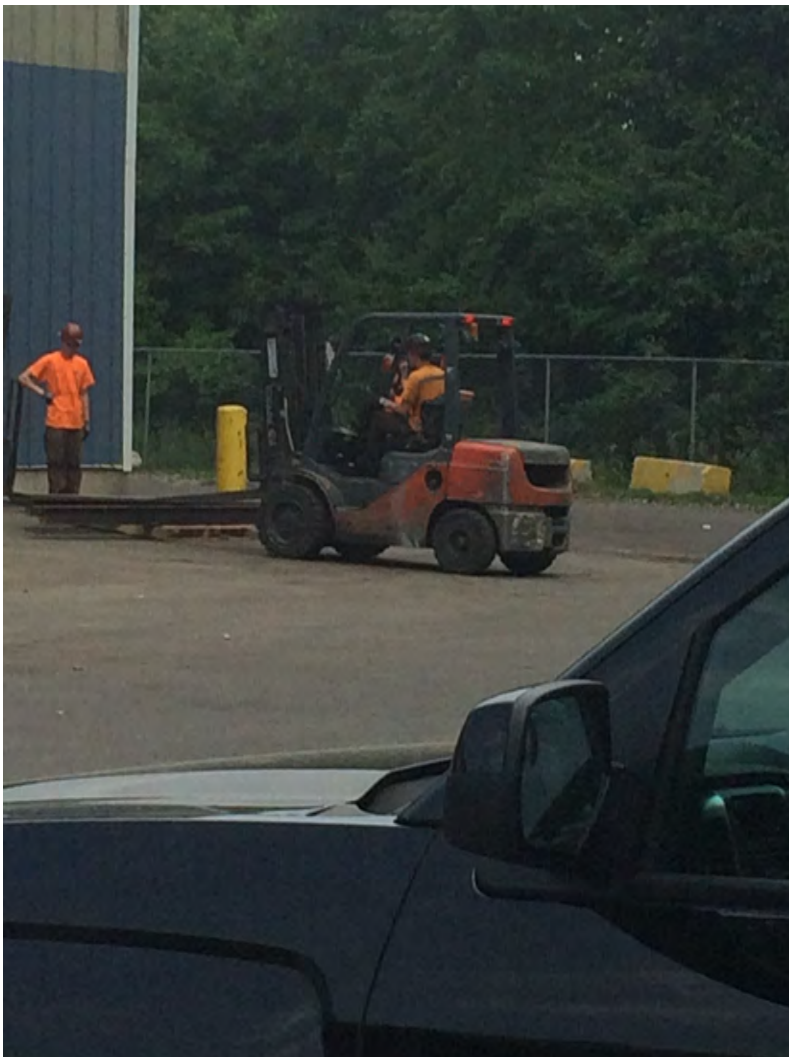
Left:

- Spotter standing in pinch-point between forklift/load and wall [1910.178(m)(1)]
- Load not secured

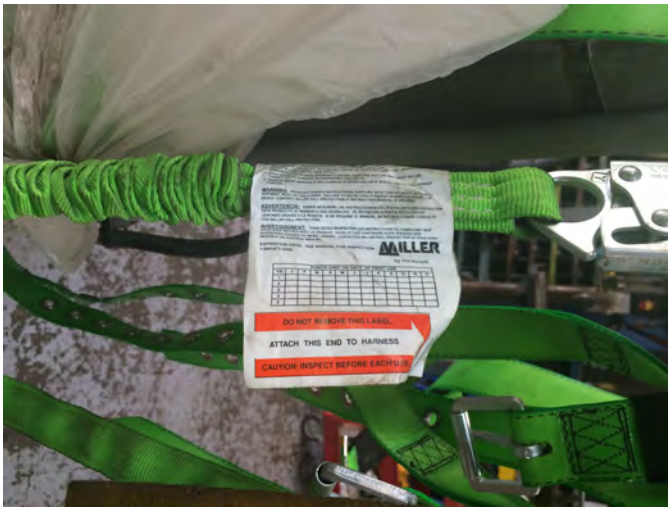
Above:

- Illegible tags
- Metal components rusted
- Cuts/abrasions
- Remove from service

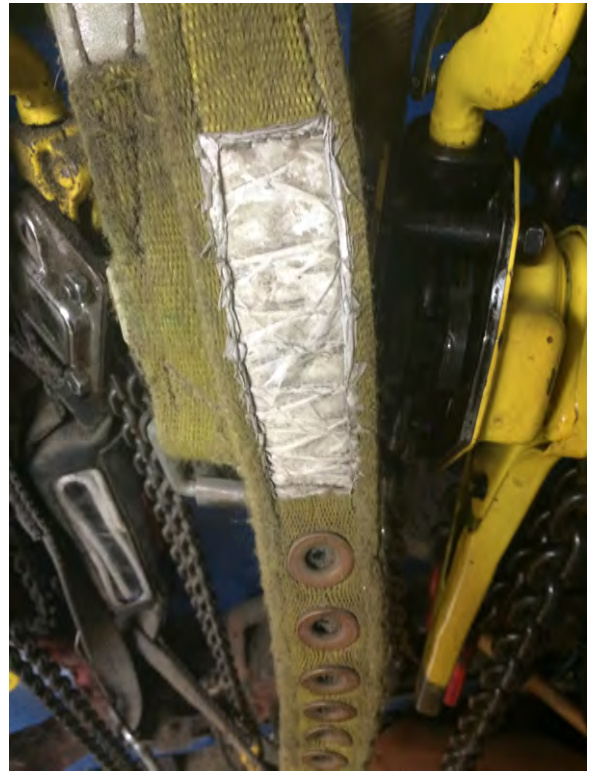
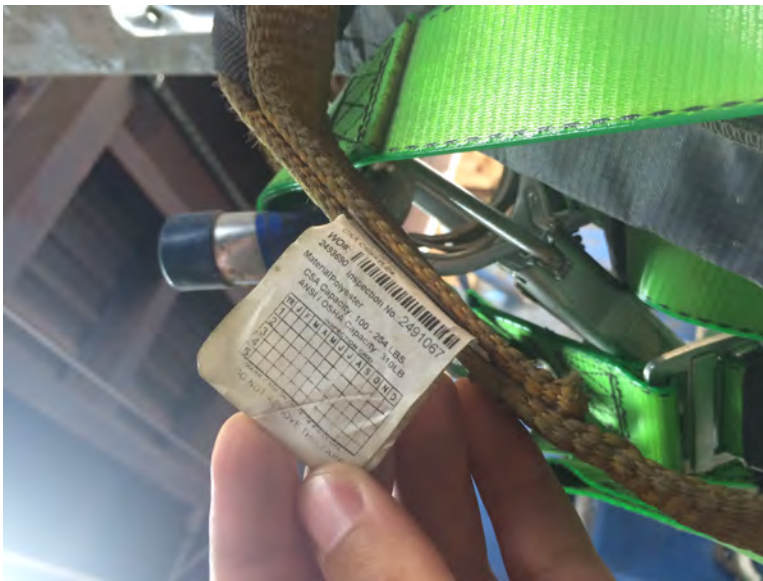
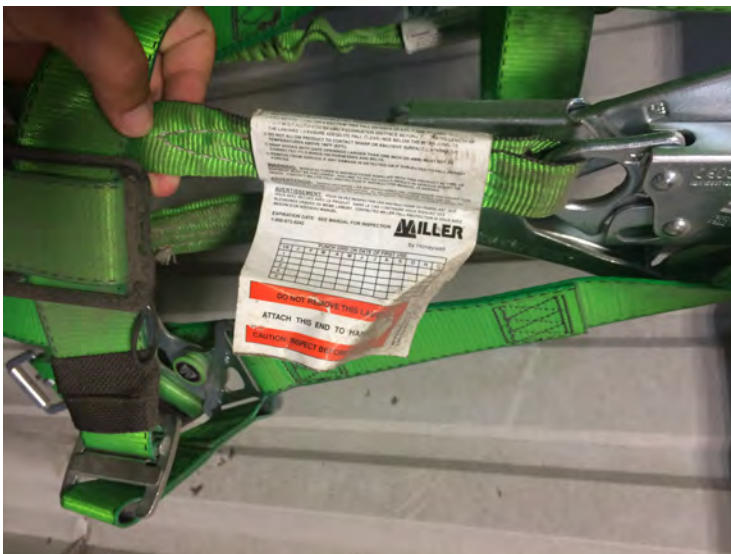
Left top/middle/bottom

- Tags show equipment inspections never performed

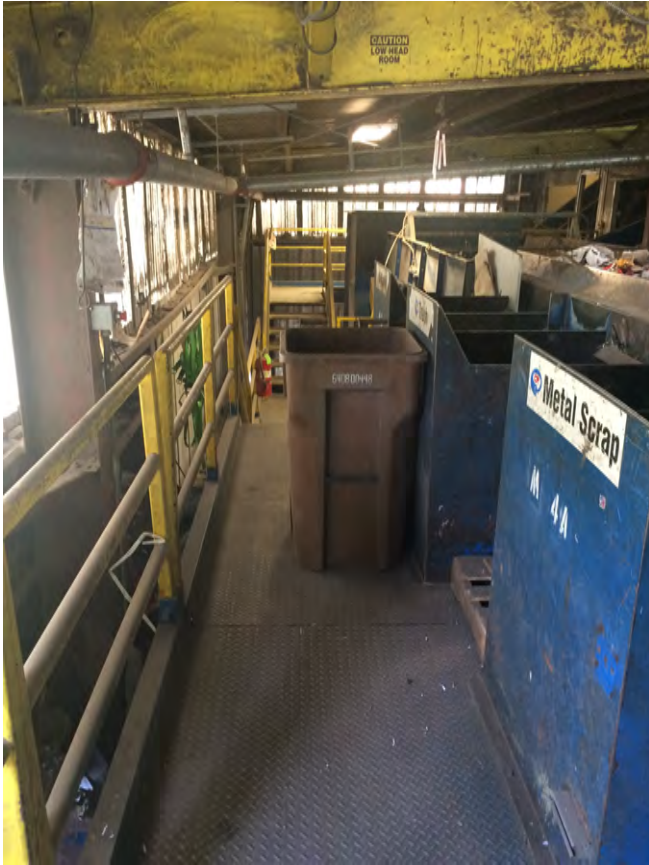
Top left:

- Refuse container blocking walkway/emergency exit route
- Beams less than 6' 8" from floor along exit route [1910.36(g)(1)]

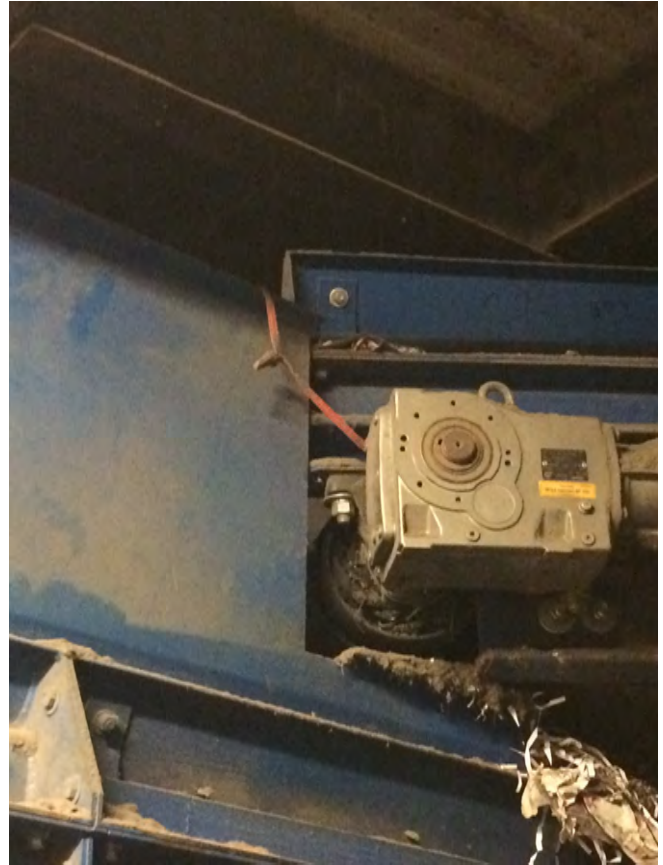
Top right: Exposed wiring

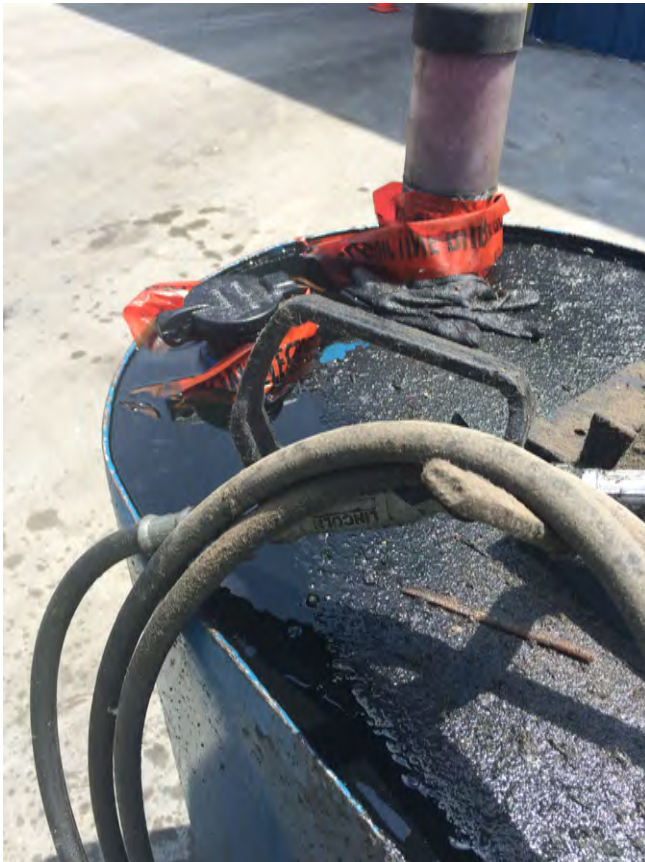
Bottom: Spill still not abated
