Materials Recovery Facility
Safety Observation Form

Date: Friday, June 24, 2016

Name of Observer: Ron Kovaleski

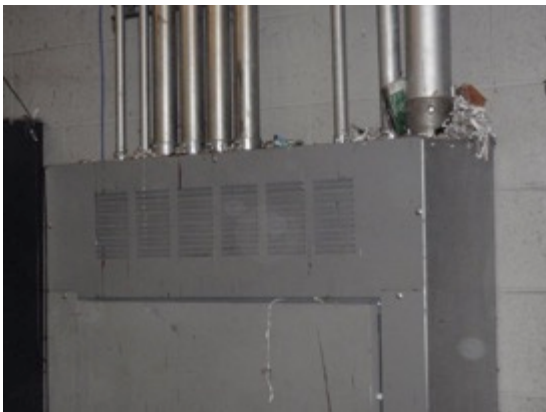
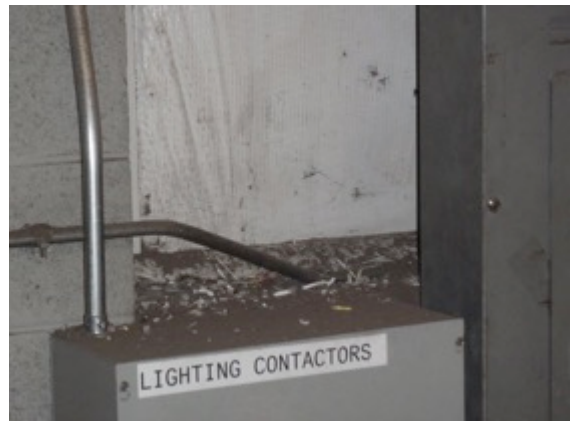
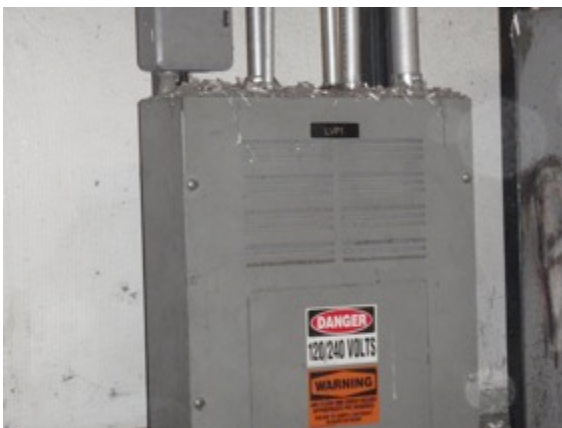
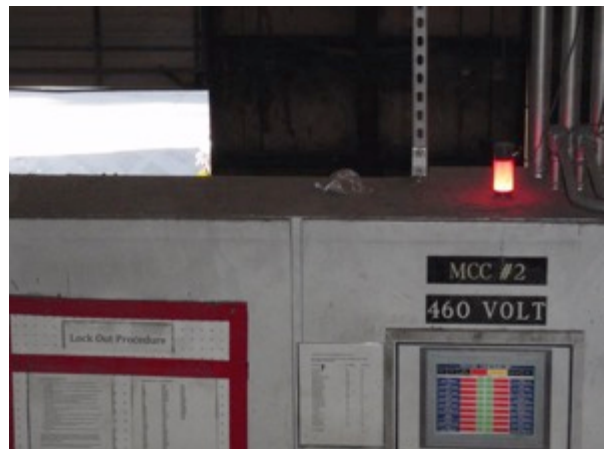
All: Dust, dirt, debris atop electrical panels

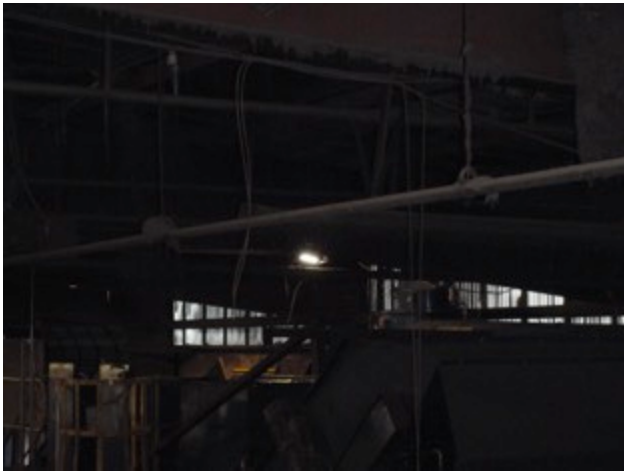
Top left: wiring hanging from ceiling, no caps.

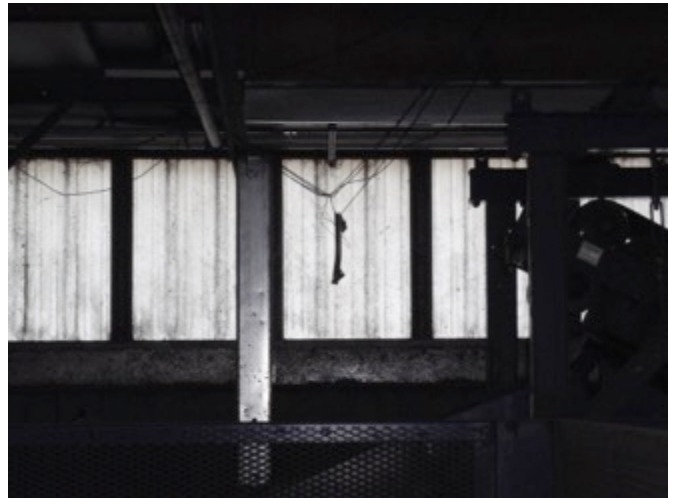
Top right: wiring hanging from ceiling w/ cardboard hanging from wiring

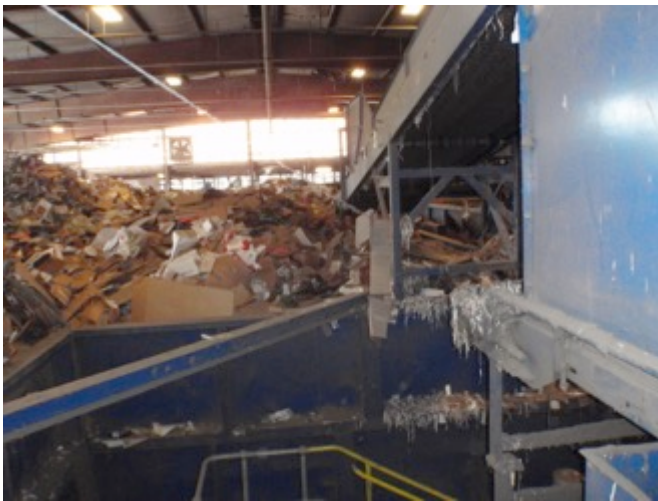
Middle: wiring strung over stairwell and under machinery

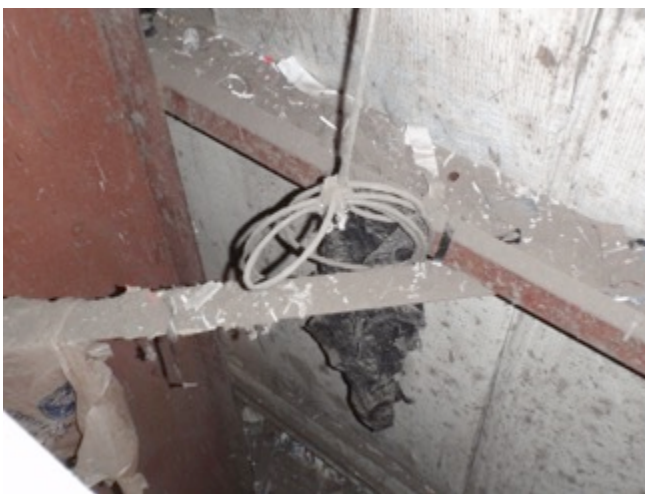
Bottom: Wiring hanging over stairway, covered with dirt & debris

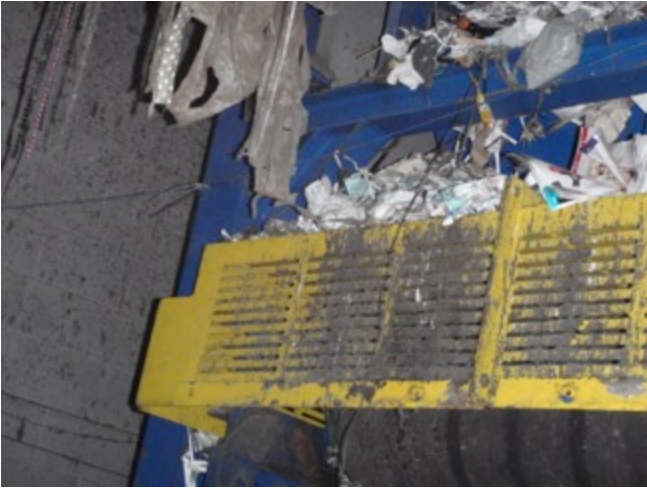
Top left: wiring under conveyer with debris over/under/on/around wire

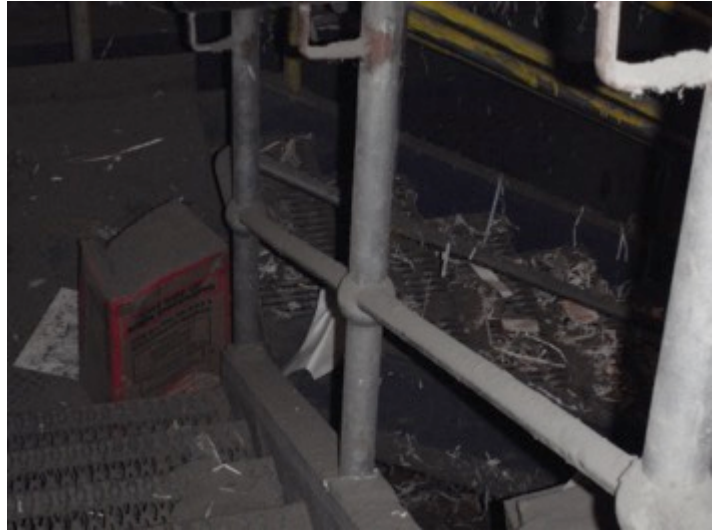
Top right: stairwell blocked, covered with debris

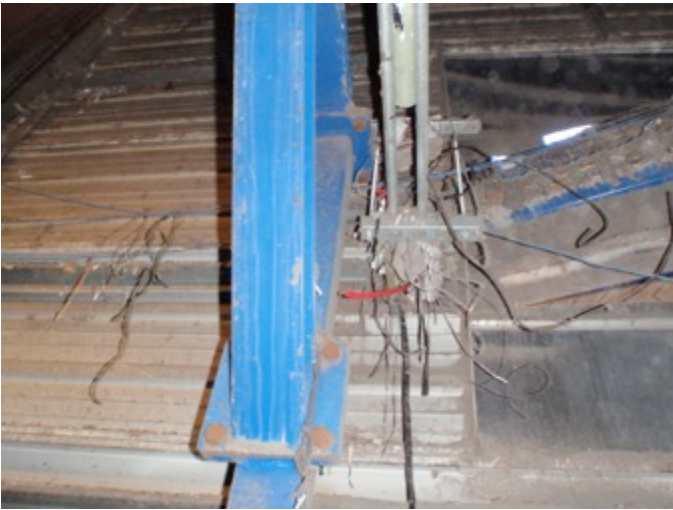
Center: wiring with debris around wire

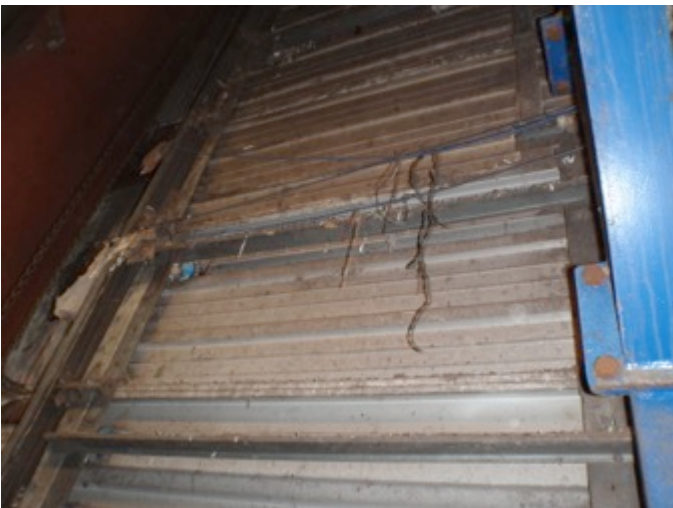
Bottom left: wiring with debris hanging from it

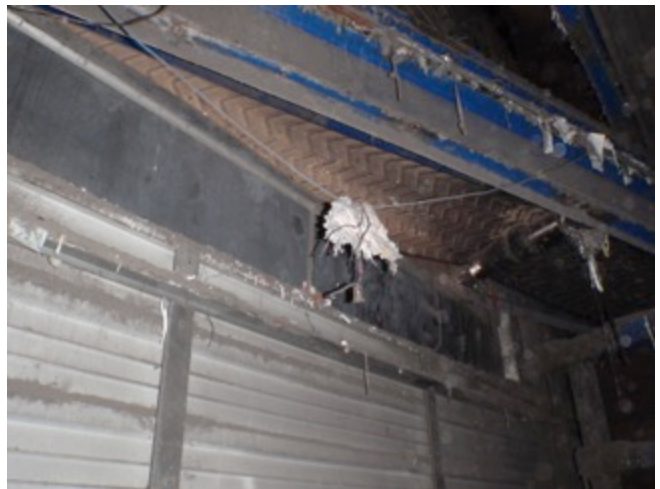
Bottom right: wiring underneath conveyer with debris hanging

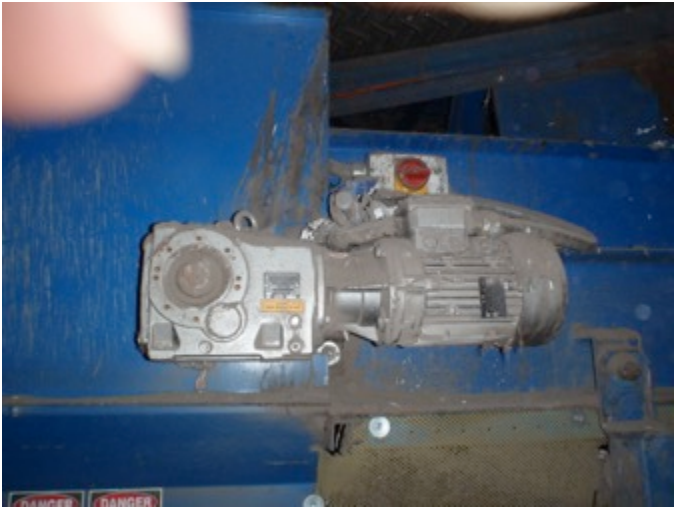
Top left: dust & debris atop electric motor

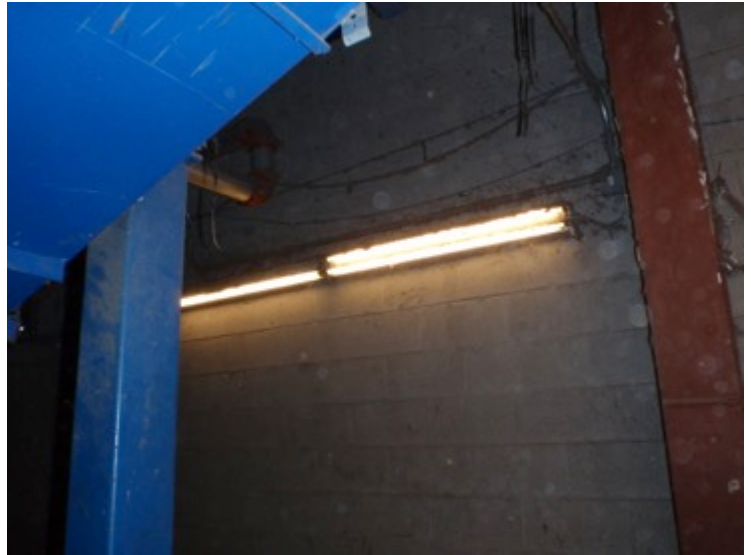
Top right: dust & debris atop light fixture

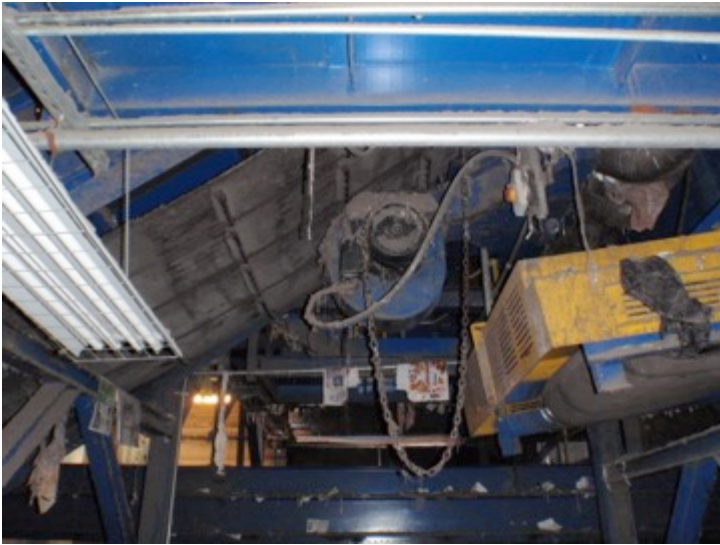
Center: dust & debris atop electric motor

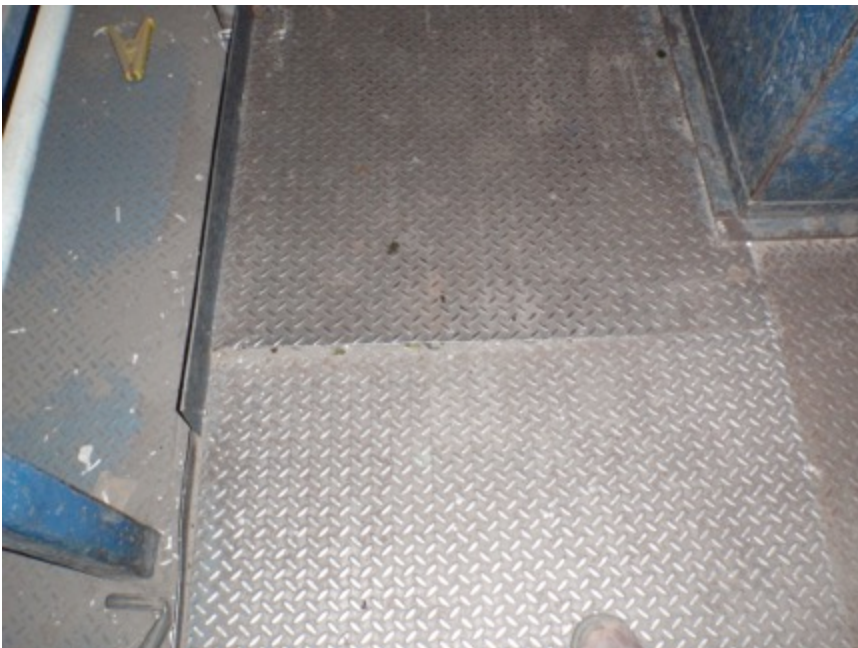
Bottom: uneven flooring – trip hazard
