Materials Recovery Facility  
Safety Observation Form

Date: Saturday, June 25, 2016

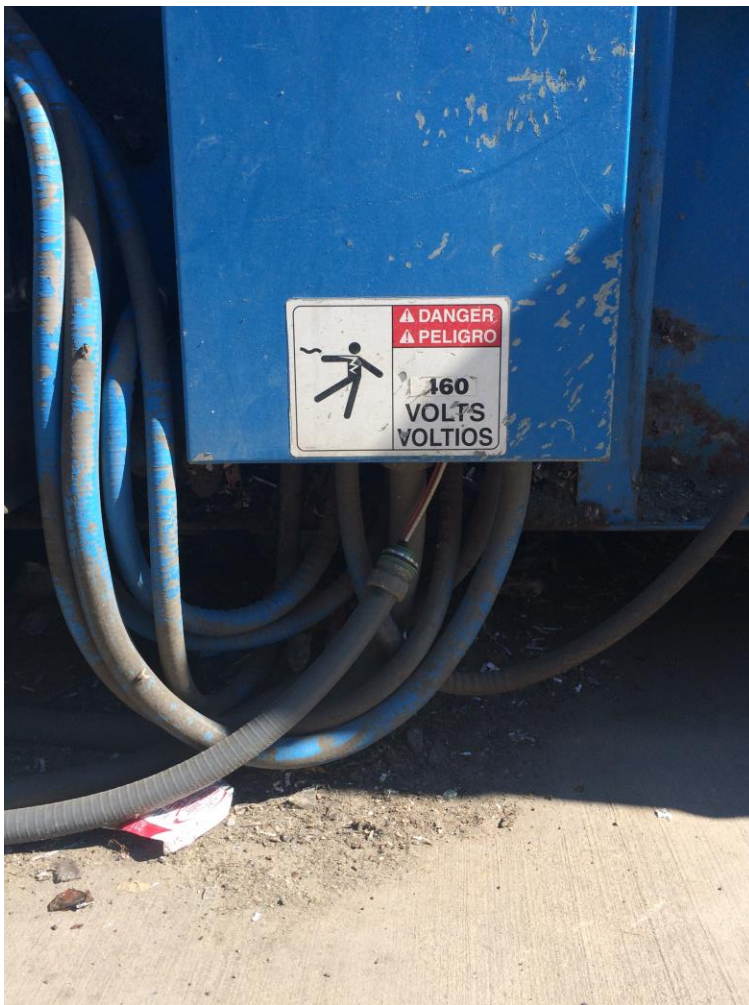
Left:

- Exposed wiring
- Labels deteriorating. Looks like '160 volts,' actually 460 volts.

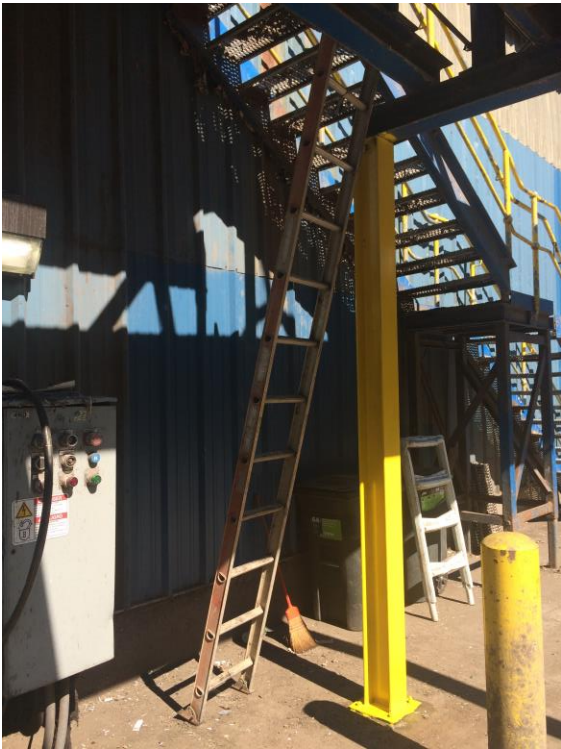
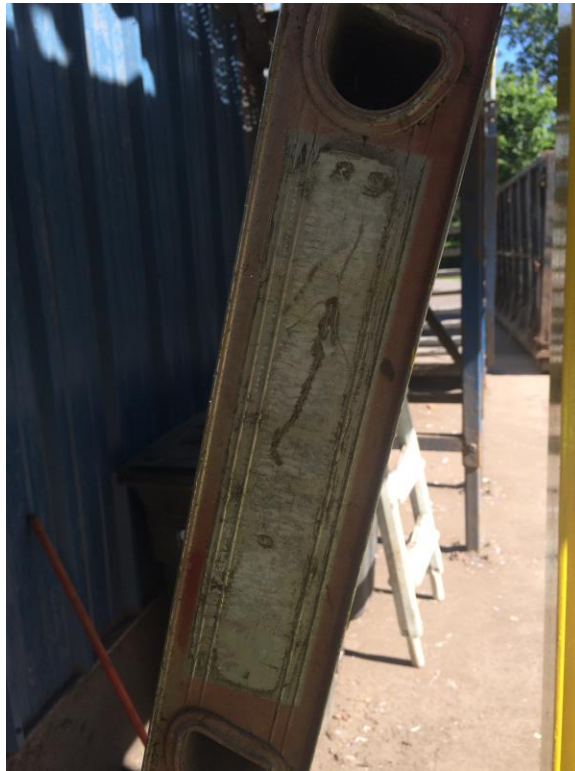
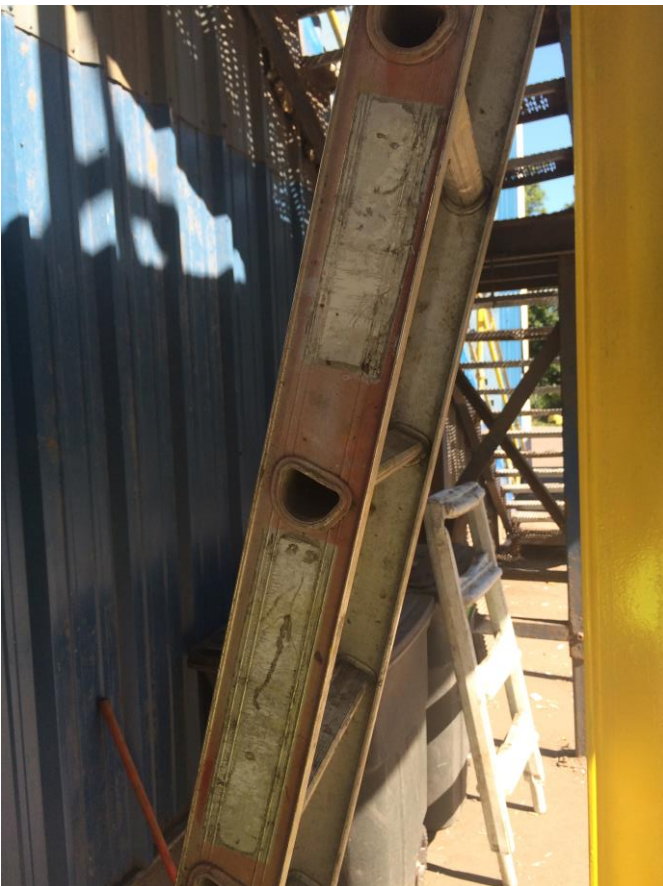
All: Ladder safety

- Ladder is backwards
- Unstable [1910.26(c)(3)(iii)]
- Angle too steep (1:4 rule not adhered to) [1910.26(c)(3)(i)]
- Not secured at top
- Warnings/labels illegible
- Damage to frame and rungs [1910.26(c)(2)(vii)]
- Not inspected prior to use
