Materials Recovery Facility Safety Observation Form

Date: Saturday, July 2nd, 2016

2 MRF INSPECTION - 07/02/2016

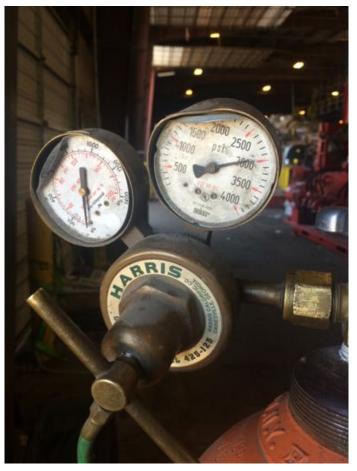
Damaged regulator: repair or replace [4.4.10.1, ANSI Z49.1]

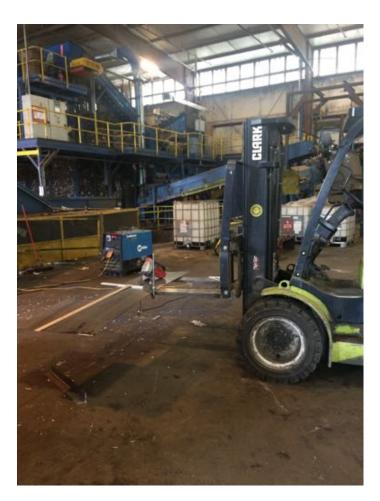
Top left:

- Forks left raised while left unattended [MIOSHA 2174]
- Improper load balancing
- Forks used as working surface? If so, hot work (cutting) taking place within 35' of combustibles. Also, no permit posted.

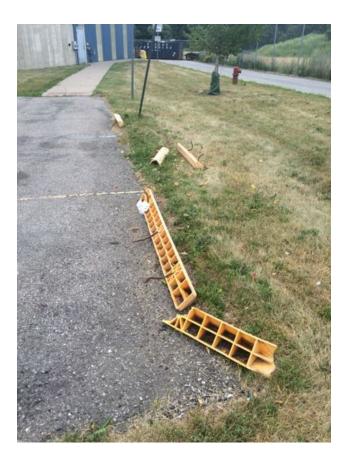
Top left: rebar protruding from overturned parking blocks

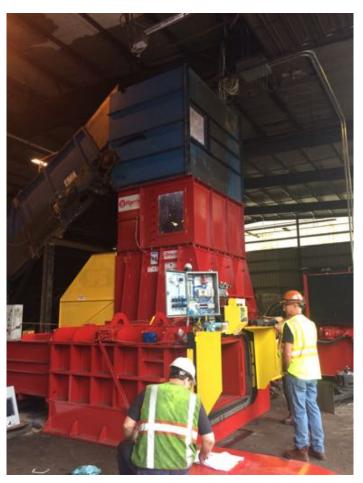
Top right: Hot work taking place (inside bailer/conveyer), no permit posted

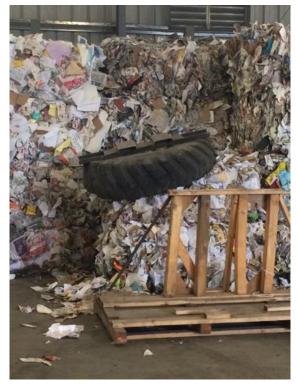
Bottom: Materials stacked improperly

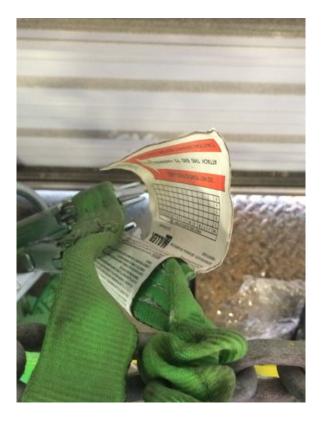
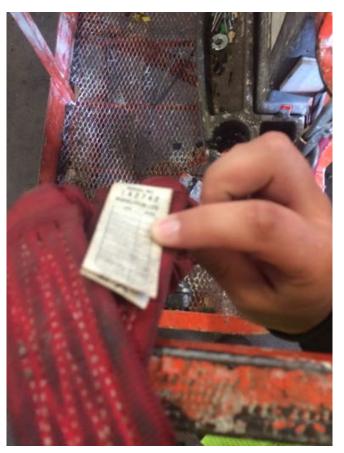
Top (both): fall protection inspection tags show no inspections

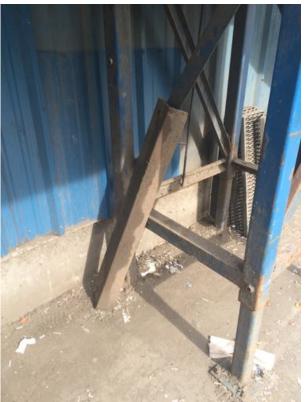
Bottom: improper materials storage

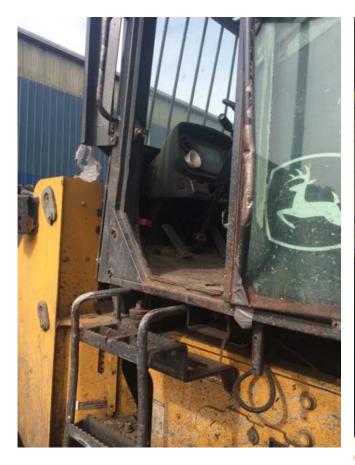
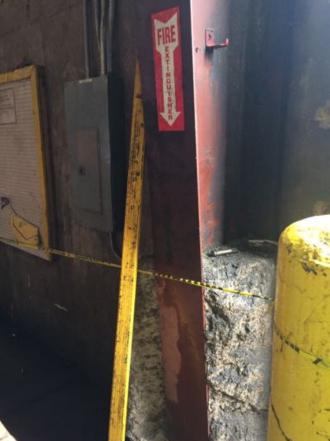
Top (both): Missing fire extinguisher

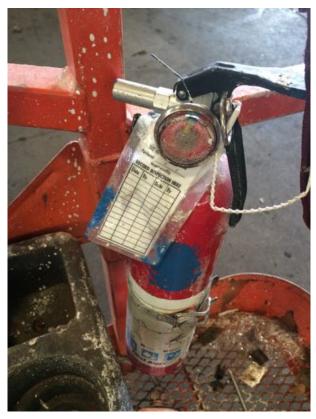
Bottom:

- Fire extinguisher in (rented) aerial lift has damaged handle
- Tag shows no inspections performed
- No inspection log aboard vehicle

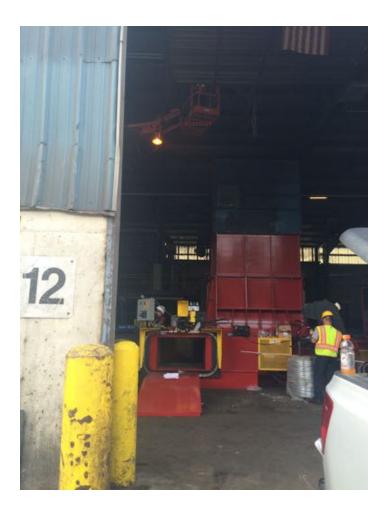
Left: Workers working directly underneath aerial lift basket; area around lift should be taped off with red danger tape

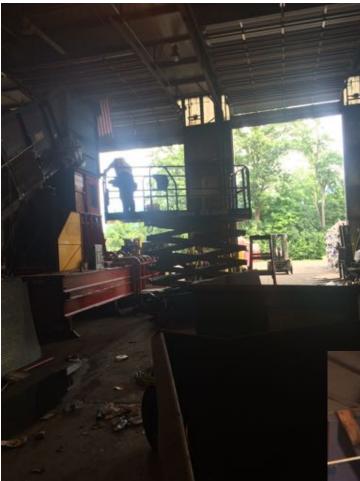
Below: Poor work positioning, worker standing on mid-rail, leaning over the edge of the bucket, with no fall protection.

(abated immediately)
