## Materials Recovery Facility Safety Observation Form

Name of Observer: Shawn Qualls Date: Tuesday, July 5th, 2016

6 MRF INSPECTION - 07/05/2016

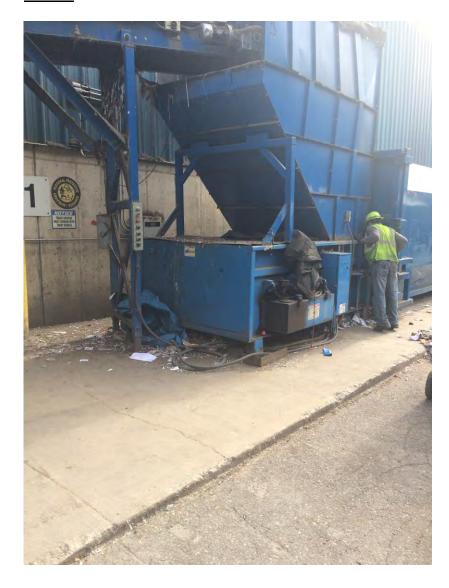
Machine not locked out. (May fall under minor service exception? [1910.147(a)(2)(ii)])

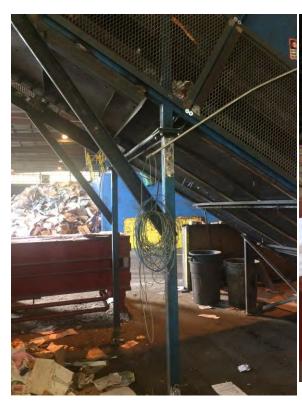
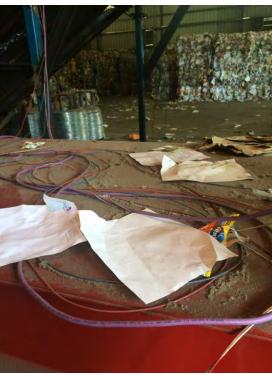
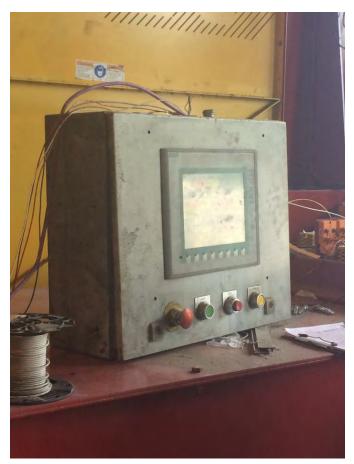
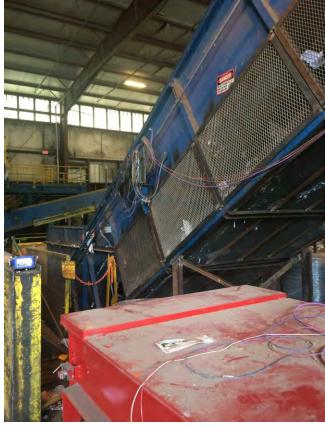
Lots of uncapped wires, potential shock hazard. (work in progress)

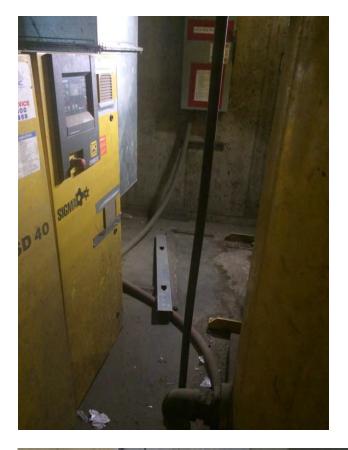
Top left: Possible clearance issue.

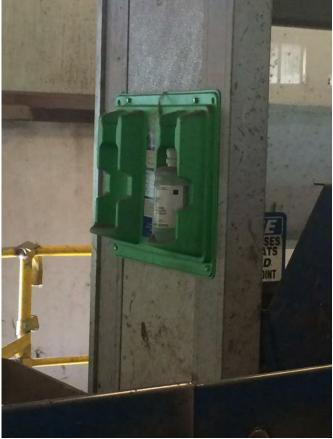
Top right: Fire extinguisher still missing

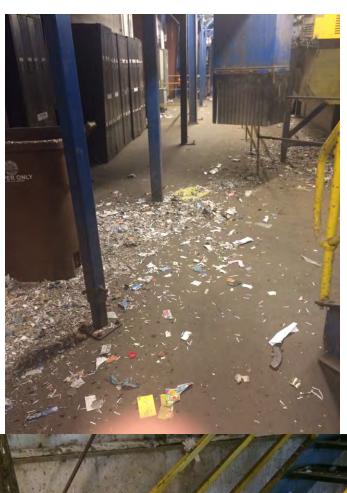
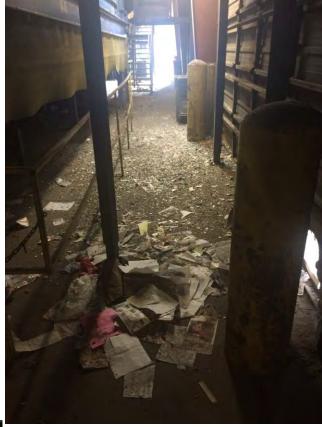
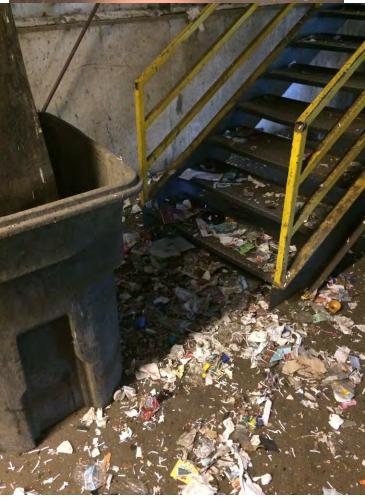
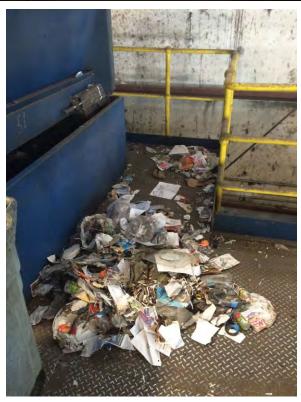
All: Housekeeping – obstructed walkways and stairways [1910.22(a)(1)] Bottom left: possible clearance issue?

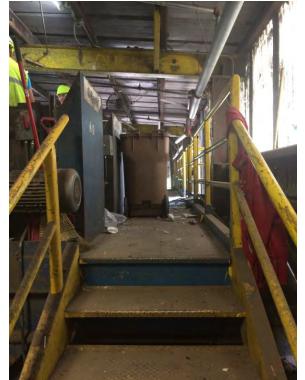
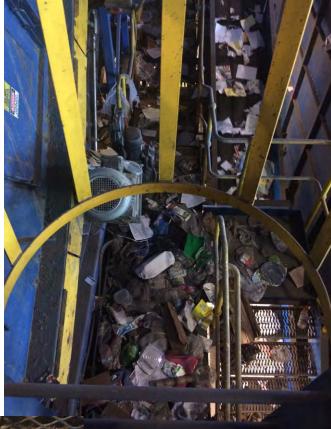
Bottom: PPE left lying around

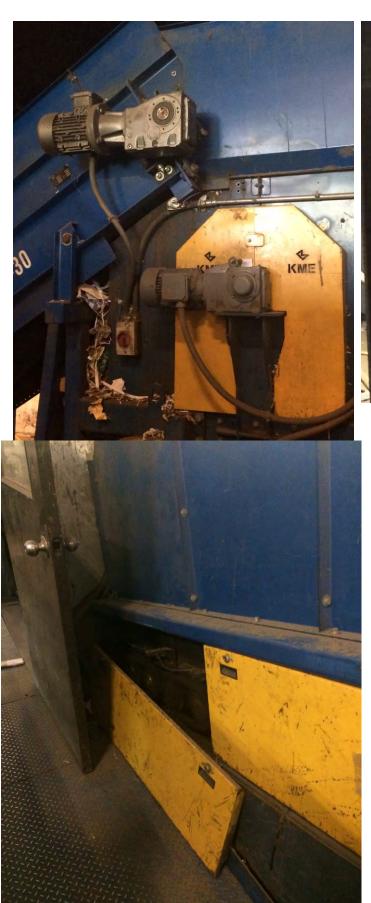
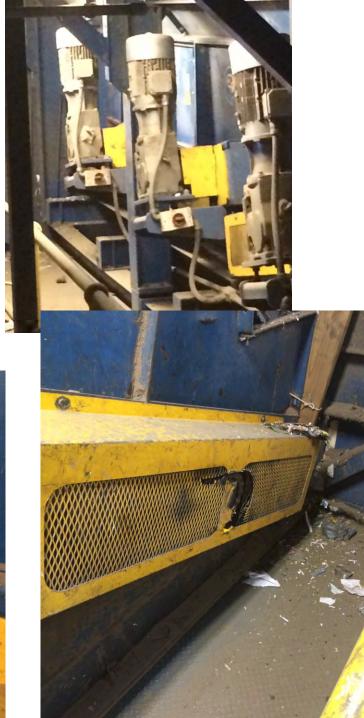
Top left: Looks like the upper motor is missing a guard

Top right: Center motor – guard (top) is not secured to motor.

Bottom left: Panel not secured

Bottom right: Damaged guard

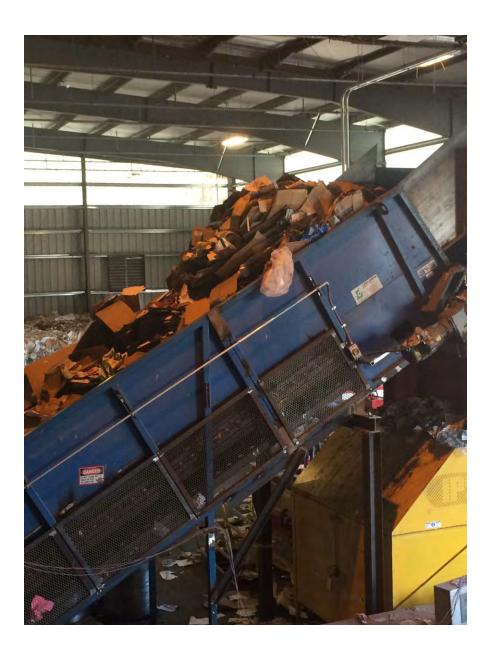
Conveyor overloaded
