Exhibit D ACCESS ROUTE

APPENDIX D

RE: Nichols Drive Slope
UM Medical Campus
Ann Arbor, Michigan
SME Project No. 073412.00

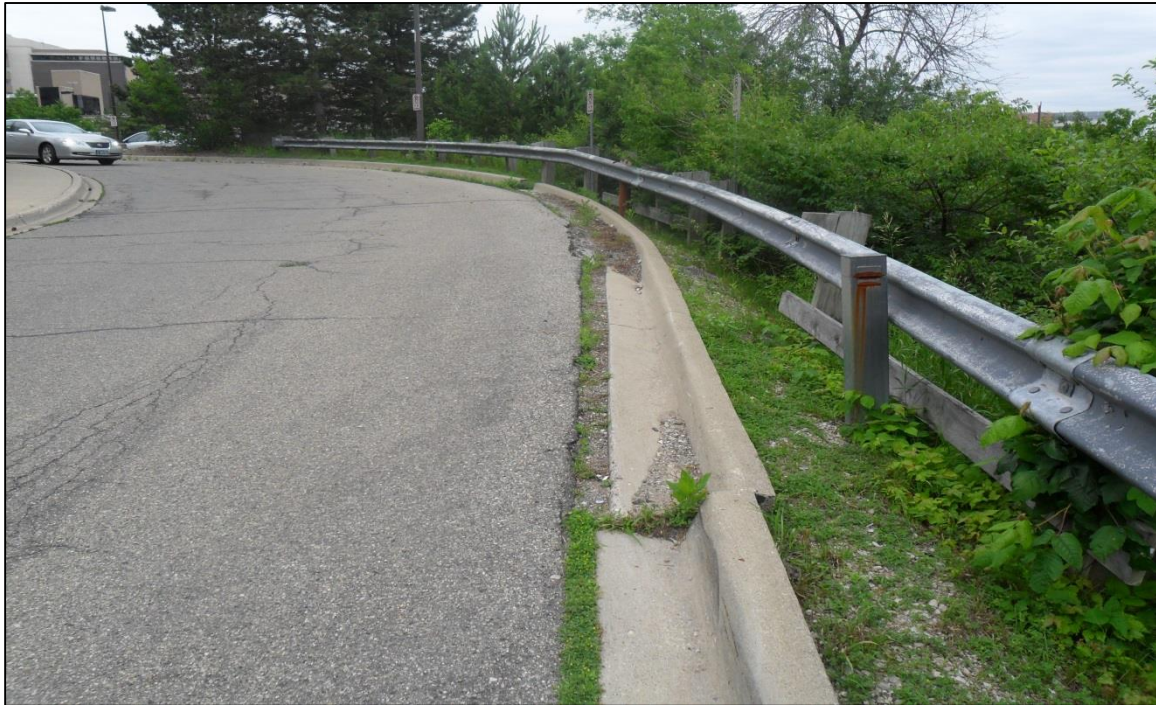
As indicated above, SME performed a visual review of the slope on December 12, 2015. Photograph Nos. 1A and 1B through 4A and 4B (attached) provide a qualitative comparison of the conditions observed on December 12, 2015, to the conditions observed on June 11, 2010. In our opinion, based on our review of these photographs, there is not a well-defined difference in the conditions illustrated in these photographs between the two visit dates, which are separated by a span of 5.5 years. In other words, even though the inclinometers indicate ongoing movement, there has not been a discernable visual change in the conditions at the top of the slope along Nichols Drive.

PHOTO NO. 1A –June 11, 2010: Looking west along the north curb line of Nichols Drive. Inclinometer I-2 is in the right of the photo between the curb and the guardrail.

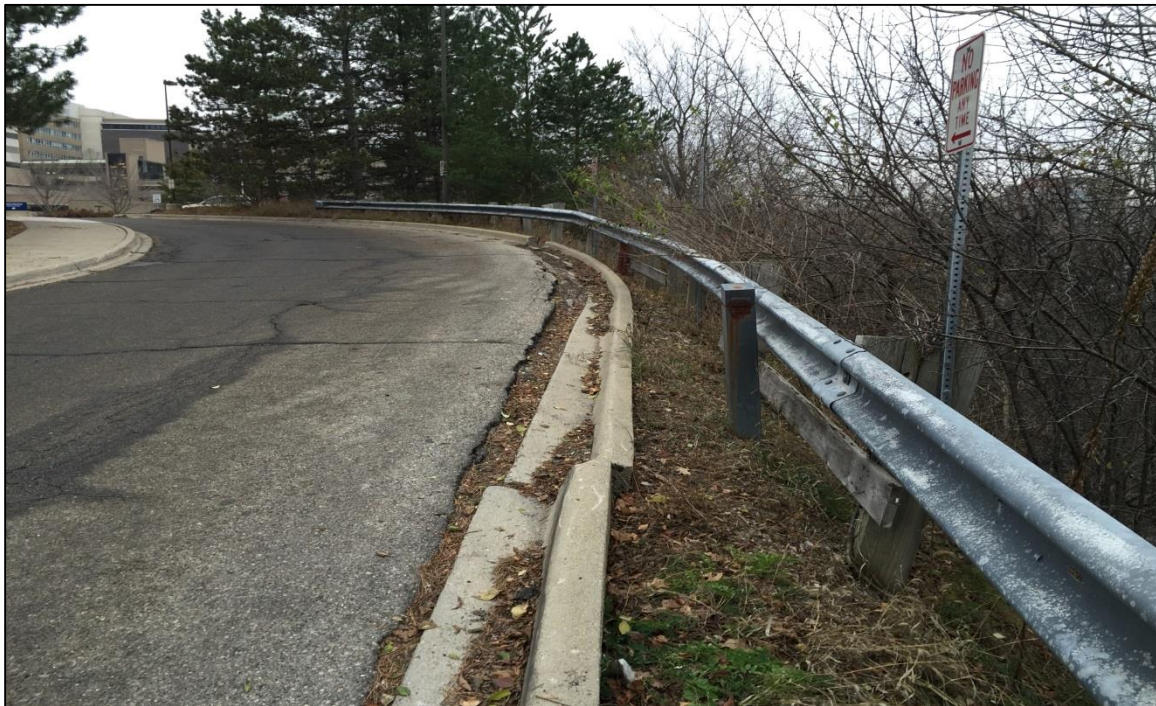
PHOTO NO. 1B – December 12, 2015: Looking west along the north curb line of Nichols Drive. Inclinometer I-2 is also visible in this photo between the guardrail and the curb line.

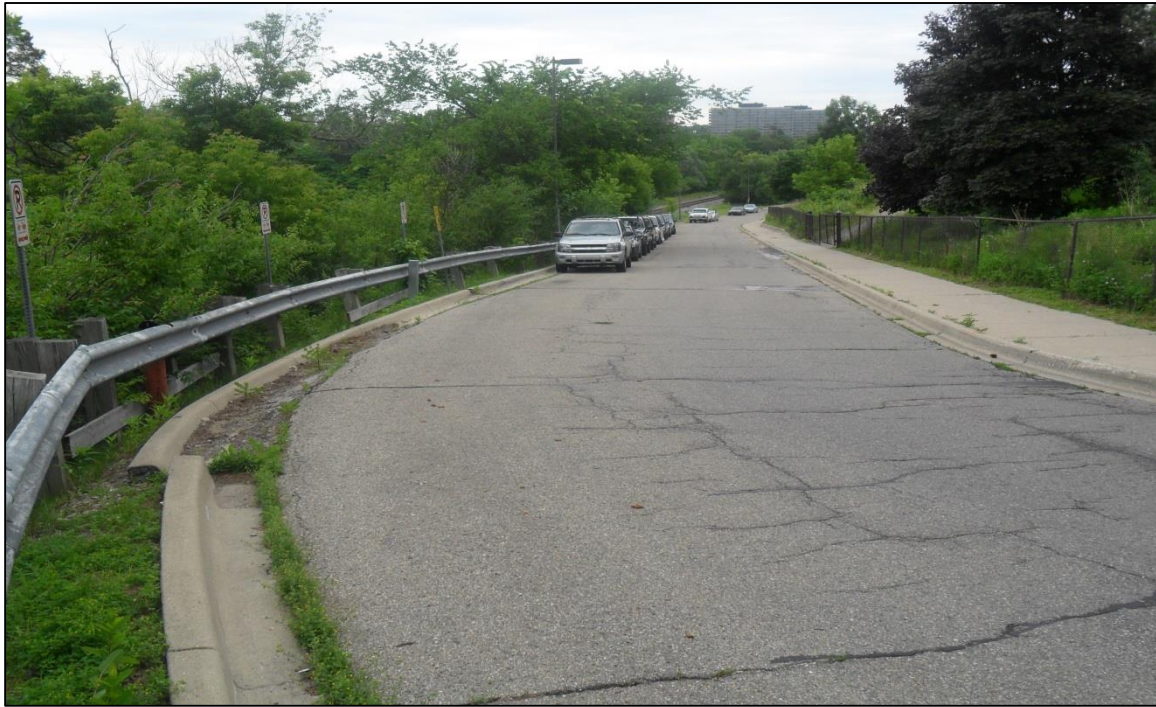
PHOTO NO. 2A - June 11, 2010: Looking east along Nichols Drive.

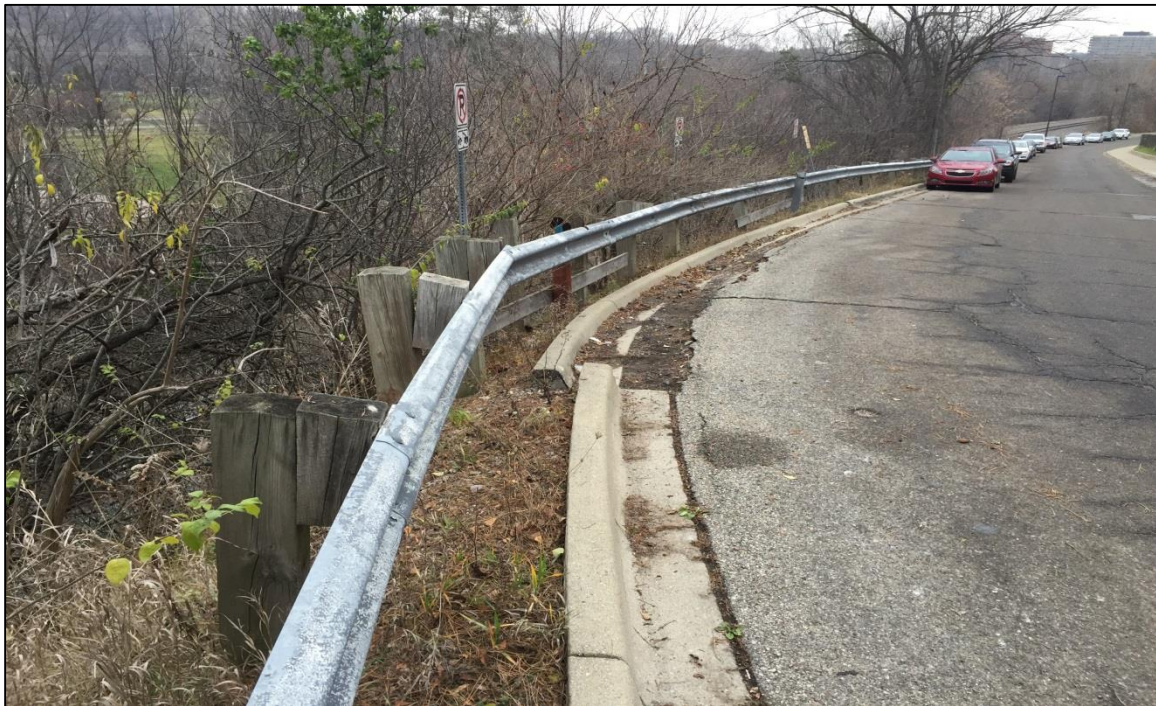
PHOTO NO. 2B – December 12, 2015: Looking east along Nichols Drive from a similar vantage point as PHOTO NO. 2A.

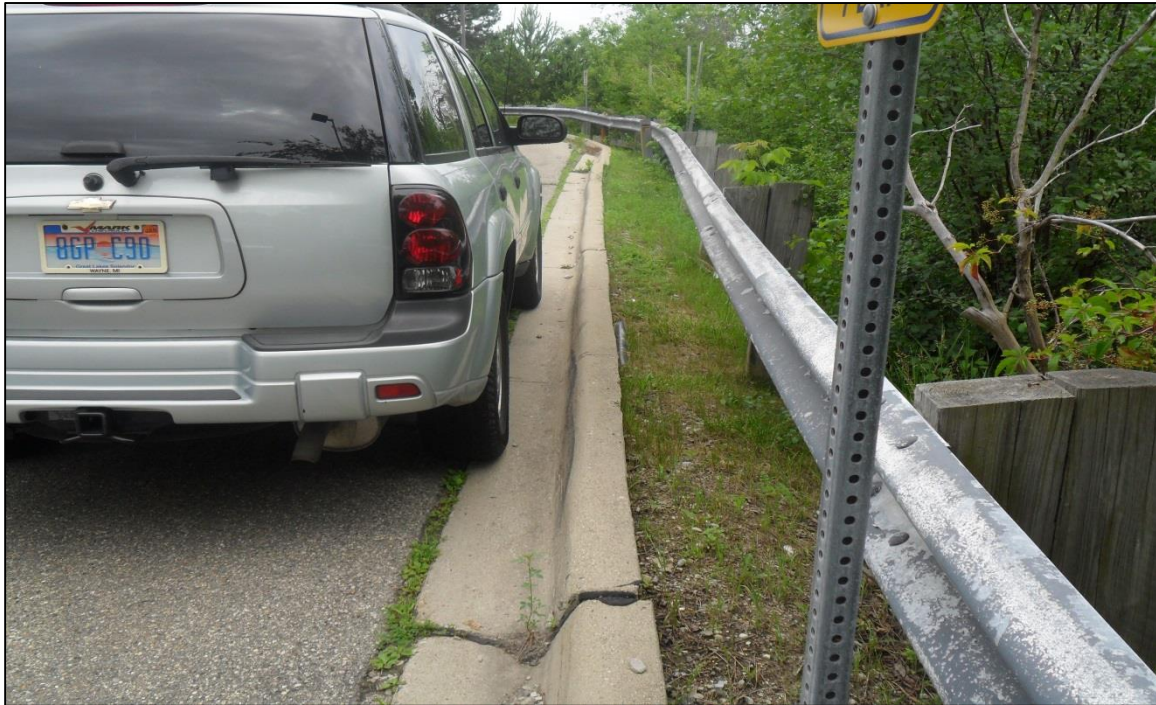
PHOTO NO. 3A – June 11, 2010: Looking west along the north curb line of Nichols Drive.

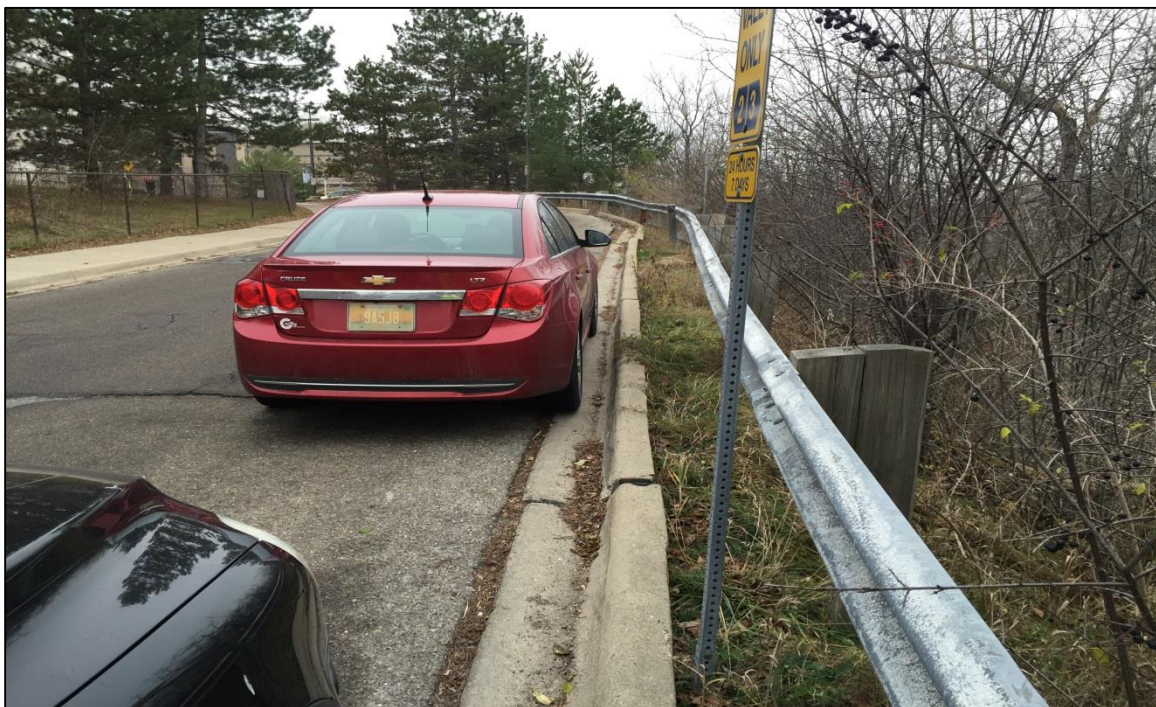
PHOTO NO.3B – December 12, 2015: Looking west along Nichols Drive from a similar vantage point as PHOTO NO. 3A.

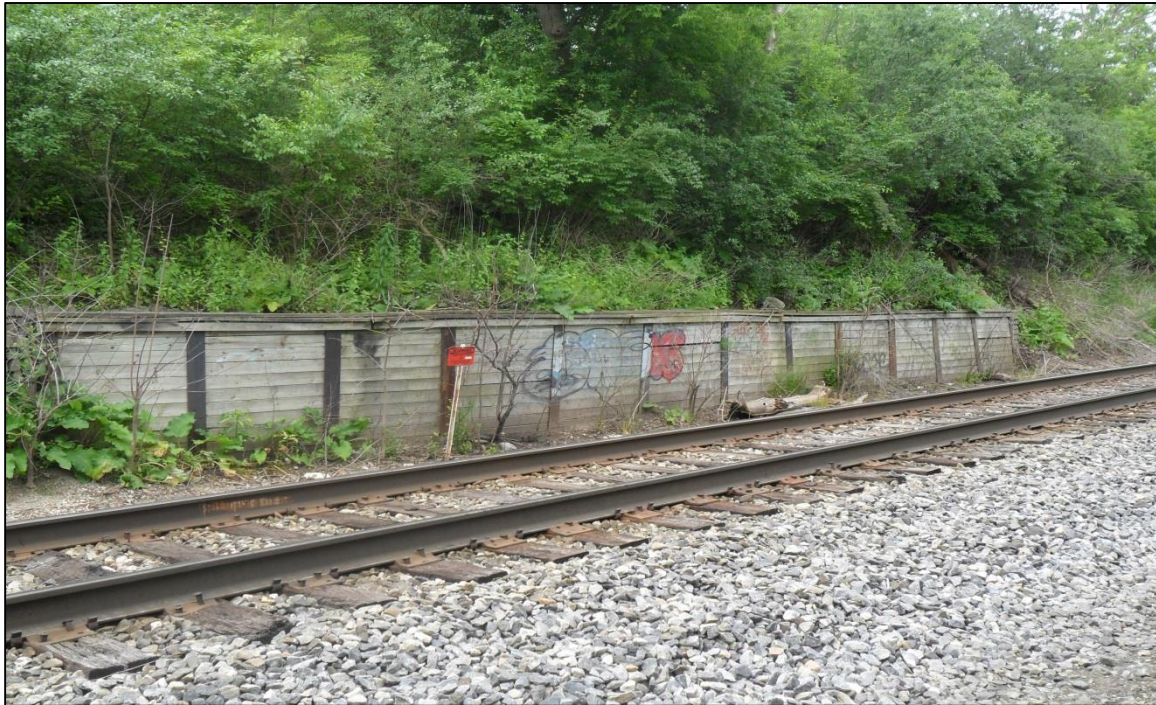
PHOTO NO. 4A – June 11, 2010: Looking at the soldier pile retaining wall at the toe of the slope on the south side of the railroad line.

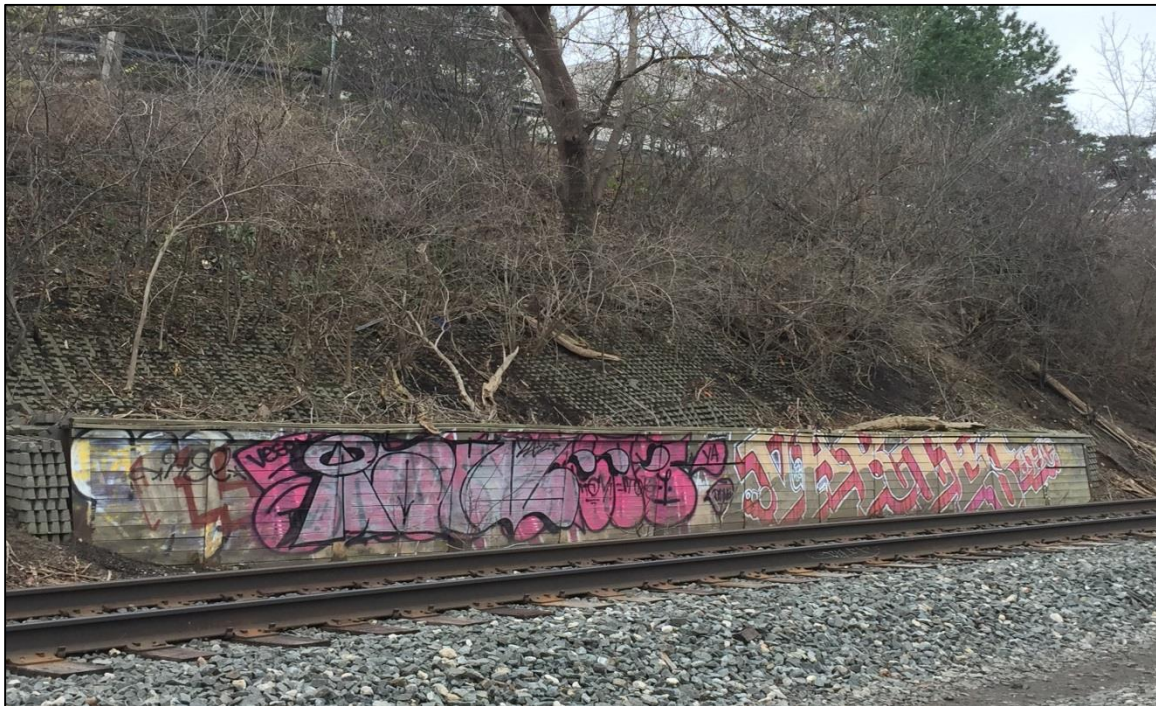
PHOTO NO. 4B – December 12, 2015: Looking at the soldier pile retaining wall from a similar vantage point as PHOTO NO. 4A.

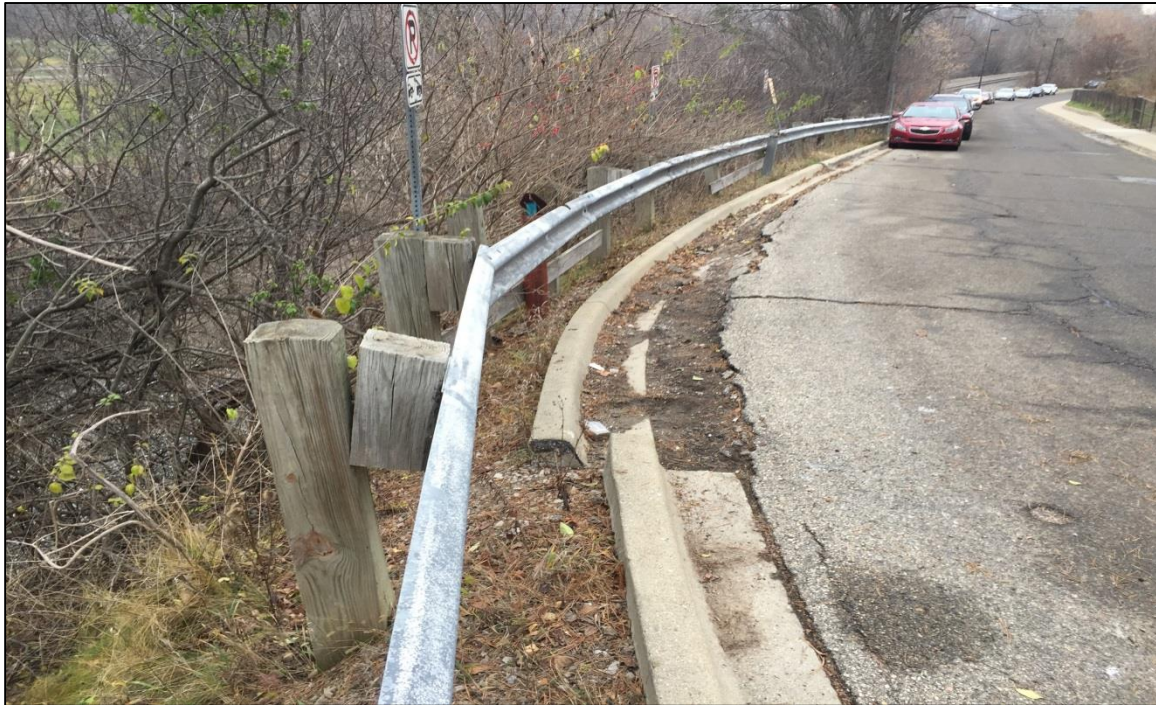
Photographs Nos. 5 through 12 (attached) provide additional documentation on the conditions observed during the site visit on December 12, 2015. Photograph Nos. 5 through 8 depict conditions along the north curb line of Nichols Drive in the area of the inclinometers where most of the discernable movement has been experienced. Photograph Nos. 9 through 12 depict conditions along the soldier pile retaining wall at the toe of the slope.

PHOTO NO. 5: Looking east along the north curb line of Nichols Drive.

Until the project moves forward with design and construction, we recommend routine inspections by UM staff be performed on a quarterly basis to assess whether visual changes in the conditions at the top of the slope indicate more rapid movement of the slope may be occurring. If discernable movement is noticed, SME should be contacted to observe the slope, and another reading of the inclinometers should be collected to provide a quantitative measure of the movement. We also recommend parking along the north side of Nichols Drive continue to be prohibited within the unstable area until the slope is repaired. Figure No. 1, Restricted Parking Area Diagram, which is attached to this report, provides the approximate area where we believe parking along the north curb lane of Nichols Drive should be prohibited at least until the slope is stabilized.

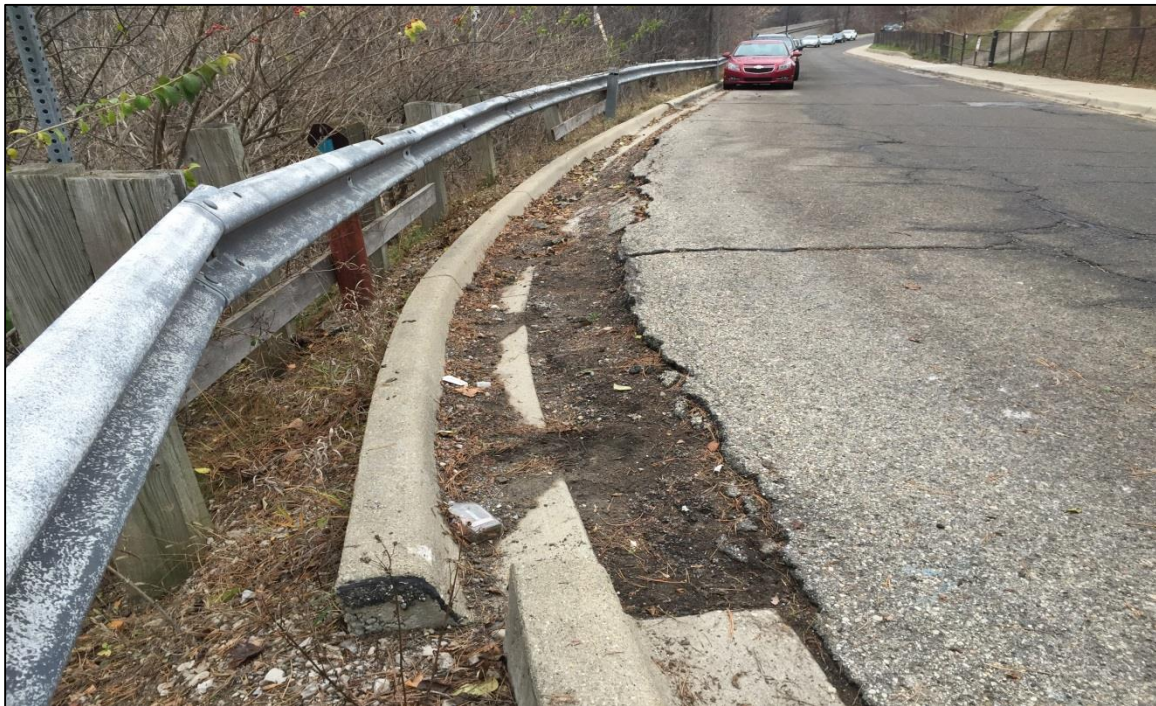
PHOTO NO. 6: Looking east along the north curb line of Nichols Drive.

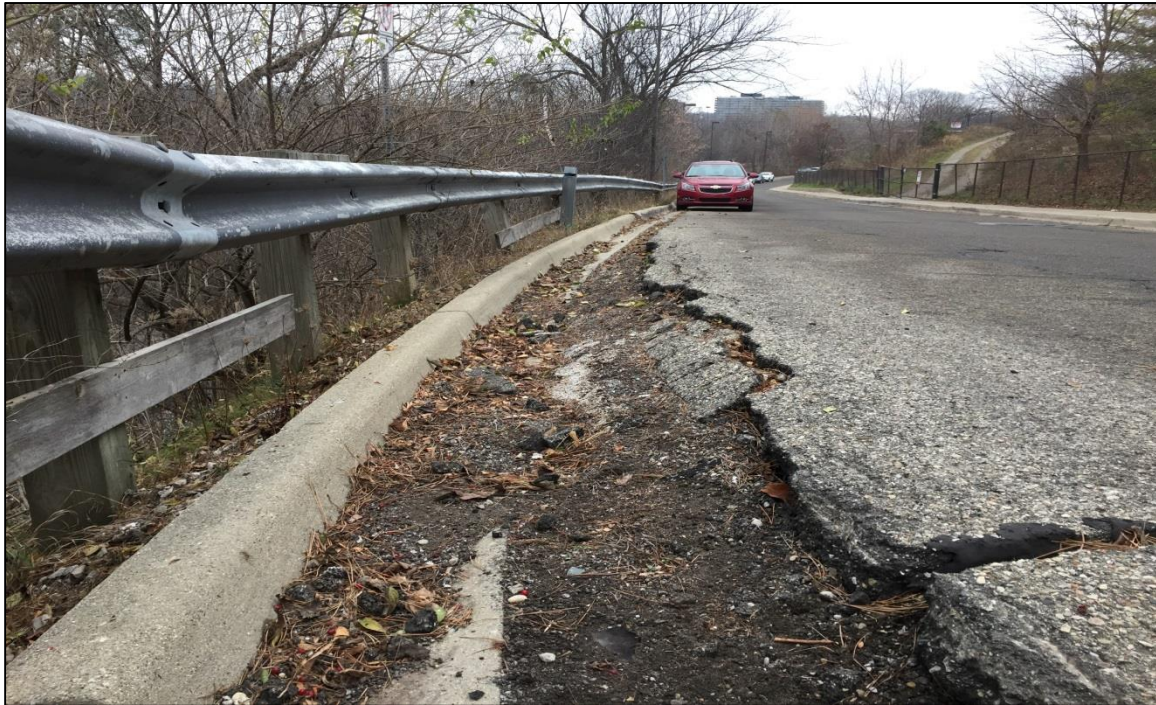
PHOTO NO. 7: Close-up of the drop in the pavement surface along the north curb line of Nichols Drive. Inclinator I-1 is located immediately to the left of this location.

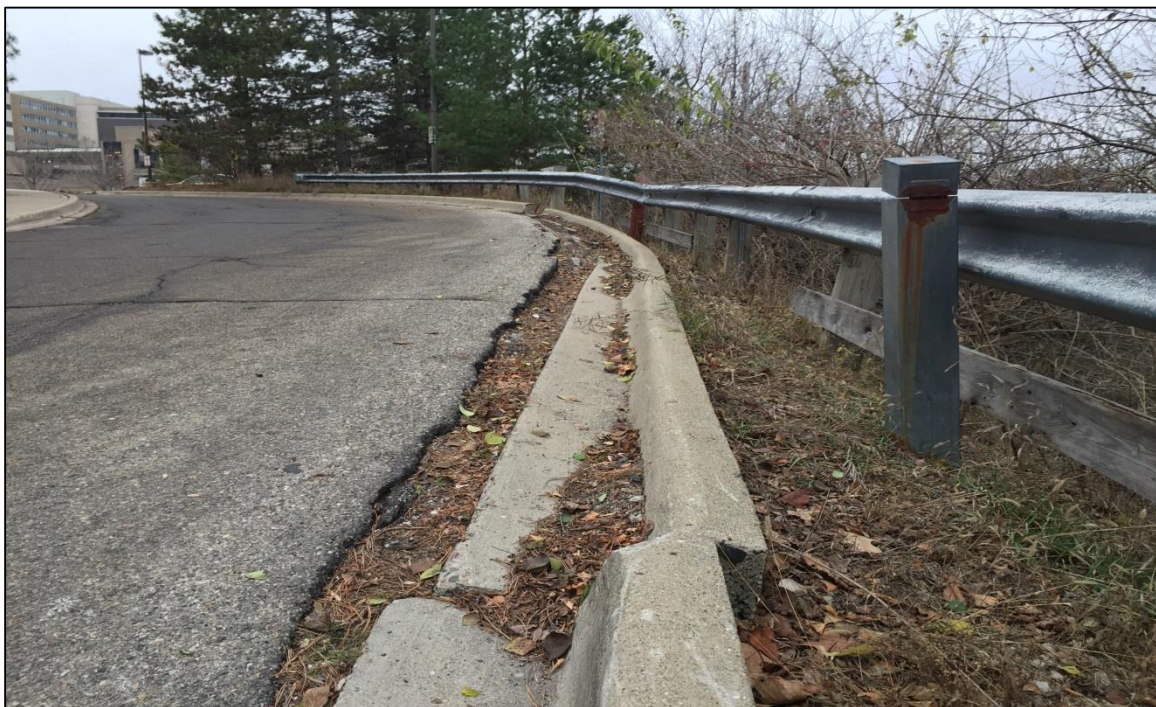
PHOTO NO. 8: Looking west along the north curb line of Nichols Drive. Inclinator I-2 is in the right of the photo between the curb line and the guardrail.

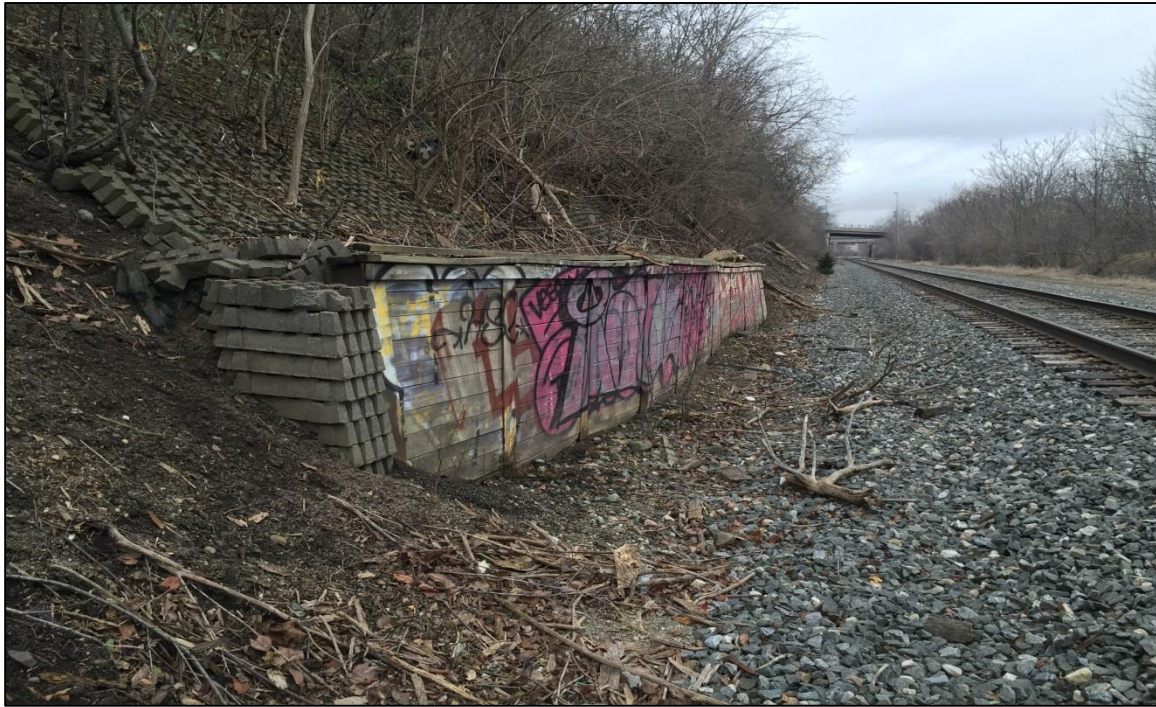
PHOTO NO. 9: Looking west at the soldier pile retaining wall at the toe of the slope.

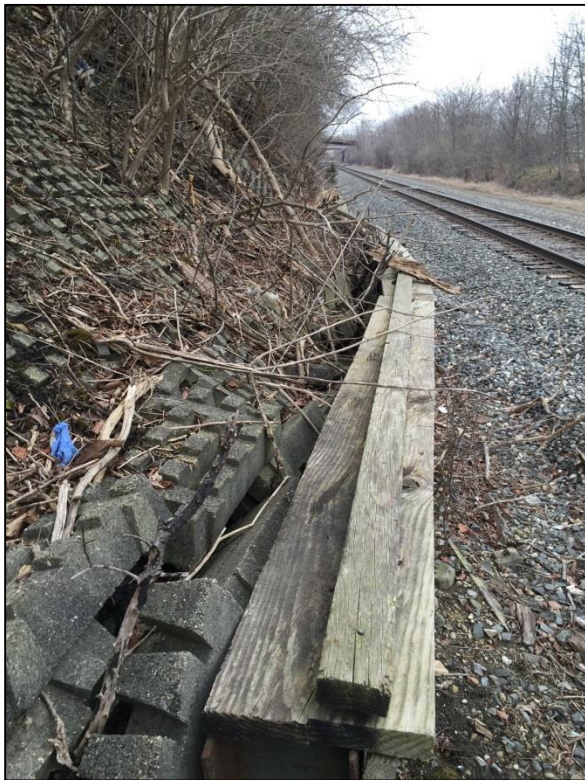
PHOTO NO. 10: Looking west along the top of the soldier pile retaining wall at the toe of the slope.

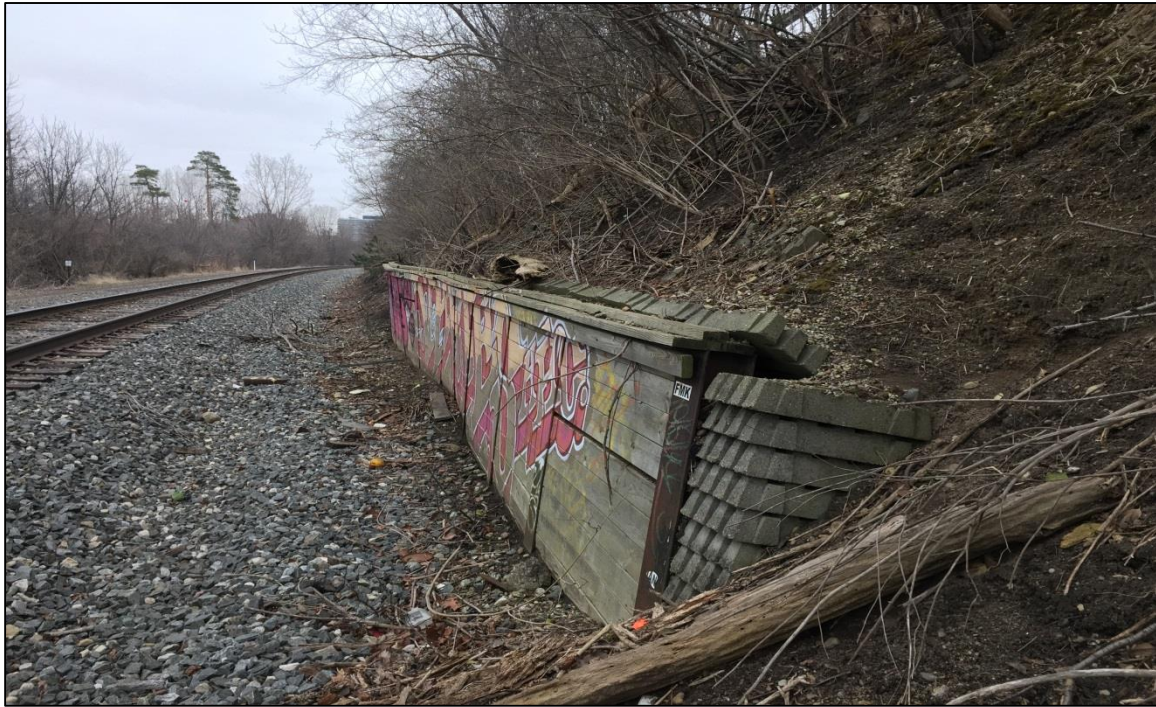
PHOTO NO. 11: Looking east at the soldier pile retaining wall at the toe of the slope.

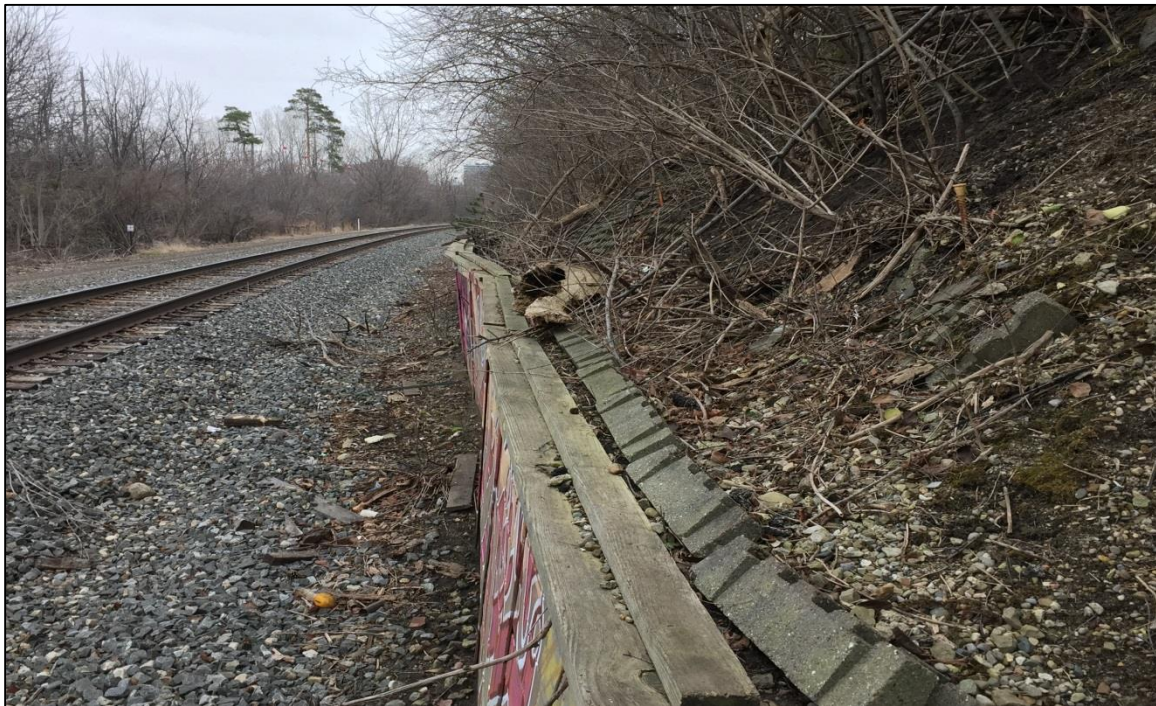
PHOTO NO. 12: Looking east along the top of the soldier pile retaining wall at the toe of the slope.

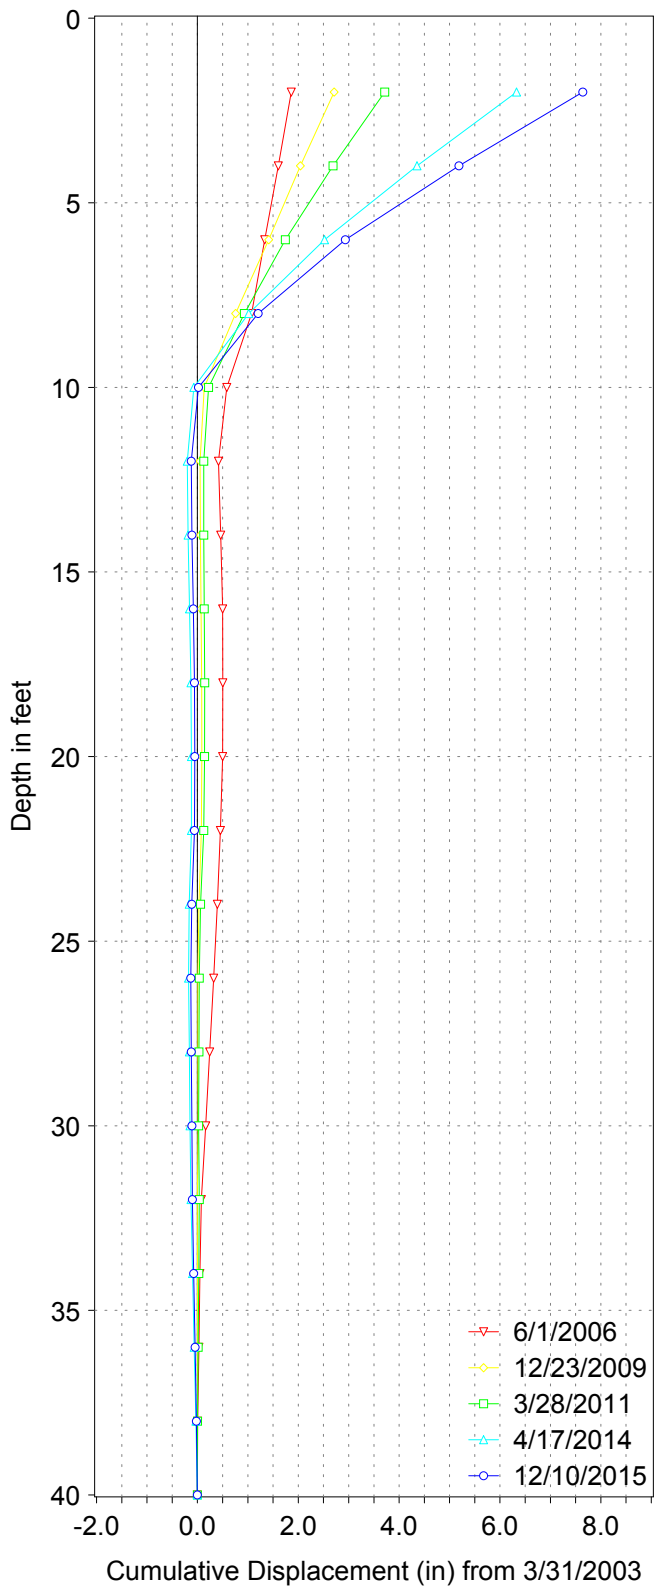
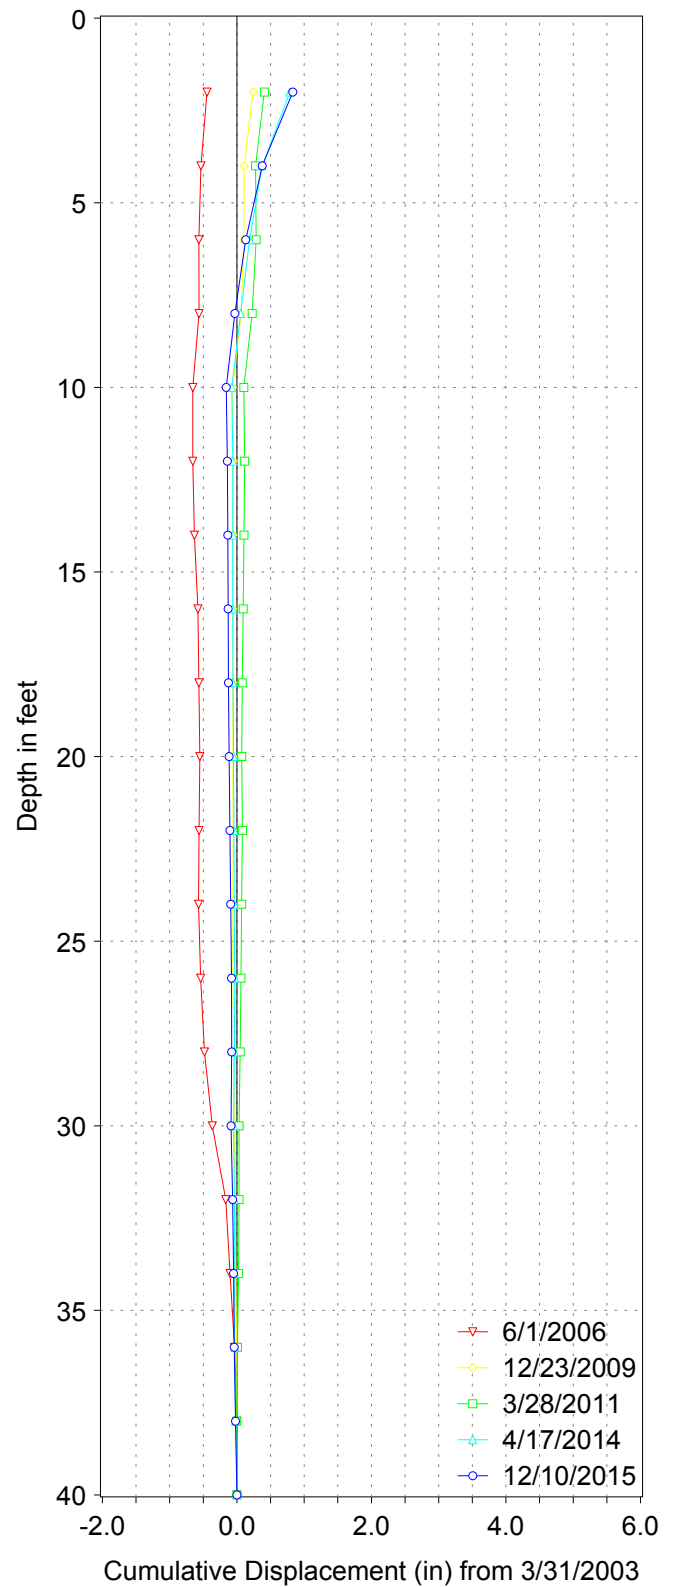
Inclinometer:I-1

Recent readings obtained in December 2015 indicated lateral slope movement since spring 2014 towards the north at Inclinometers I-1 and I-2 at depths of 10 feet or less. An additional movement of 0.5 inches was observed at I-1 at a depth of 2 feet below the top of casing. This corresponds with a total cumulative displacement of 7.6 inches since installation in 2003. Additional incremental movement of 0.1 inch was observed at I-2 at a depth of 7 feet below the top of the casing. This corresponds with a total cumulative displacement of 4.8 inches since installation in 2003. Note the maximum cumulative displacement observed at I-2 since installation in 2003 is 5.0 inches at a depth of 5 feet below the top of the casing.

The accompanying graphical presentations of field readings obtained from inclinometers I-1 and I-2 since the fall of 2003 through April 2014 indicated cumulative possible slope movement of *7.6 to 5.0 inches* towards the north. It appears that the recorded slope movements indicated by both inclinometers has occurred within the upper 15 feet of fill soil below the pavement at the top of the slope.

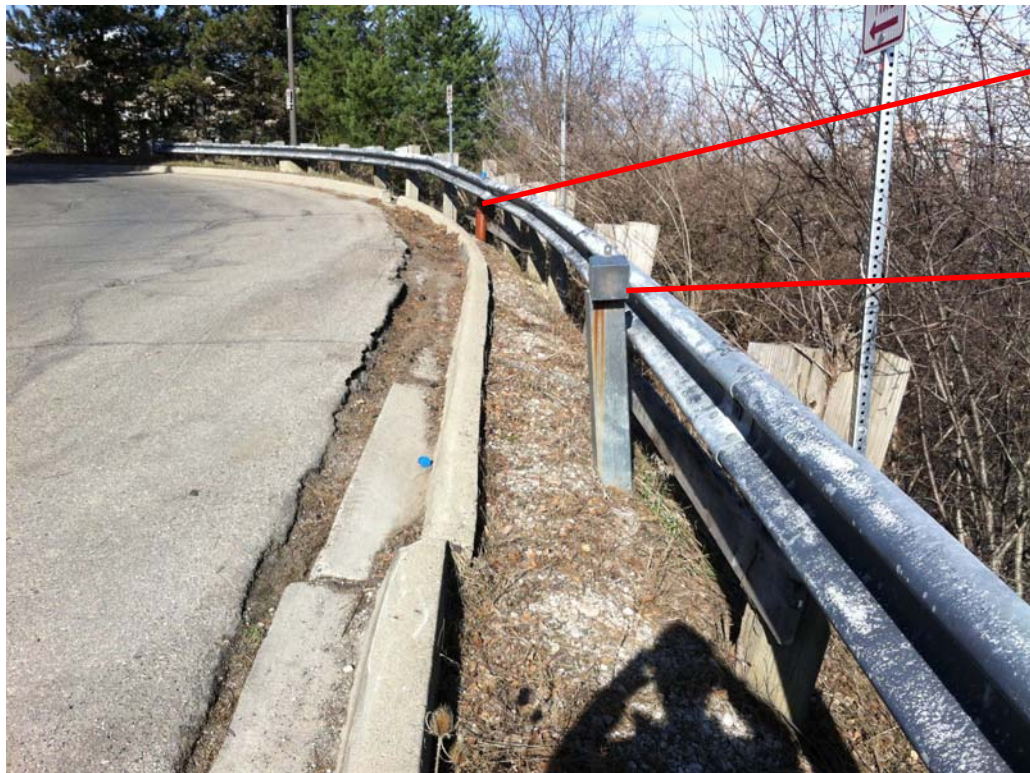
2014 Looking west, toward inclinometers I-1 and I-2 [provided for comparison]

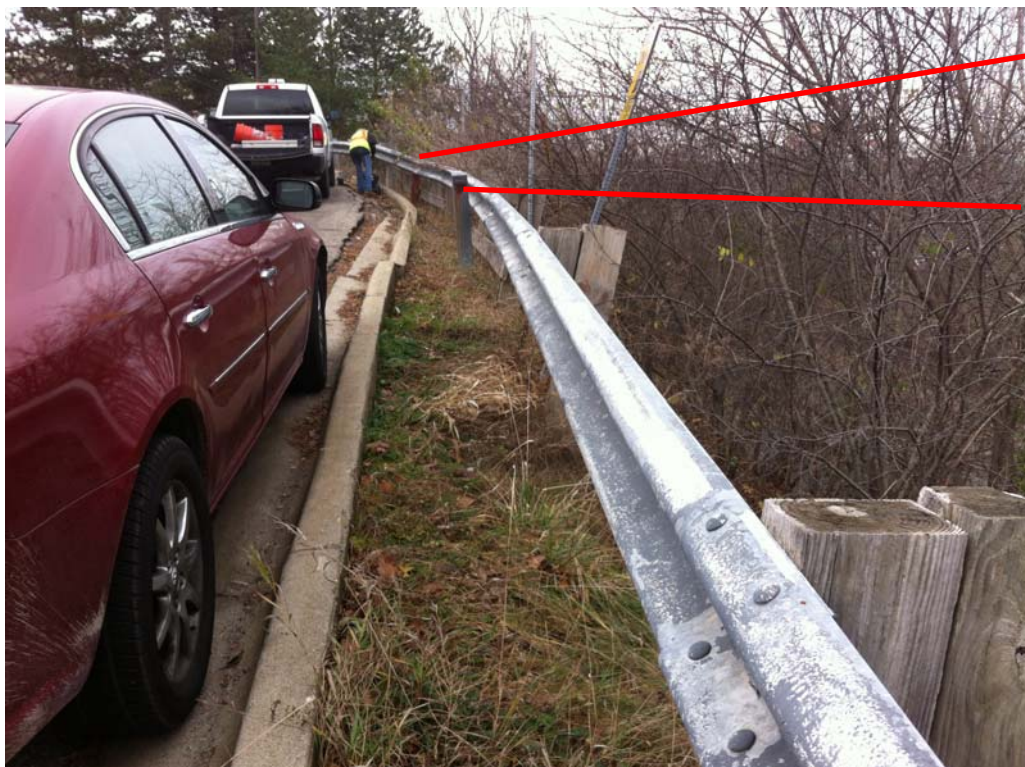
2015 Looking west, toward inclinometers I-1 and I-2

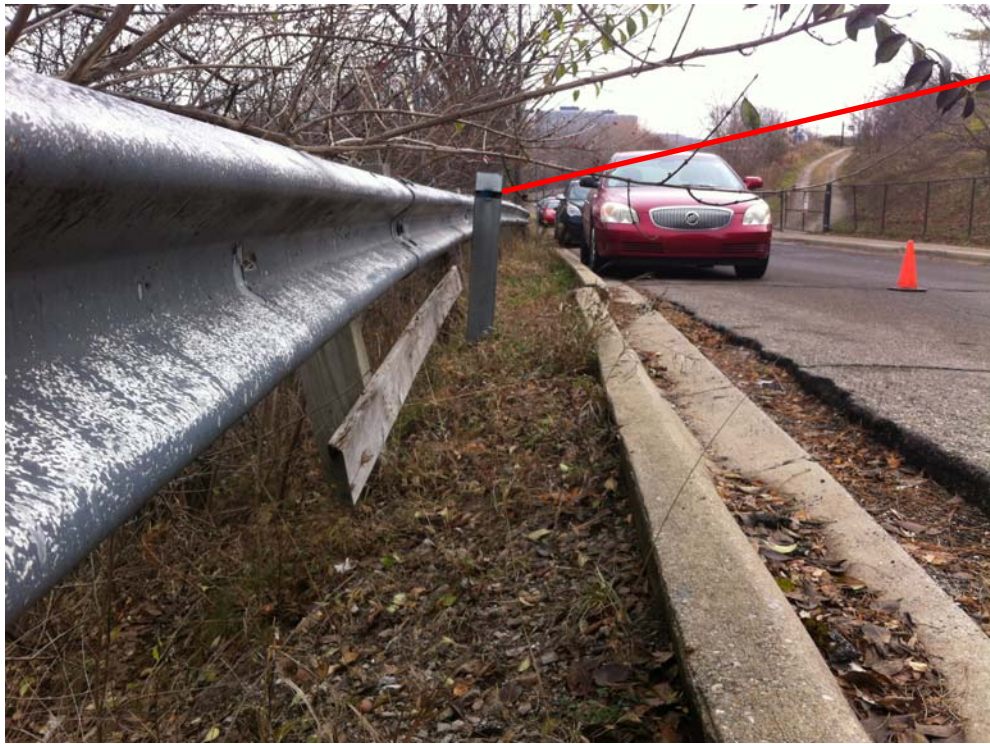
2015 Looking east, toward inclinometer I-2

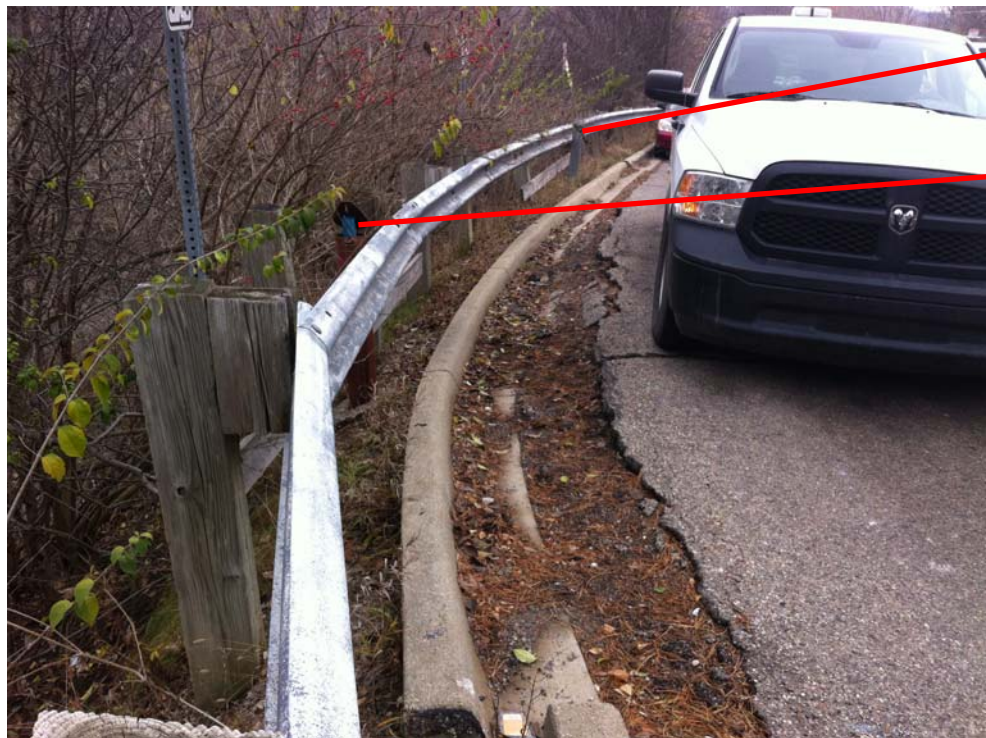
2015 Looking east, toward inclinometers I-1 and I-2
