Community Services Area

## CITY OF ANN ARBOR, MICHIGAN

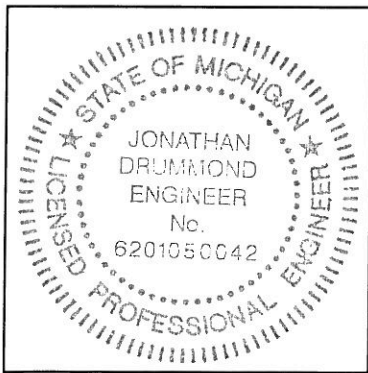
<u>Page</u>
<b>Background</b>	1
<b>Inspection Findings</b>	1
<b>Bridge Compliance With Current Standards</b>	1
<b>Bridge Load Capacity Rating Summary</b>	2
<b>Repair Recommendations</b>	2-3
<b>Summary of Repair Costs</b>	3
<b>Photographs</b>	4-11
<b>Appendix A – Updated SIA &amp; BIR Forms</b>	
<b>Appendix B – Load Rating Summary</b>	
<b>Appendix C – Repair Cost Estimate</b>

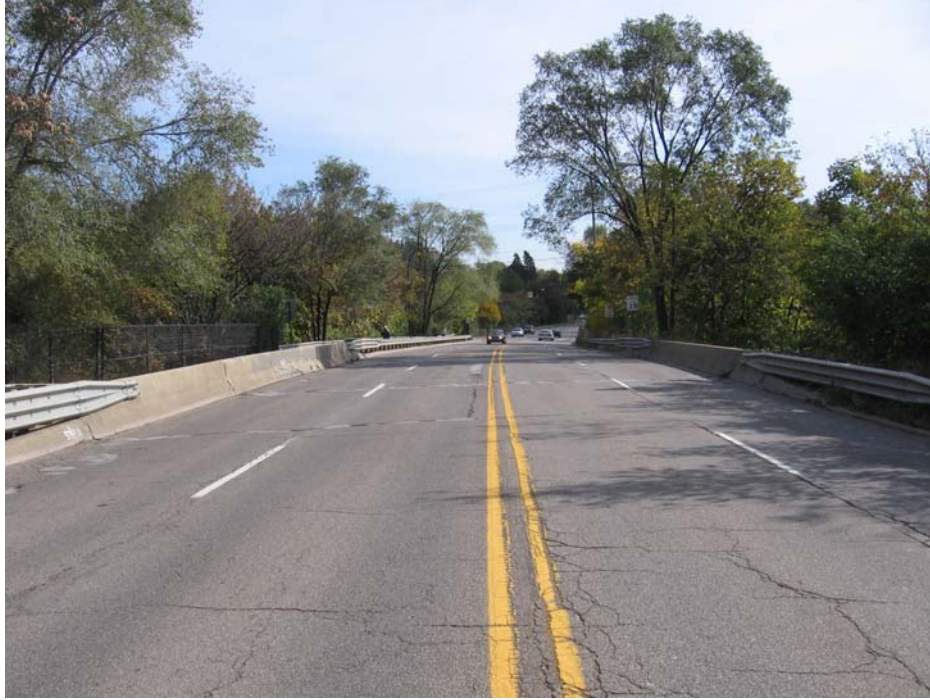
**Photo 1:** Stadium Boulevard over State Street looking East.

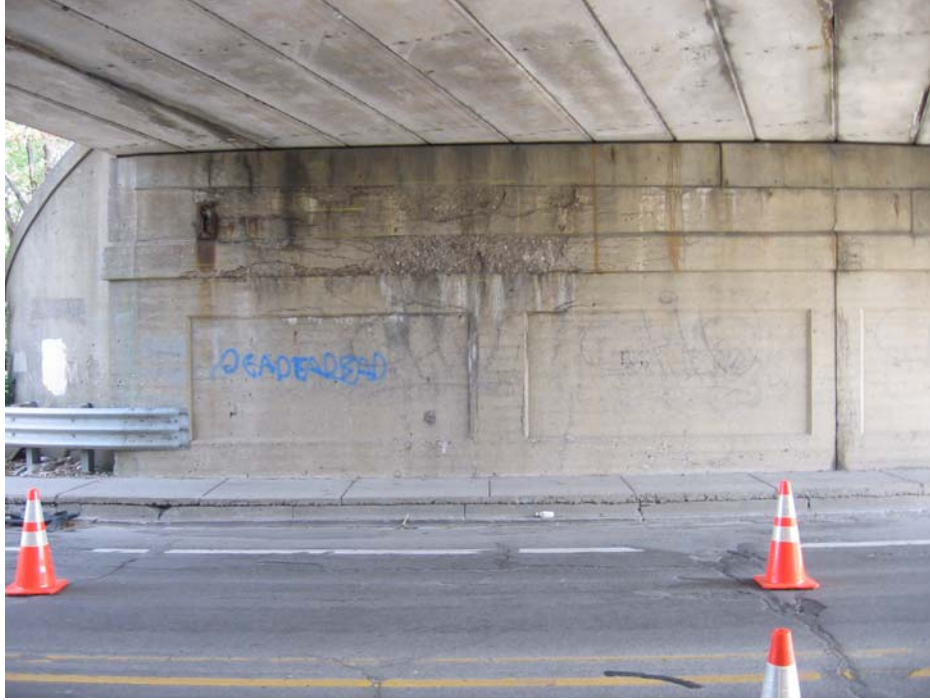
**Photo 5:** Picture showing north half of east abutment with delaminated areas and cracks.

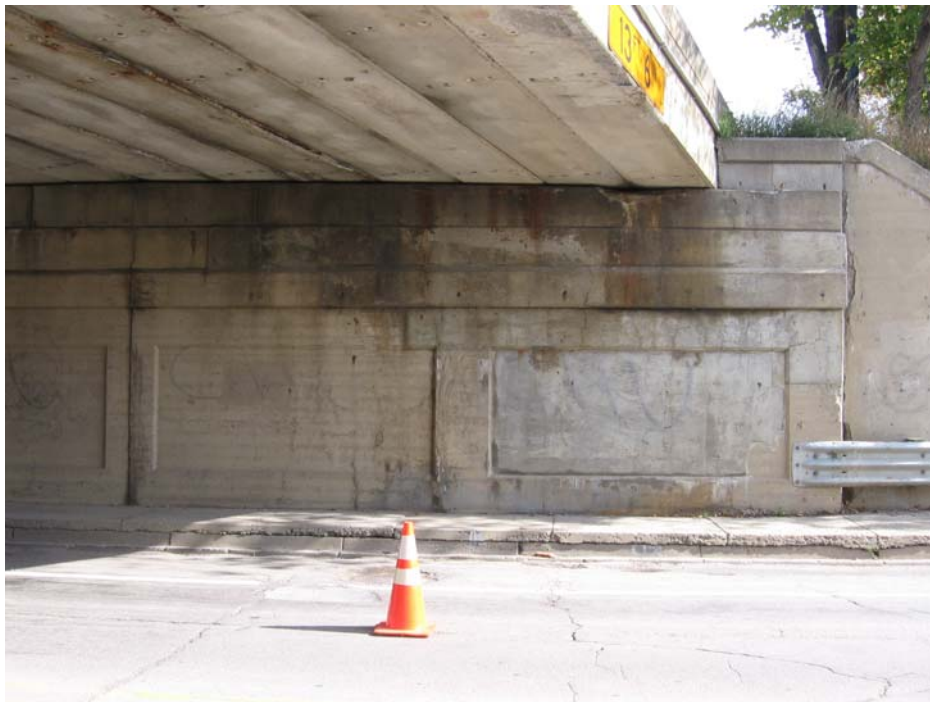
**Photo 6:** Picture showing south half of east abutment with delaminated areas and cracks.

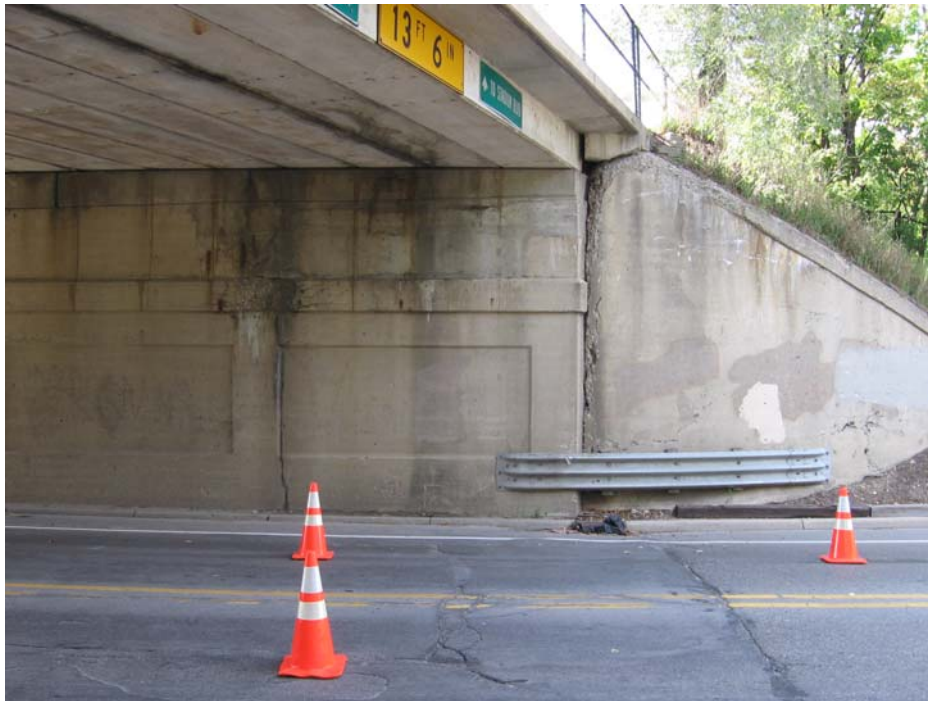
**Photo 7:** Picture showing north half of west abutment with delaminated areas and cracks.

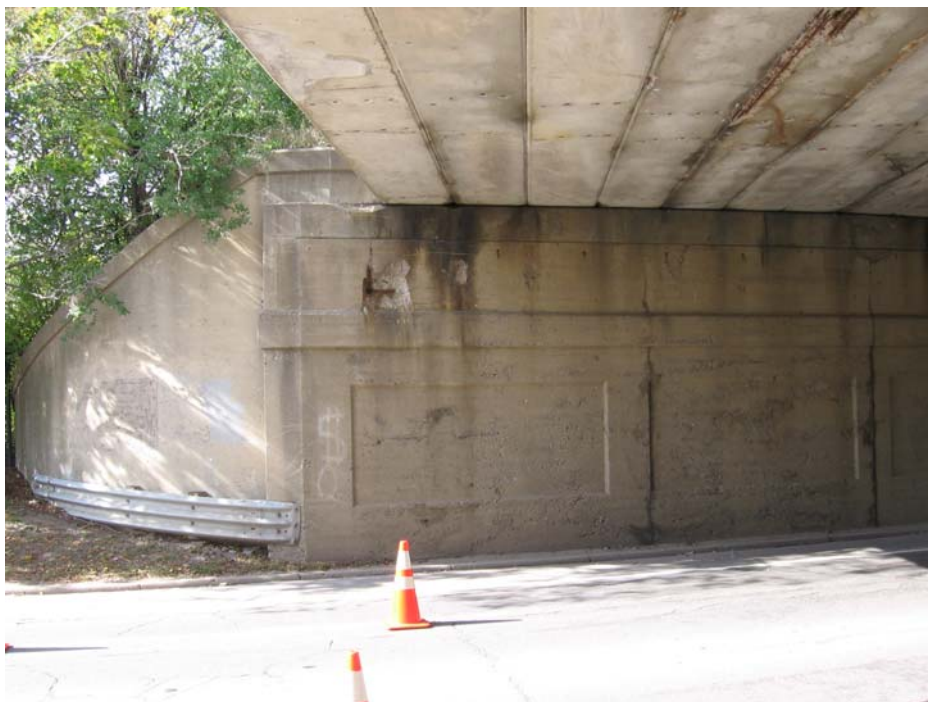
**Photo 8:** Picture showing south half of west abutment with spalled concrete, exposed rebar, delaminated areas, and cracks.

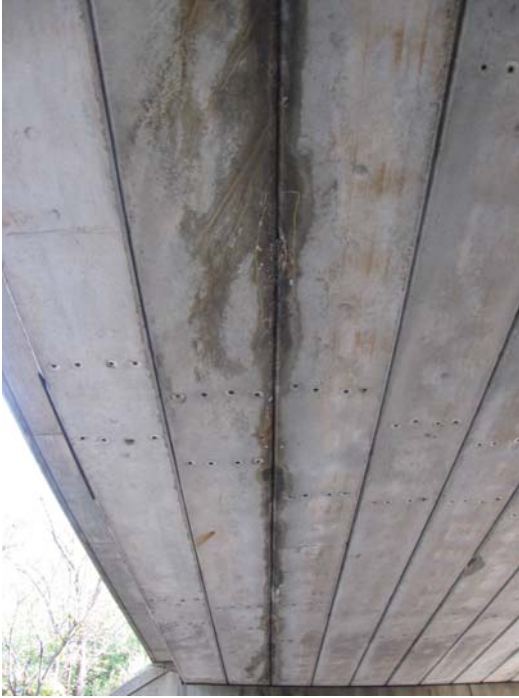
**Photo 9:** Picture showing east side of bottom of beams with spalled concrete and exposed reinforcing strands on north side of bridge.

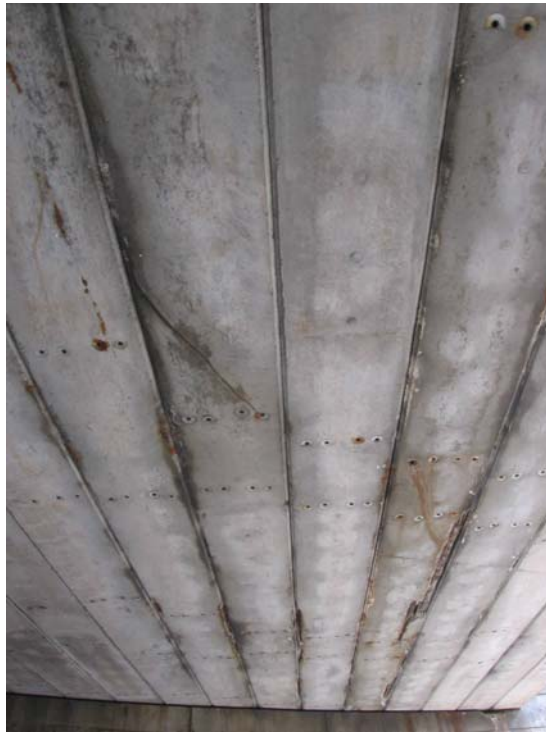
**Photo 10:** Picture showing east side of bottom of beams with spalled concrete and exposed reinforcing strands on south side of bridge.

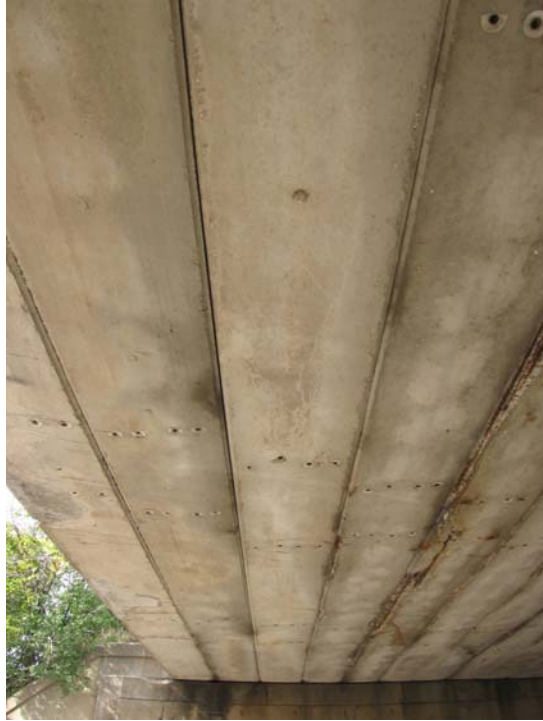
**Photo 11:** Picture showing west side of bottom of beams with spalled concrete and exposed reinforcing strands on south side of bridge.

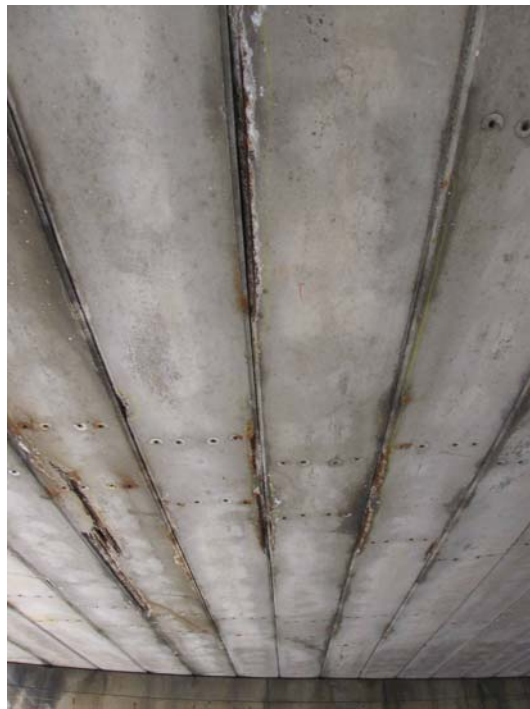
**Photo 12:** Picture showing west side of bottom of beams with spalled concrete and exposed reinforcing strands at center of bridge.

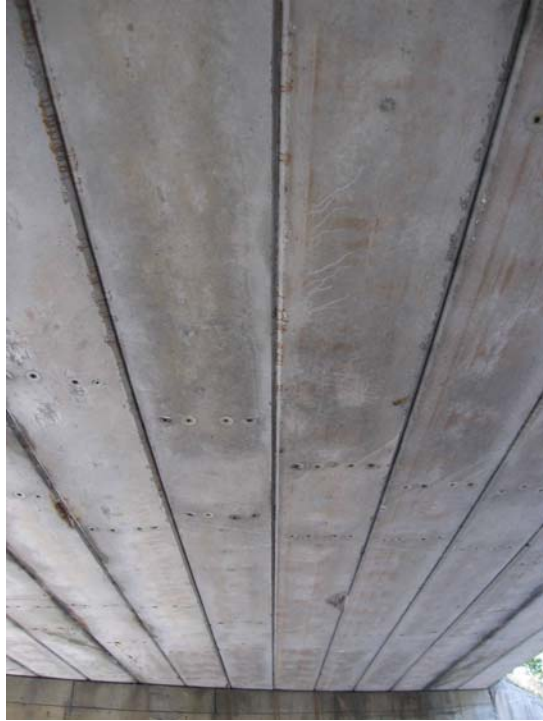
**Photo 13:** Picture showing west side of bottom of beams with spalled concrete and exposed reinforcing strands on north side of bridge.

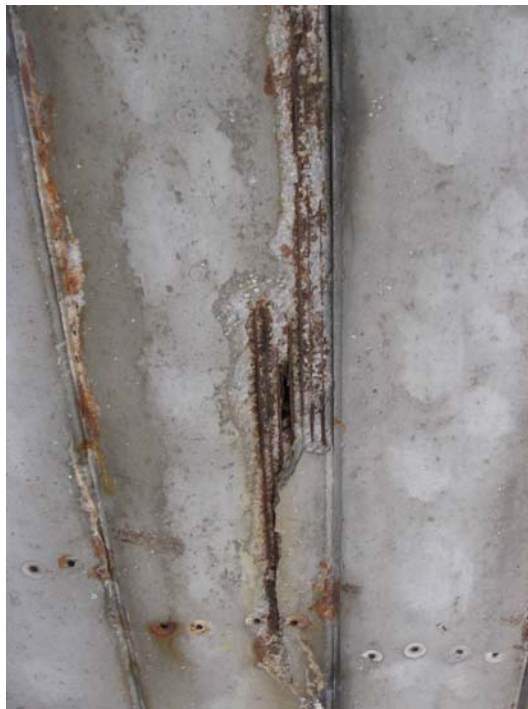
**Photo 14:** Picture showing bottom of beam with spalled concrete, multiple reinforcing strands exposed, and a hole to the center of the box.

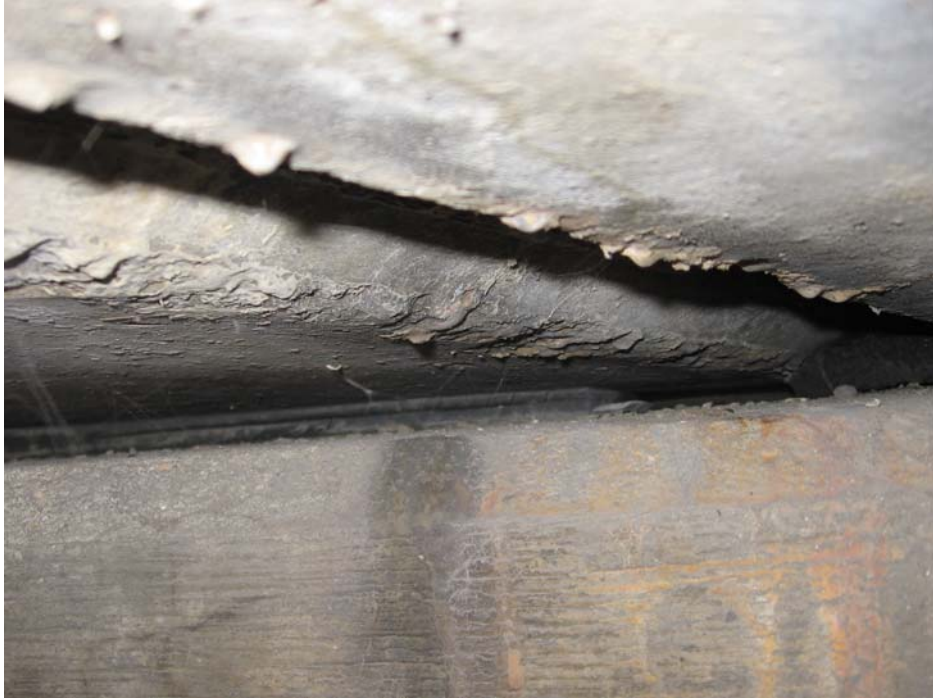
**Photo 15:** Picture showing bearing pad on east abutment in good condition.

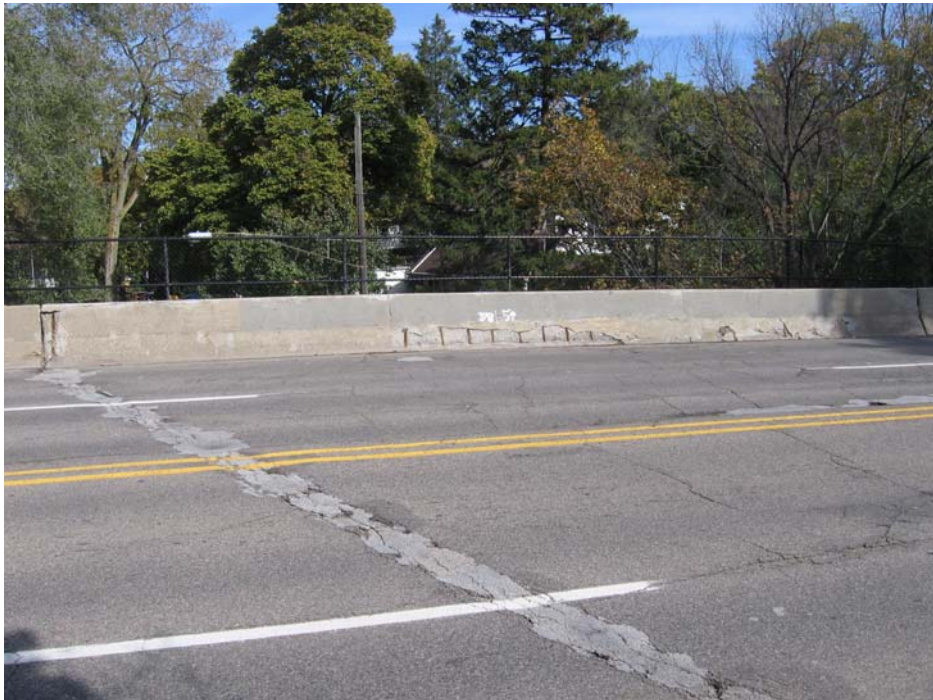
**Photo 16:** Picture showing spalled concrete and exposed rebar on north barrier.
