HURON RIVER DAMS
Argo Dam

**FIVE-YEAR
INSPECTION AND SAFETY REPORT**

December 1992

**Argo Dam
Inspection Report**

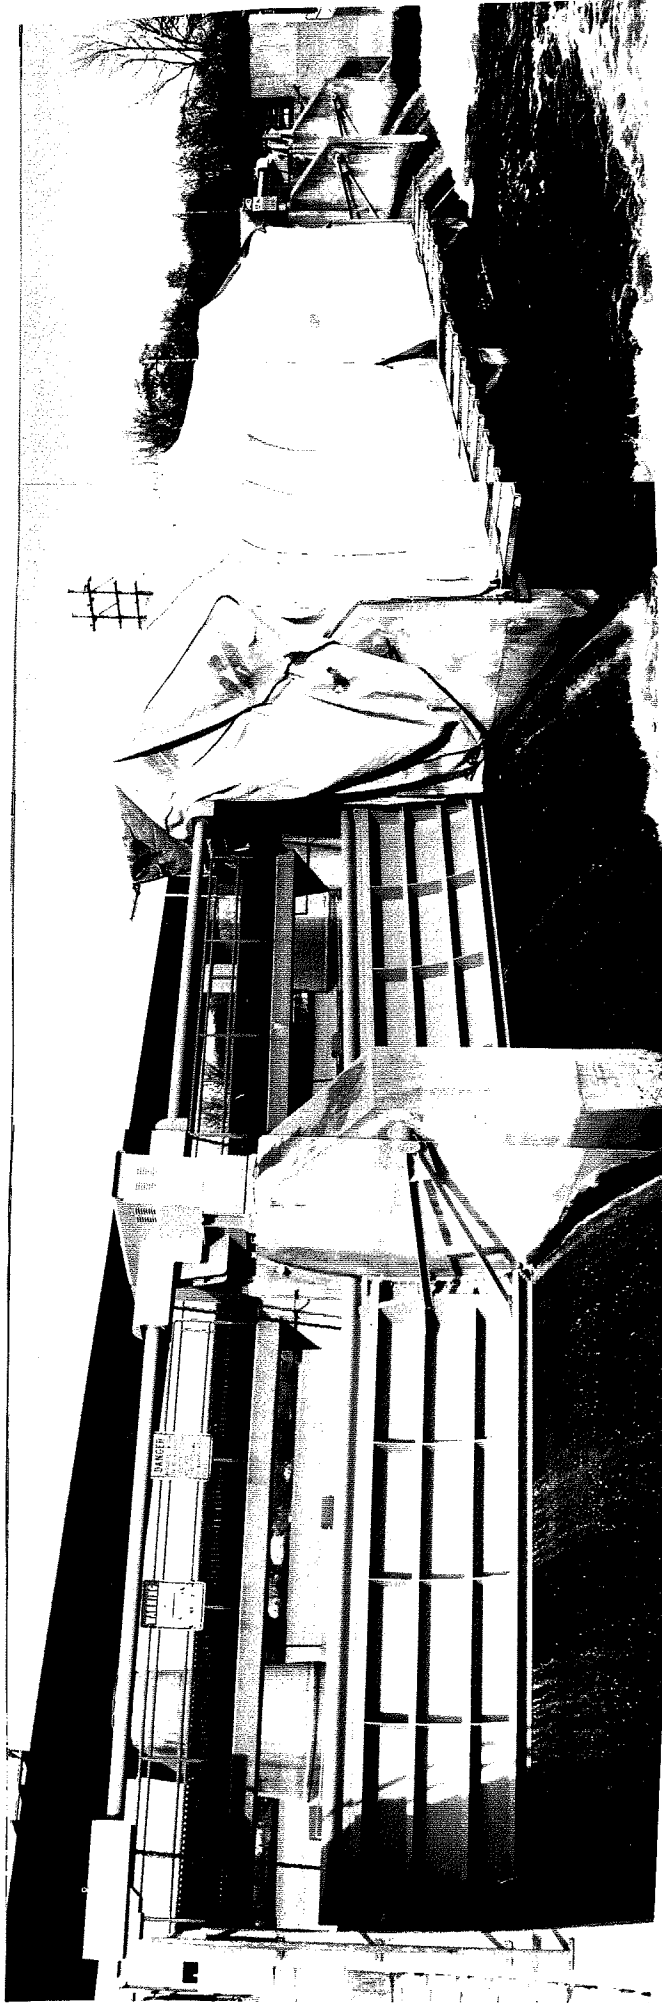
The spillway is in good condition with no signs of settlement, movement, or structural cracking. The spillway piers are in excellent condition with no areas of deteriorated concrete. Two bays were covered with tarp for repainting of the gates and other metalwork (see photo 1). In these bays a closer inspection of the piers, trunnions, gates, and spillway face was possible because of the painting contractors scaffolding in place. All of the above mentioned components were in good condition. The pool and tailwater levels were within

Photo 1: Downstream side of dam. View from right downstream bank. Note tarp over two spillway bays for repainting. Nov. '92

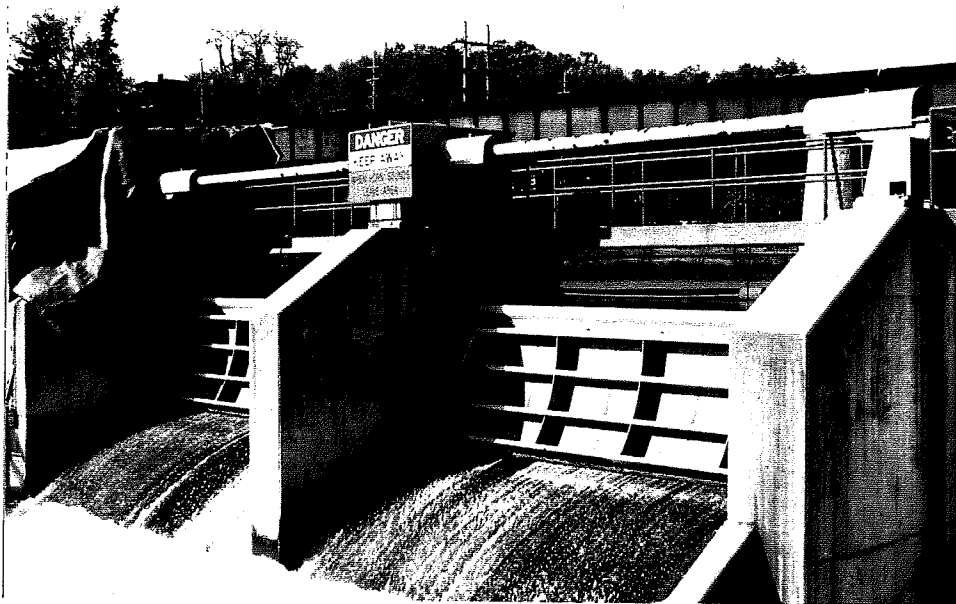
Photo 2: Two spillway bays with radial steel gates in operation. Nov. '92

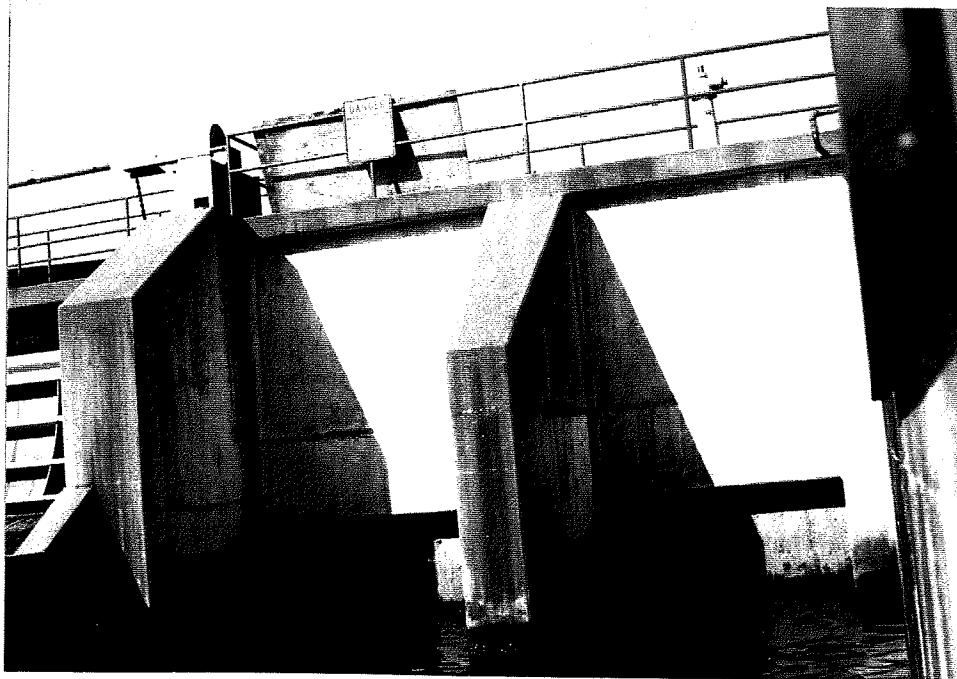
Photo 3: The two sluiceway bays on left side of dam. Vertical steel gates to control sluiceway openings at bottom of picture. Nov. '92

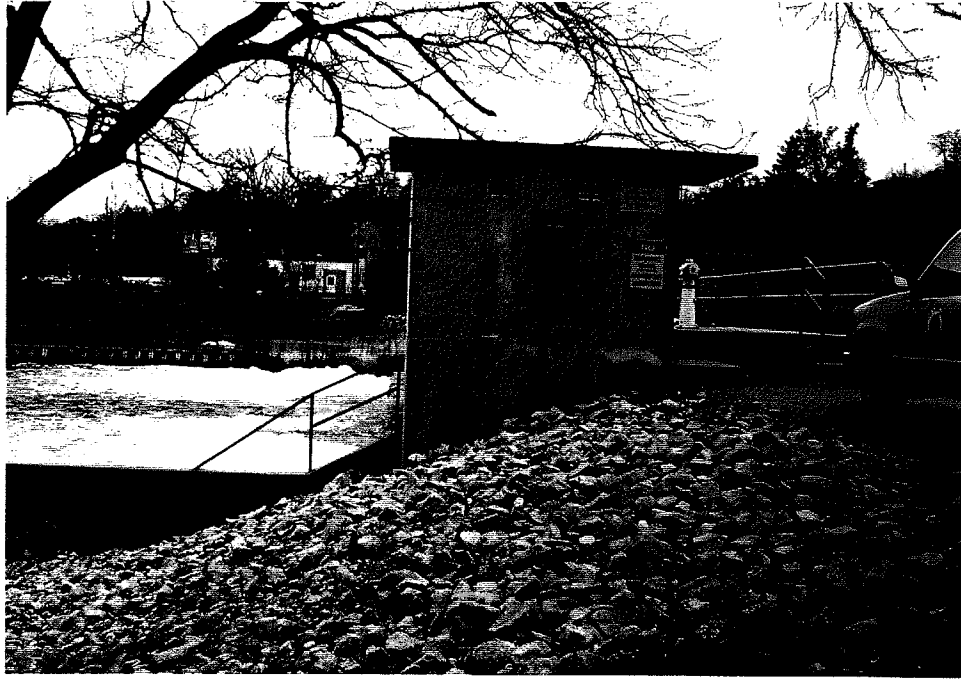
The left earth embankment is 1,500 feet long and also has a crest width of 10 feet and elevation of 777 feet. Both the upstream and downstream slopes are 2.5H:1V and have been overlain with rip-rap. The rip-rap protection extends approximately 30 feet from the left spillway retaining wall (photos 4 & 5). The abandoned powerhouse structure is located on the far left (south) end of the earth headrace dike extension of the left embankment. The old powerhouse intake openings were blocked permanently with a reinforced concrete bulkhead 15 in. thick. The powerhouse contains DECO's switchgear, but no turbines or generators. To maintain circulation of water through the headrace a V-shaped concrete side spillway chute is located at the far left end of the headrace dike. A valve-controlled 12 inch pipe from the headrace to the old tailwater also provides circulation. The forebay was backfilled and is used as a City Park. There is a dike branching off from the headrace dike/left embankment, that ties into the railroad embankment. This dike has a concrete box culvert which has slots for stoplogs.

The regrading and new rip-rap protection of the upstream and downstream slopes of the left embankment is in excellent condition (see photo 4, 5, and 7). The stoplogs which were recommended for emergency closure of the box culvert entrance to the abandoned powerhouse channel have not been designed or fabricated. When available they should be stored at Barton Dam.

Photo 4: Control house structure. Rip-rap along downstream face of left embankment. Nov. '92

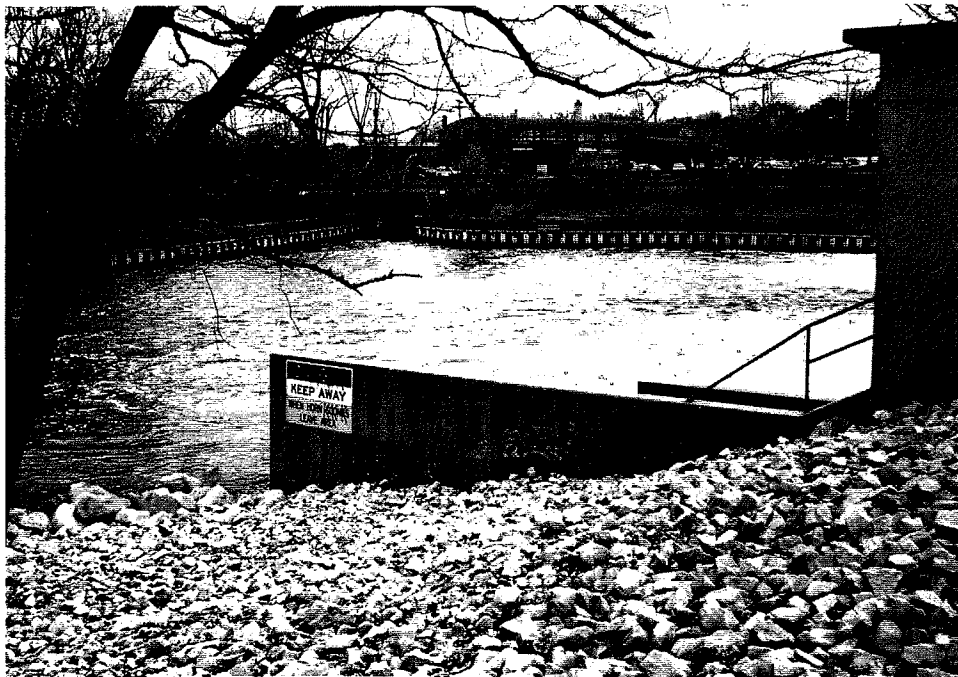
Photo 5: Rip-rap along downstream face of left embankment. Steel pilings along right downstream bank can be seen across spillway. Nov. '92

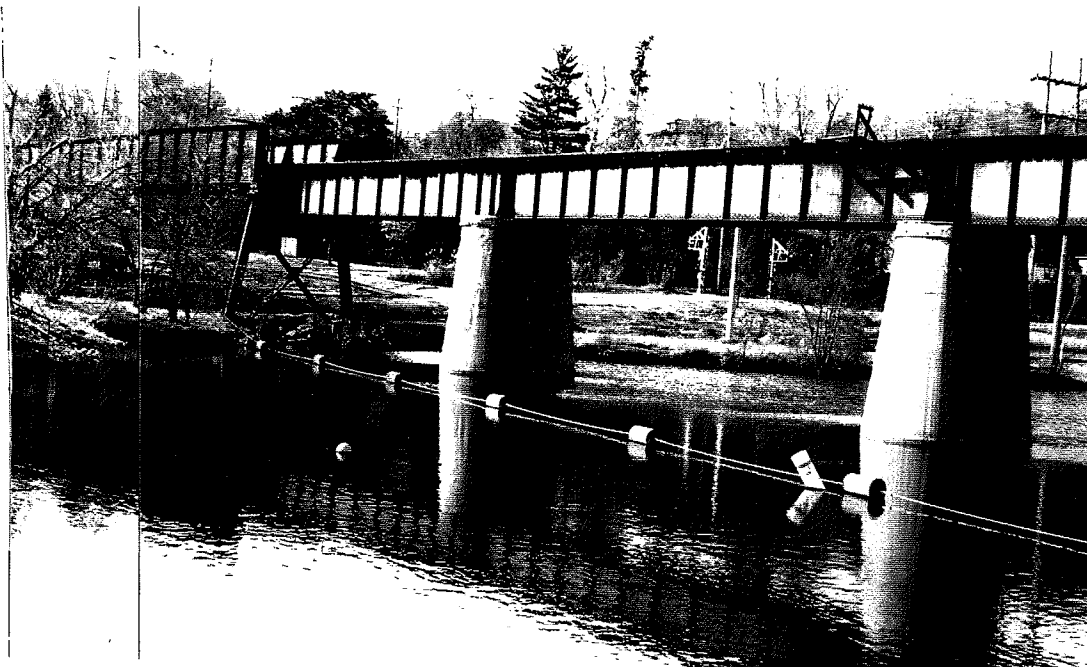
Repairs being made to the railroad adjacent to and just upstream of the right embankment was observed and it appears that the new cut for the railroad is lower than the top of the right embankment (see photo 6). However, the embankment and upstream shoreline along the reservoir have not been changed and remain approximately at the same or slightly above the elevation of the embankment crest.

The upstream safety float and cable line is in good condition (see photos 6 and 7). The line is anchored to a steel railroad support on the right bank and to a pipe near the box culvert on the left bank, which are in good condition. The danger signs on and along the dam are clearly visible and in good condition. In addition warning sirens sound before gates are operated. The city receives complaints weekly because of the volume of the sirens.

Photo 6: Right earth embankment and upstream bank. Float and cable system can also be seen. Nov. '92

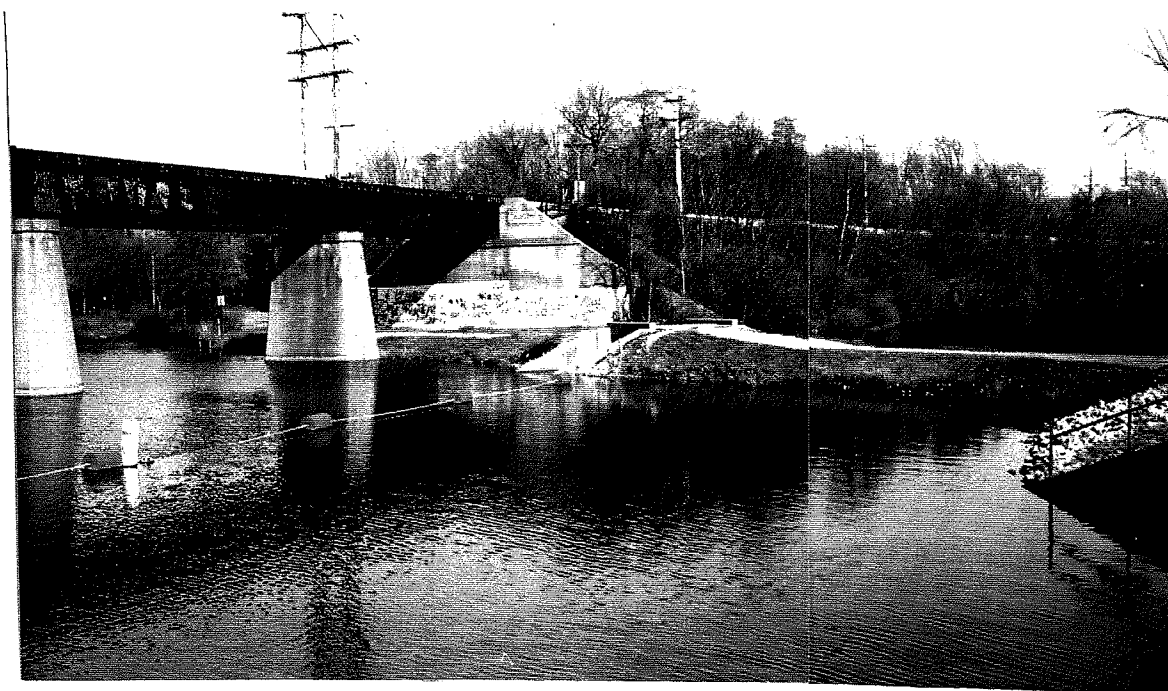
Photo 7: Upstream face of left earth embankment protected by rip-rap. Earth dike that branches off old headrace dike. Nov. '92

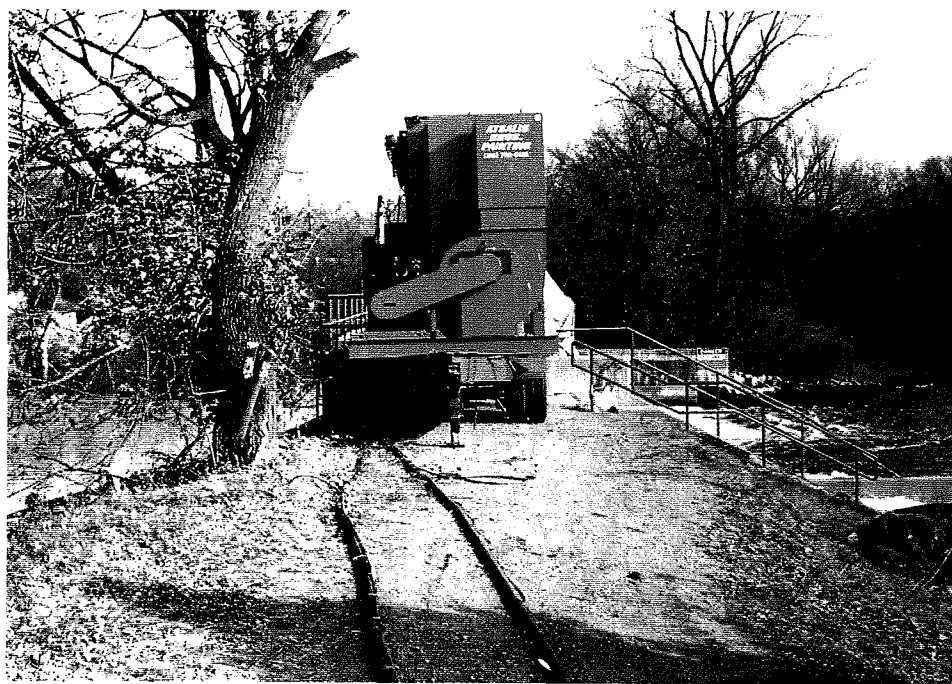
Photo 8: Crest of right embankment. New stairway and railing can be seen. Painting contractors equipment can also be seen. Nov. '92

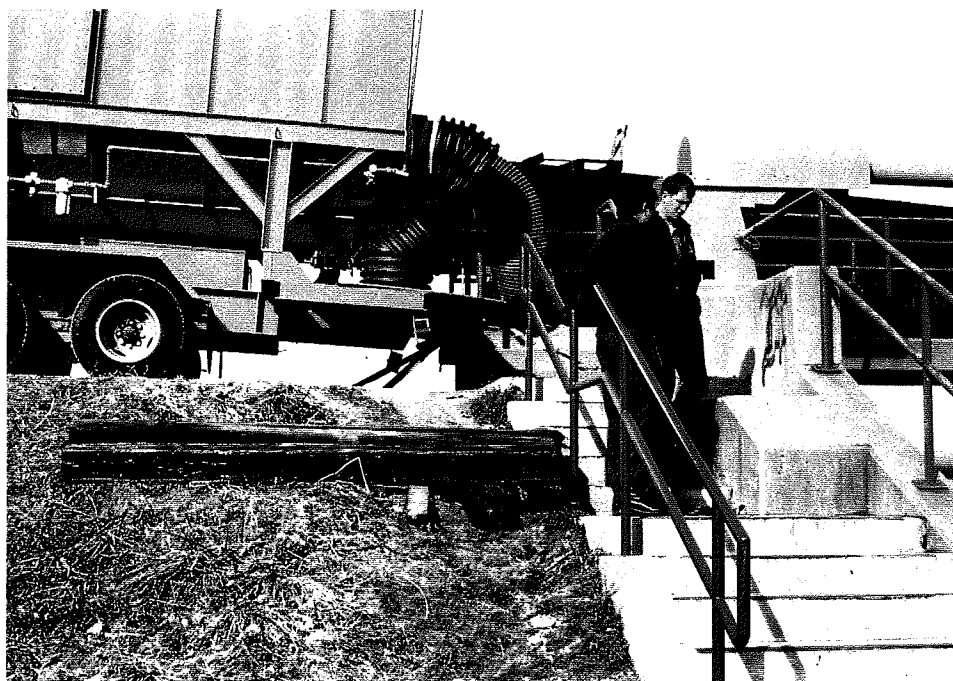
Photo 9: Downstream slope of right embankment. New concrete stairway and painting contractors equipment can be seen. Nov. '92
