Water Damage and Mold Assessment Report
Ann Arbor Fire Department
2415 Huron Parkway, Ann Arbor, Michigan
(Fire Station #4)
Date of Inspection: November 7, 2013

**Subject: Water Damage and Mold Assessment Report
Ann Arbor Fire Department, Fire Station #4
Located at 2415 Huron Parkway, Ann Arbor, Michigan
TEK Project Number: CI0044/635**

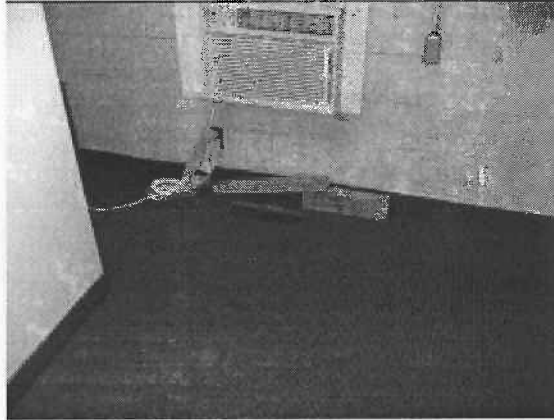
However, the south wall of the Southwest bunk area was determined to contain elevated moisture conditions. The cinderblock wall system had elevated moisture greater than 35%.

1. Southwest bunk South wall below the air conditioning unit, visible damage to the cinderblock and carpet

- Abrasively clean or scrape the cinderblock South wall to remove visible paint bubbling and damage to this wall below the air conditioning unit.
- Remove and dispose of glued down flooring within the Southwest Bunk, and abrasively scour any existing staining present. * **Proceed with carpet removal cautiously as 9x9 tiles and mastic may be present beneath flooring that have been identified as asbestos containing.***
- After abrasive methods are used on the cinderblock wall system and cement flooring, treat the remaining components (structural) with a professional grade anti-microbial disinfecting agent pre-approved by the property owner.

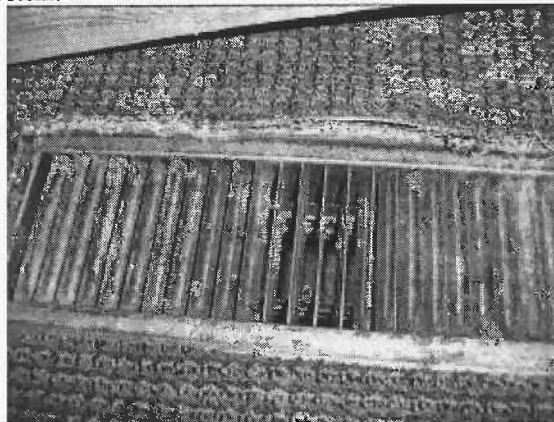
2. Southwest Bunk South wall damage to the carpet and evidence of water intrusion to the duct system below the air conditioning system.

- The air conditioning unit that is currently installed should be removed from the wall cavity and inspected for the possible cause of damage and/or water intrusion to the south block wall, minimally this wall cavity should be inspected and/or addressed to meet industry standards for acceptable allowable moisture levels within cinderblock materials.

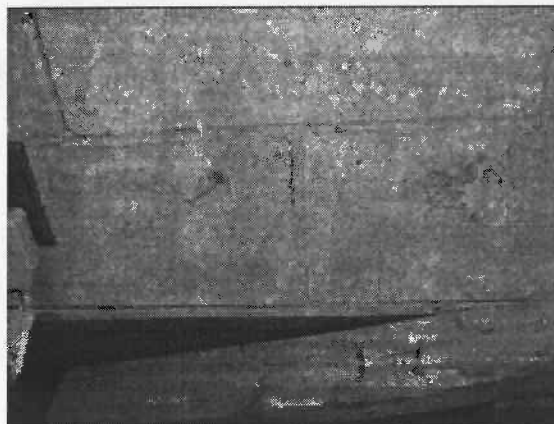
3. Bunk South wall with visible damage to the wall, paint bubbling and calcification indicating water intrusion.
