Materials Recovery Facility Safety Observation Form

Date: Saturday, July 2nd, 2016

2 MRF INSPECTION - 07/02/2016

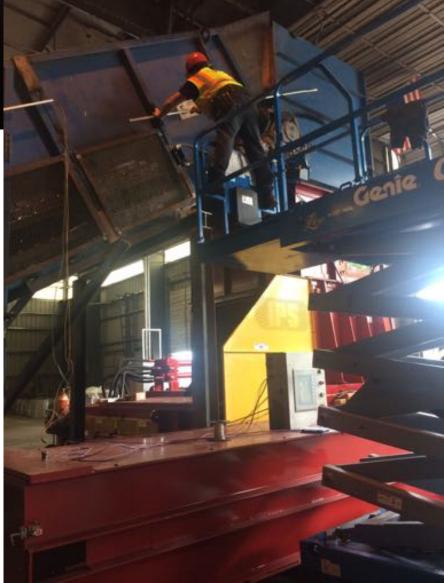
Below: Poor work positioning, worker standing on mid-rail, leaning over the edge of the bucket, with no fall protection.

(abated immediately)
