Exhibit D ACCESS ROUTE

APPENDIX D

RE: Nichols Drive Slope
UM Medical Campus
Ann Arbor, Michigan
SME Project No. 073412.00

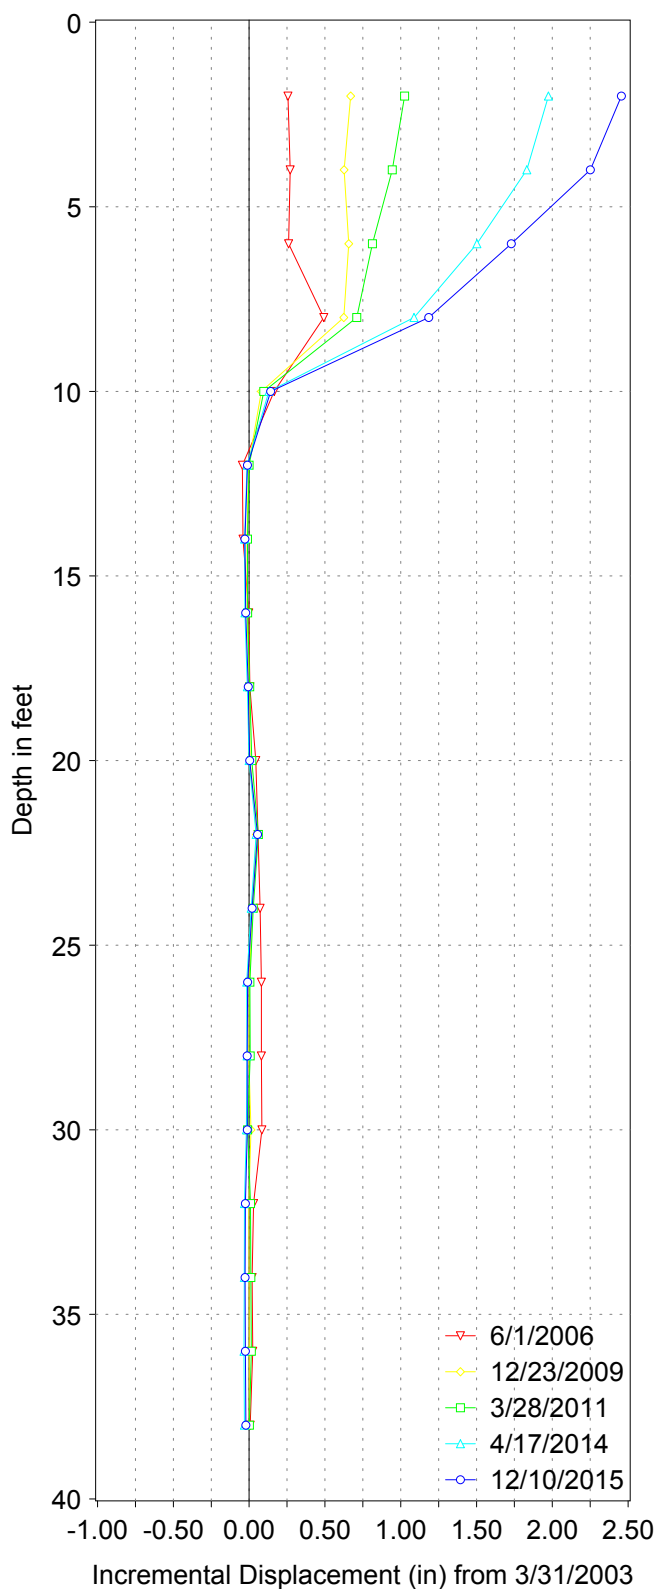
I-1, N-S Axis (AO=North)

Our review of the latest inclinometer data indicates the slope is still continuing to move to the north at a relatively constant rate. There is no reason to expect that the movement will stop, although the rate of movement in the future may dissipate or increase compared to the average, long-term rate experienced since the inclinometers were installed in 2003. In general, based on our experience, an increase in the rate of movement would likely be an early indicator of pending slope failure. This rate increase may occur over a relatively short period of time (months, weeks, or even days).
