Materials Recovery Facility Safety Observation Form

Date: Thursday, June 23, 2016

Name of Observer: Shawn Qualls

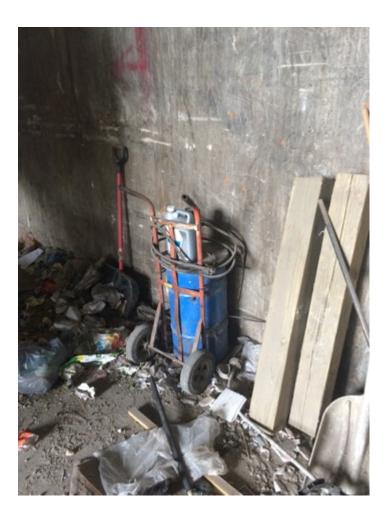
Improper chemical storage:

- Placed in pinch-point between wall and mobile equipment
- No labels

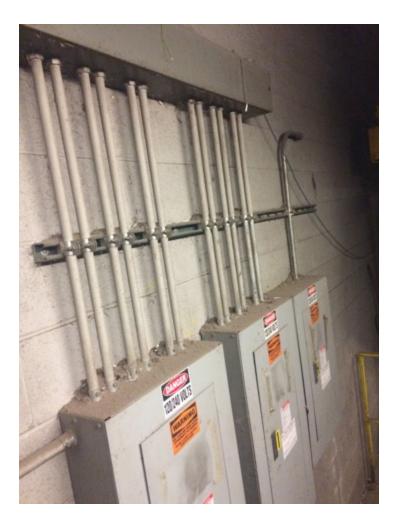
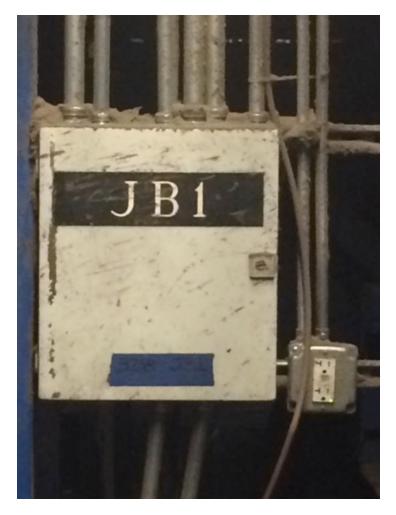
- All:
 - Dust & debris built up atop electrical equipment fire hazard
 - Cover not secured
 - Improper labeling [1910.303(e)]

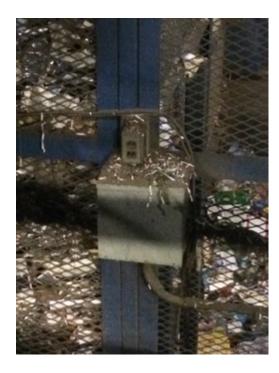
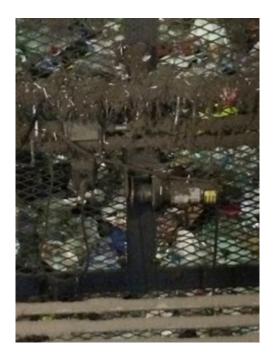
All: Dust & debris atop electrical equipment – fire hazard

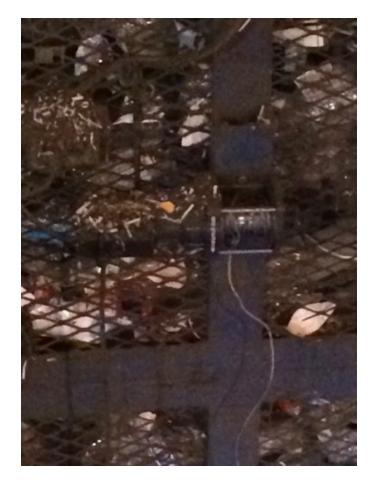
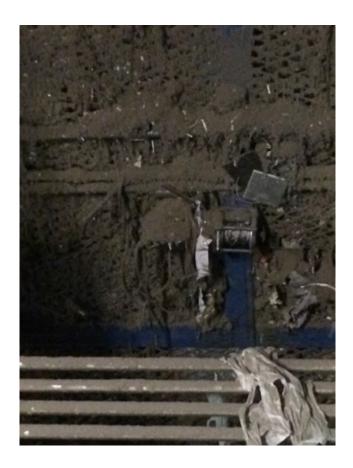
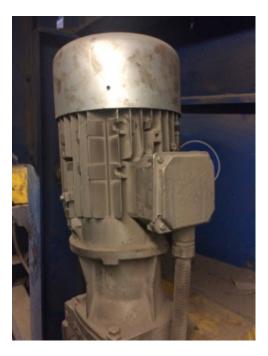
All: Dust & debris in/on/around electric motors. Susceptible to overheating/failure; fire hazard

Top left & middle: metal caps not secured, screws missing

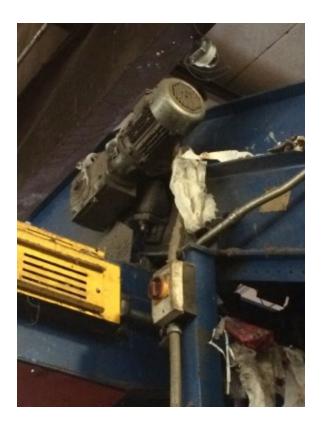
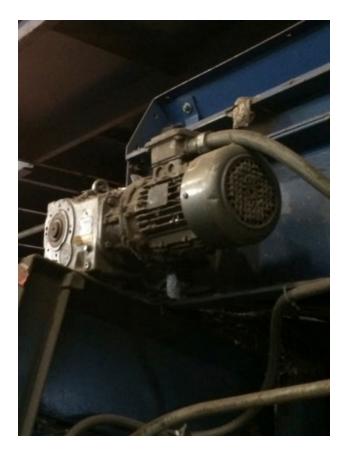
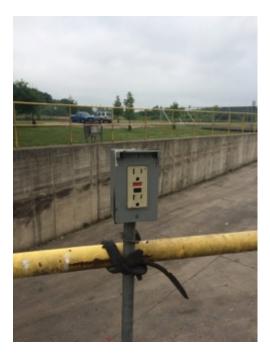
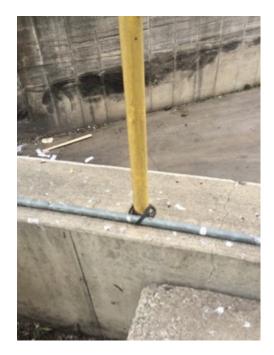
Left: GFCI

- Improperly secured to railing
- No cover

Right: Improperly secured

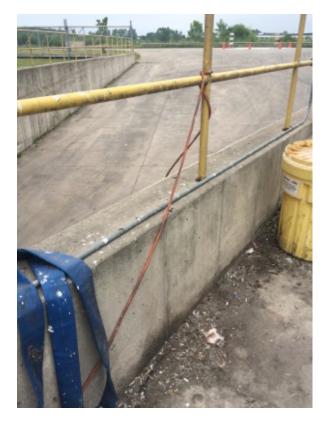
Bottom:

- Broken extension cord w/ exposed leads
- Cord not removed and stored immediately after use [1910.305(a)(2)(ii)]

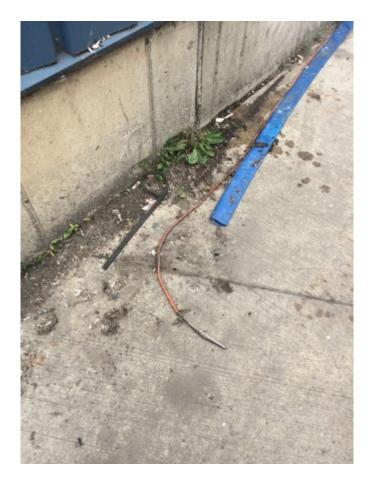
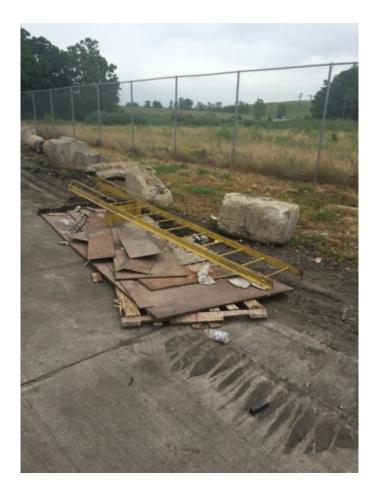
All: Improper materials storage/poor housekeeping

Bottom: Container not labeled

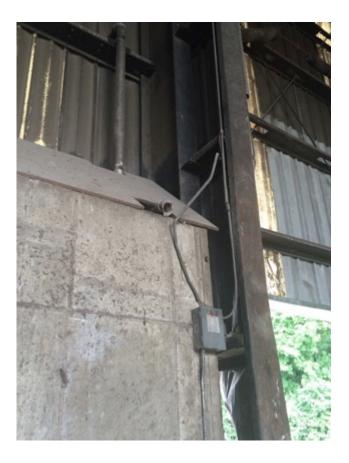
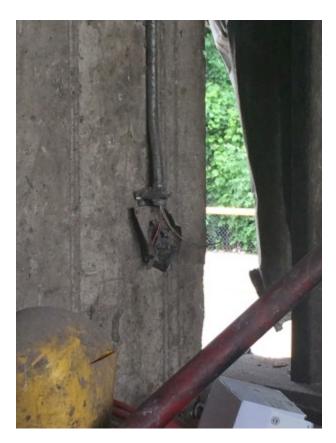
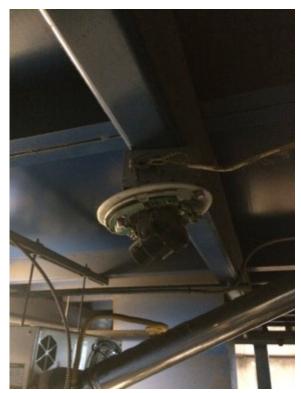
All: Exposed wiring Bottom right: dust/debris build-up

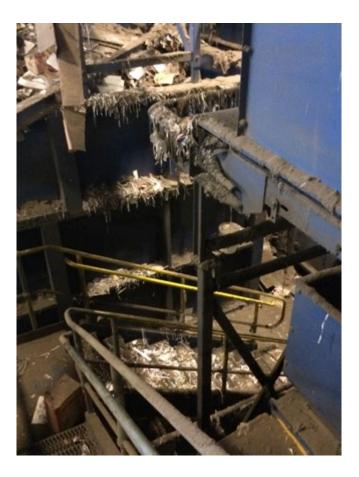
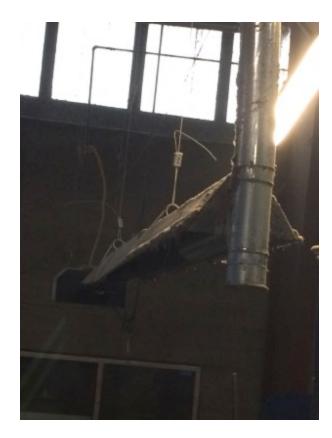
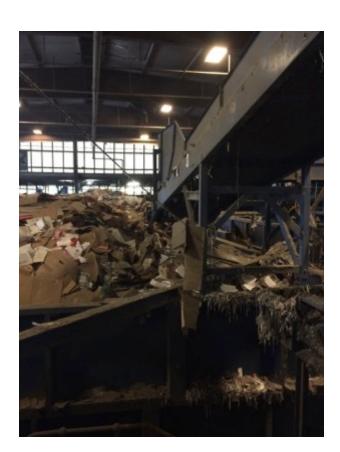
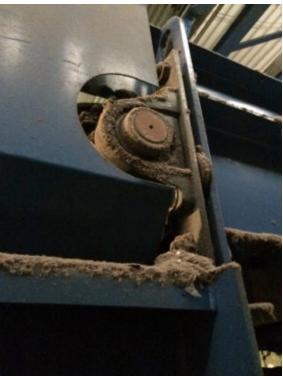
Top left: dust/debris built up atop heater – fire hazard

Top right: wiring strung over/underneath machinery, large piece of cardboard got caught on it.

Bottom: moving part left unguarded

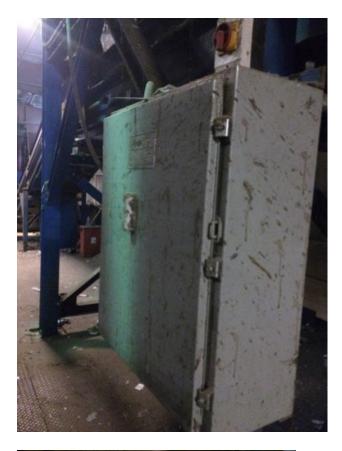
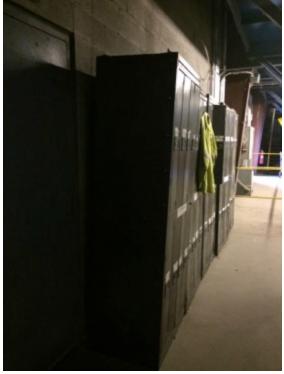
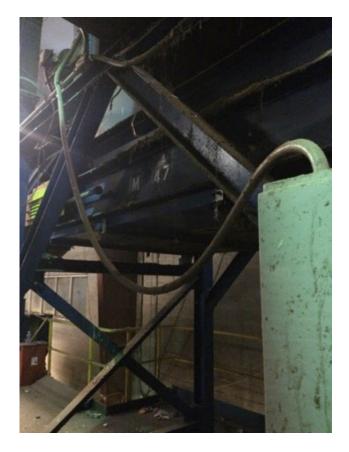
Top left: Not properly labeled

Top right: high-voltage line not secured

Bottom: lockers set on uneven surface, potential crush hazard.
