## Materials Recovery Facility Safety Observation Form

Date: Wednesday, July 6th, 2016 Name of Observer: Shawn Qualls

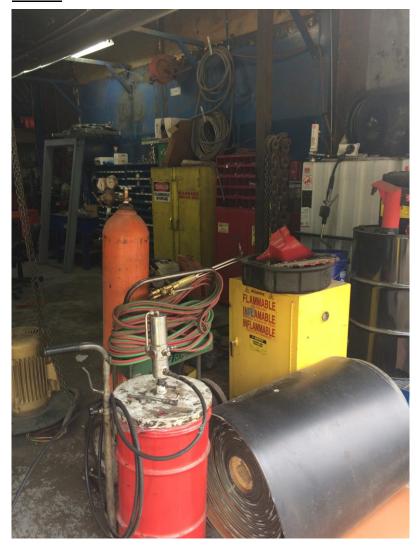
CG cylinders stored less than 20 feet from flammables/combustible materials (NFPA 51 2-2.1, 2-4.1)

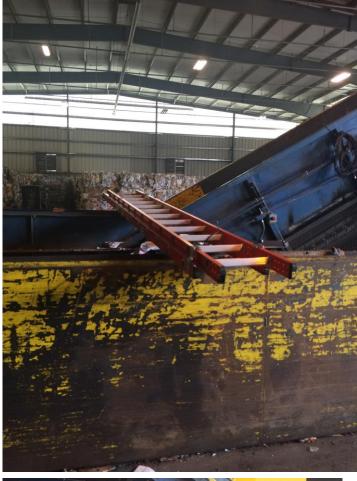
## Top left: Ladder storage

- Improper storage
- Ladder looks as though it may have been set up for use as a platform. Did not witness anyone using it as such, but 1910.26(c)(3)(vii) prohibits the use of ladders as platforms, gangways, etc.

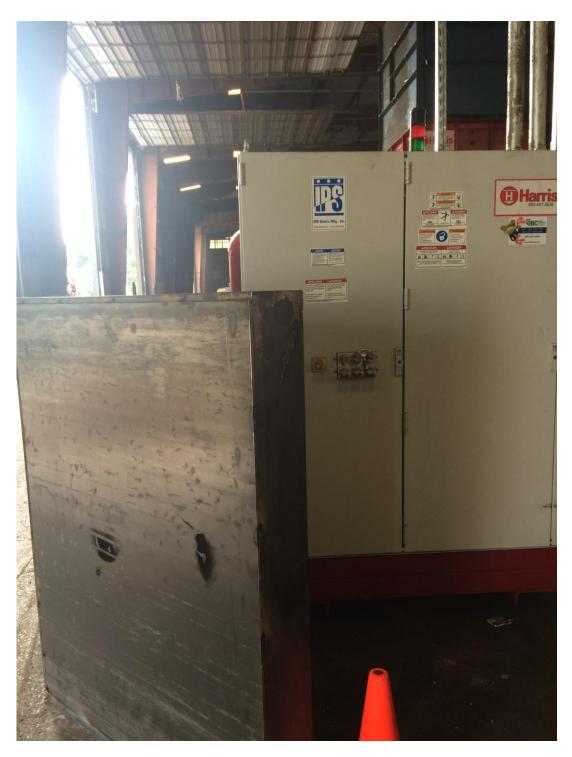
New wall presents possible clearance issue. 20 CFR 1910.303(g)(1)(i)(B) states: "The width of working space in front of the electric equipment shall be the width of the equipment or 762 mm (30 in.), whichever is greater. In all cases, the working space shall permit at least a 90-degree opening of equipment doors or hinged panels"
